I Aluminium Fresh Water Tanks – Near Collapse due to Serious Corrosion

2 Lacerated Wound and Fracture of the Knee

3 Dangers of Battery Charging

4 Drugs Tampering

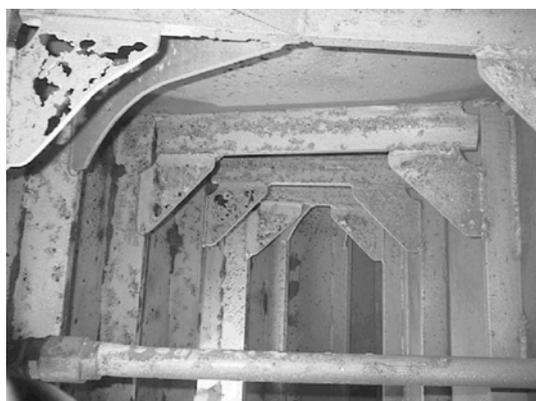
Brackets and stiffeners were found partly corroded through, as shown in figures 1 and 2. The corroded areas in the fresh water tank had to be partly renewed and repaired to an acceptable standard.

Figure 1: Transverse bulkheads and deckhead

The process for cleaning the fresh water tanks was considered to have been a major factor in the corrosion process. The fresh water tanks were sterilised annually, which exposed the tanks to a solution of hypochlorite for 12-24 hours. In addition, the shore-supplied water was frequently chlorinated, which meant that the tanks were frequently exposed to chlorides.

Even small amounts of hypochlorite can be very dangerous for aluminium, irrespective of the Al-alloy chemical composition, resulting in the development of serious pitting. Once pitting corrosion has started, it may continue to develop for a certain period if the tank is not properly washed with water after the application of hypochlorite. The filling and emptying of the tank is not sufficient to remove all the corrosion products. The reason for the corrosion attack is considered to be that the thin aluminium film on the surface is depolarised and locally broken down, in connection with the formation of chlorine released from the hypochlorite.

- ◆ Hypochlorite or other chloride-containing chemicals should not be used for sterilisation of aluminium fresh water tanks if the tanks have not been fully coated;
- ◆ In the case of uncoated aluminium fresh water tanks, other means of sterilisation than chloride-containing chemicals is needed, e.g. by using ultra-violet light;
- ◆ If hypochlorite is used in coated tanks, it is essential that the tanks are thoroughly cleaned after the process. This is to minimise the change of corrosion occurring in the event of the coating breaking down.

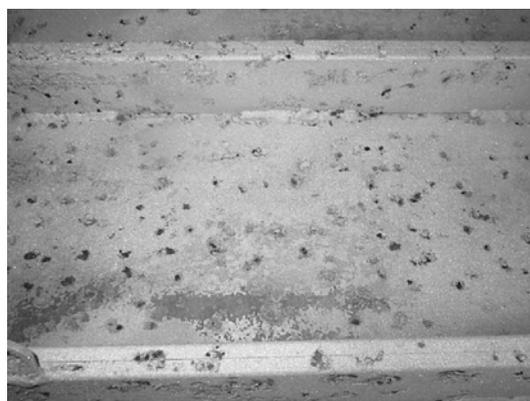
Figure 2: Bottom plating

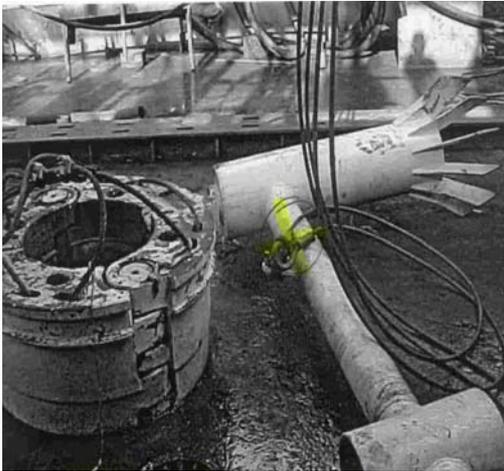
Figure 3

An assistant driller and others were trying to lift the balancing frame to 'Guide line' with the aid of a tugger winch, so that it could be lowered to the well head. Because the frame winch wasn't in a proper balance position, the assistant driller tried to adjust the sling for lifting. When he had just finished shackling the frame to the winch sling, the balancing frame fell backward onto his right knee. The photos allow a better understanding of the accident.

The injured person had not observed that there was no tension on the sling that he shackled to the frame before carrying out the adjustment on the sling. He probably failed to signal to the winch operator to pick up and tension the sling.

The assistant driller suffered a lacerated wound on the lateral side of his right leg and a fracture of the knee.

- ◆ Riggers on board to be properly trained;
- ◆ Activity to be planned with proper toolbox meetings and job safety analysis, as this helps avoid this kind of incident occurring in the future;
- ◆ Improve communication between operator involved in the operation.

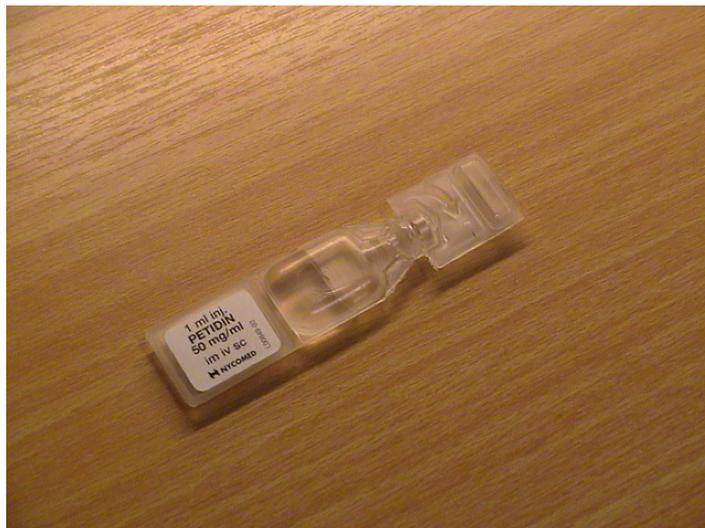
A member has reported that drugs kept on board were found to have been tampered with. The drug was either morphine or pethidine and was kept in a plastic ampoule. Someone used a small needle, inserted into the top cap of the ampoule (below the imprinted 'twist arrow'). After either all or some of the drug had been removed, any shortfall was replaced with a clear liquid – the levels of tampered and non-tampered were the same. The hole was then covered with what looked like clear modellers glue.

Members may need to re-consider their own security arrangements. Wherever drugs are kept on board vessels or installations, security is paramount. Apart from serious concern over drugs going astray, the dangers of this sort of tampering are evident. It highlights that, at an inventory check, personnel need to give the ampoules more than just a cursory glance. Despite whatever security is in place, this incident underlines the extreme importance of carefully checking any medical supplies before use, especially drugs.
