These flashes summarise key safety matters and incidents, allowing wider dissemination of lessons learned from them. The information below has been provided in good faith by members and should be reviewed individually by recipients, who will determine its relevance to their own operations.

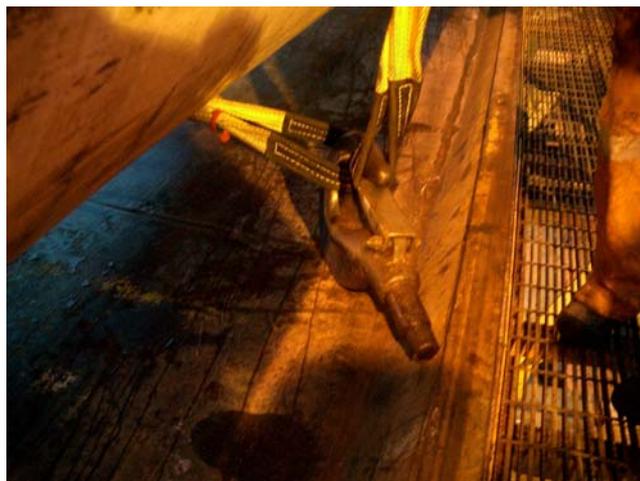
We have received a report of a crane incident that happened in connection with the transport of a riser joint from pipe shuttle to pipe storage deck. In order to transport the riser joint to the pipe storage deck, it was lifted up approximately 1 metre with a gantry crane (pipe handling crane). The crane hook loosened from the hook block fastening point and both the hook and the riser joint fell down again into the pipe shuttle. The 12m long pipe weighed 7.3 tonnes. No persons were in the area during the incident.

- ◆ worn-out threads; and
- ◆ 'play' in the hook;

- ◆ the 'play' in the hook had been reported earlier but this had not been followed up;
- ◆ check routines had been insufficient;
- ◆ mounting failure was possible;
- ◆ there had been insufficient control; and
- ◆ the hook fastening was badly designed.

- ◆ Establish relevant check routines;
- ◆ Control other similar hooks/lifting arrangements;
- ◆ Contact supplier.

- ◆ Soft material inserts to be replaced and a better designed hook to be installed;
- ◆ Total survey of technical condition of crane to be executed;
- ◆ Operating time to be evaluated;
- ◆ Checks to be carried out to ensure that all necessary certificates for lifting equipment are in place and easily accessible.

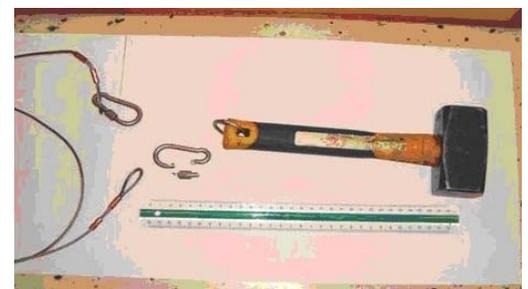
Work was ongoing to remove an obsolete bracket from a derrick beam. A 1.6 kg hammer in use came loose from its double sealed spring hook and fell 6-7 metres

- ◆ The finger articulation on the carbine hook was riveted to the spring hook body. However, the spring hook was found to be without this rivet. It might have slid out during the work due to incorrect riveting or the rivet might have been broken in two pieces during the work. The spring hook itself was not deformed or damaged in any way.

- ◆ The spring hook (length = 54 mm, bow diameter = 25 mm, t = 5mm) is made of solid stainless steel.
- ◆ The spring hook was designed for tension along its longitudinal axis and not for loads directly on its locking mechanism.

- ◆ All similar spring hooks have been taken out of use
- ◆ Spring hooks have been temporarily replaced with shackles with split pins

- ◆ The spring hooks are to be replaced with a better quality double seal type
- ◆ The vendor has been informed of the incident
- ◆ Relevant findings from the investigation are being distributed appropriately.

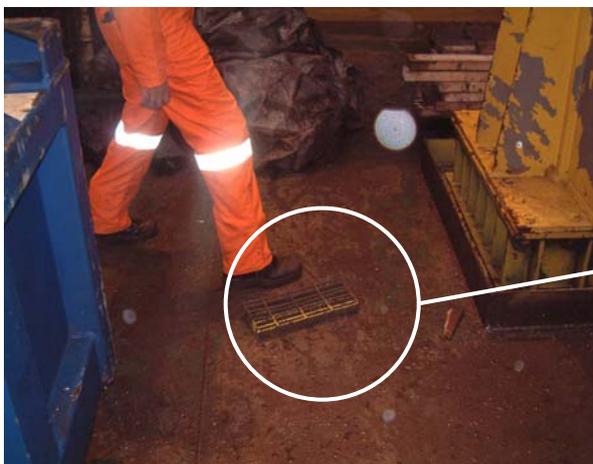
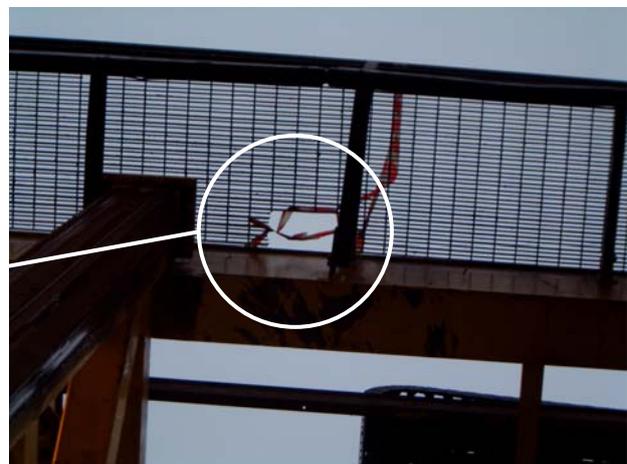
One of our members reports an incident wherein a piece of grating, of size 37x15 cm and weight 3 kg, fell 11 metres from a catwalk onto the pipe-deck below. Whilst there were crew members in the area, no-one was hurt.

- ◆ Insufficient quality control/verification of finished work
- ◆ The weld that secured the piece of grating failed
- ◆ Work management – insufficient following up of work

- ◆ Inspect grating in derrick and grating in other elevated areas for similar unsupported cut-outs.
- ◆ Ensure the areas around lifting operations are well closed off in all directions. (This was done in this case.)
- ◆ Ensure personnel avoid area below elevated areas when repairs are being conducted.
