IMCA Safety Flash 01/07

February 2007

1 Subsea Chain Lever Hoist Failure

2 Pipe Under Tension on a Reel

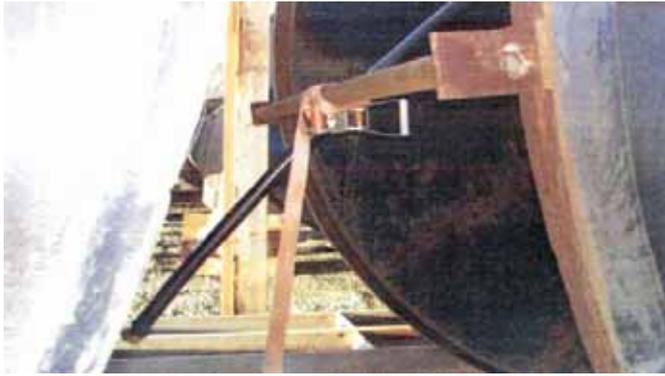
A member has relayed a report of an incident involving a reel containing pipe under tension at a third party's onshore facility. An employee, unaware that the pipe was under tension, removed the ratchet strap securing the pipe on the reel. When the tension was released, the pipe sprang out and struck the employee above the left eye, causing a wound which required subsequent medical treatment.

How the pipe was secured on the reel using a ratchet strap.

- ◆ Tensioned pipes should be tied off/secured using either a mechanical 'U' clamp or pipe clamp with a ratchet strap (or rigging) being used as a back up.
- ◆ Any warning signs should be attached to the pipe end or near the securing mechanism such that they are clearly visible to all personnel who will be handling the reel and pipe.

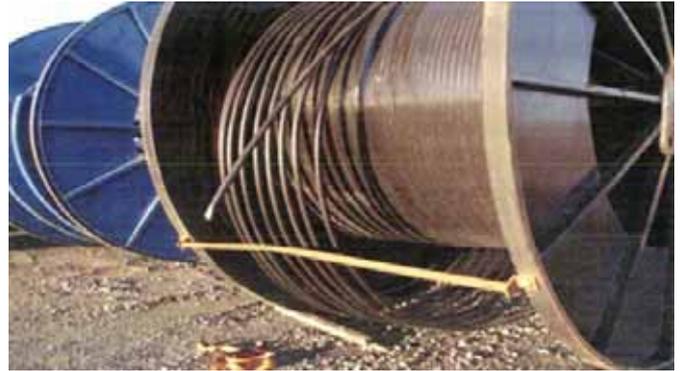
The unwound reel after the ratchet strap was removed and the stored energy released.

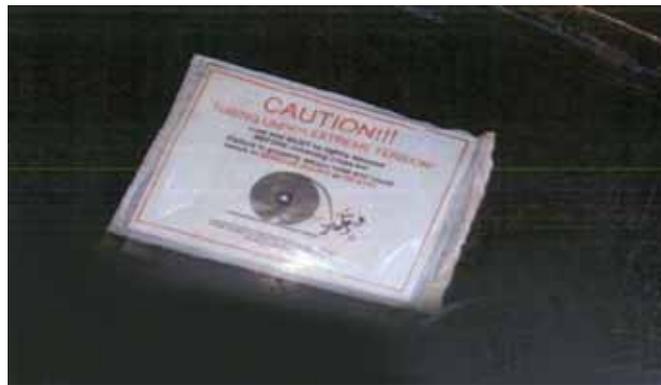
There was a caution label warning that the pipe was under tension. However, this was on the flange of the reel and not clearly visible.

The warning label that was on the flange of the reel.
