IMCA Safety Flash 01/10

February 2010

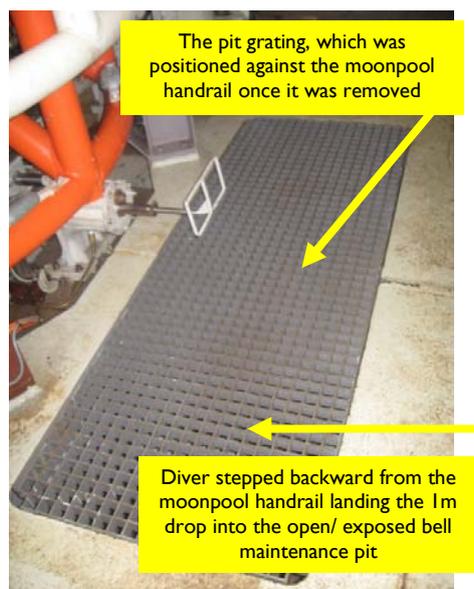
A member has reported that as part of bell maintenance activities, a diver and dive supervisor removed grating from the bell maintenance access pit and positioned it against the moonpool handrail in the bell handling area. After the grating was removed the dive supervisor proceeded into dive control, at which point the diver moved the grating further and overstepped backward into the pit, falling 1m.

The diver sustained a minor laceration to his lower lip and injuries to his ribs on the left hand side of his body, resulting in a lost work day case for the company.

- ◆ The direct cause of the injuries was the 1m fall into the maintenance pit;
- ◆ The root causes included:
 - inadequate design/engineering of the bell maintenance pit, including depth of the pit itself;

- ◆ The bell maintenance pit did not have to be 1m deep in order to be fit for the purpose for carrying out bell maintenance activities;
- ◆ Manual handling and falls into the open pit, were not included in the risk assessment tools used, so may not have been recognised and discussed at the time;

Bell maintenance pit located in the bell handling area of the vessel

- ◆ Review of the existing task based risk assessment (TBRA) and creation of a TBRA specific to bell maintenance, including working in and around the bell maintenance access pit;
- ◆ False floor installed into maintenance pit to reduce the depth as required;
- ◆ Audit and review of employees onboard to ensure minimum safety training modules and requirements have been completed as per procedure.

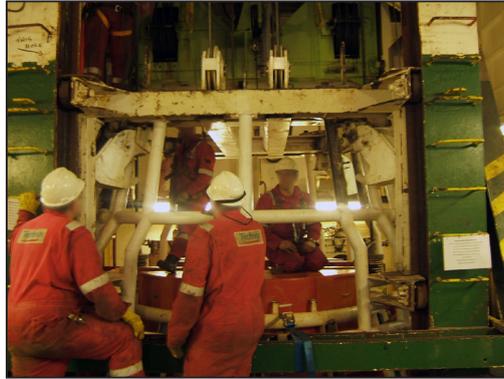
A crew member suffered fatal injuries while carrying out modification work on the diving bell recovery system of the diving support vessel *Wellservicer*.

Part of the modification required the removal of buoyancy blocks from the top of the diving bell. A rigger climbed on top of the bell to do this, but the blocks were very cumbersome and it became apparent that the cursor would have to be raised further to enable the blocks to be removed. Power was applied to the new winch and an operator went to a control position sited above the cursor and diving bell from where he began to raise the cursor. From the control position, the operator was unable to see the top of the diving bell and he was directed by a rigger using hand signals from a visible part of the deck below. Once the cursor was at a suitable height, lifting was stopped, power to the winch was switched off and work on top of the bell set to continue. A few seconds later the winch rendered and the cursor fell, trapping the rigger between the diving bell and the cursor.

The cause of the winch failure was attributed to a faulty pilot valve in the cursor's winch control system, which prevented the winch brakes from applying once hydraulic power was removed.

- The design of the hydraulic circuit for the new cursor winch meant that the two brakes fitted to the winch did not operate independently, as they were required to do, since a single, defective, pilot valve was common to both brake circuits.
