IMCA Safety Flash 01/11

January 2011

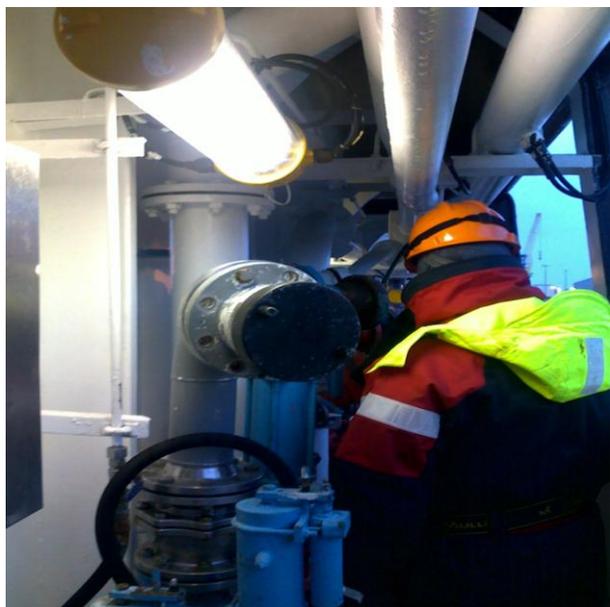
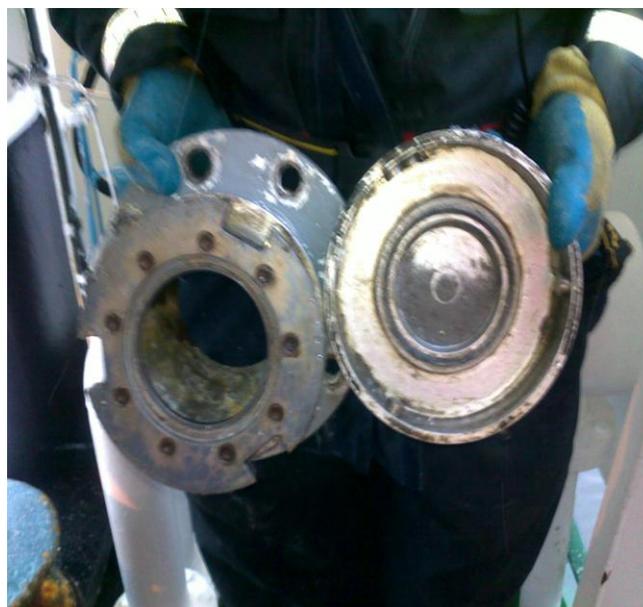
Showing discharge manifold from which cap was blown

- ◆ The cap had not been removed from the discharge manifold prior to energising the pump and pressurising the line;
- ◆ The second chief officer was experienced and the subject of good reports, who was not fatigued and acknowledged awareness of the procedure and the responsibility to ensure the lines were set up and the cap removed;
- ◆ The assumption that the line was open was incorrect – the second chief officer acted out of character, made an incorrect assumption and did not follow procedures;
- ◆ The risks associated with not having a NRV in place were not considered;

- ◆ Had procedures been followed the incident would have been prevented;
- ◆ The Avery Hardoll male connection was damaged and did not function as designed. Had it operated properly it would have sealed the pipework, preventing the pressure build up behind the cap;
- ◆ Whilst the decision to use the line cannot be faulted (i.e. the lack of a NRV made the configuration all but identical to a water ballast tank which does not have an Avery Hardoll) the presence of a NRV would still have been a barrier against incident;
- ◆ Having made the initial misjudgement and as a consequence pressurised the line, the task should have been stopped and a new toolbox talk convened to consider the risks and take appropriate action to mitigate them;
- ◆ The root cause of the incident was failure to follow procedure and to stop the job once a deviation from the norm was experienced.

- ◆ Had procedures been followed the accident would not have happened;
- ◆ The presence of a NRV in this context would act as an additional safety barrier;
- ◆ Having made the initial misjudgement and as a consequence pressurised the line, the task should have been **stopped** and a new tool box talk convened to consider the risks and take appropriate action to mitigate them.

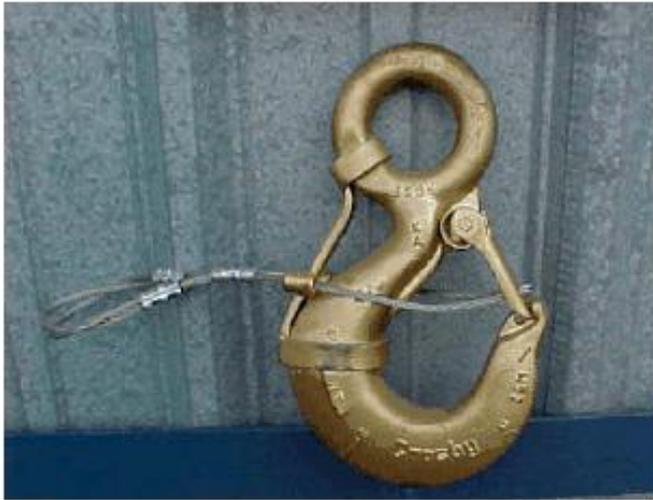
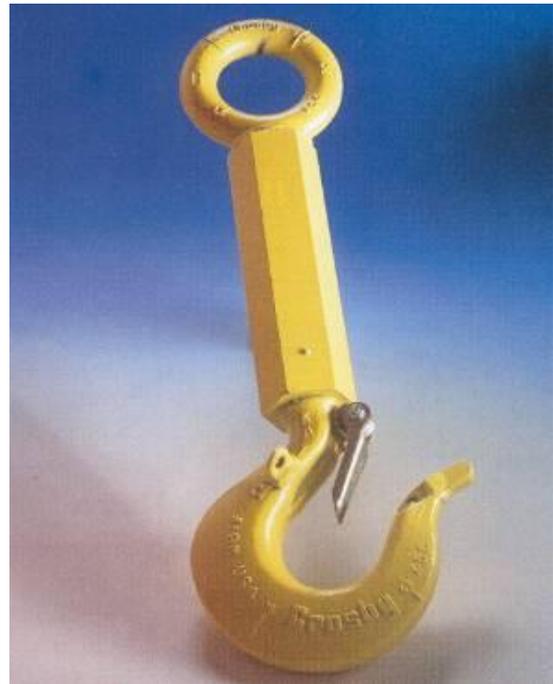
Examples of modern ROV-friendly safety hook designs

Our member notes that suppliers have been approached to address the latch design issue and analyse potential strength upgrades. New safety hook designs that can be operated by an ROV operable are being evaluated.

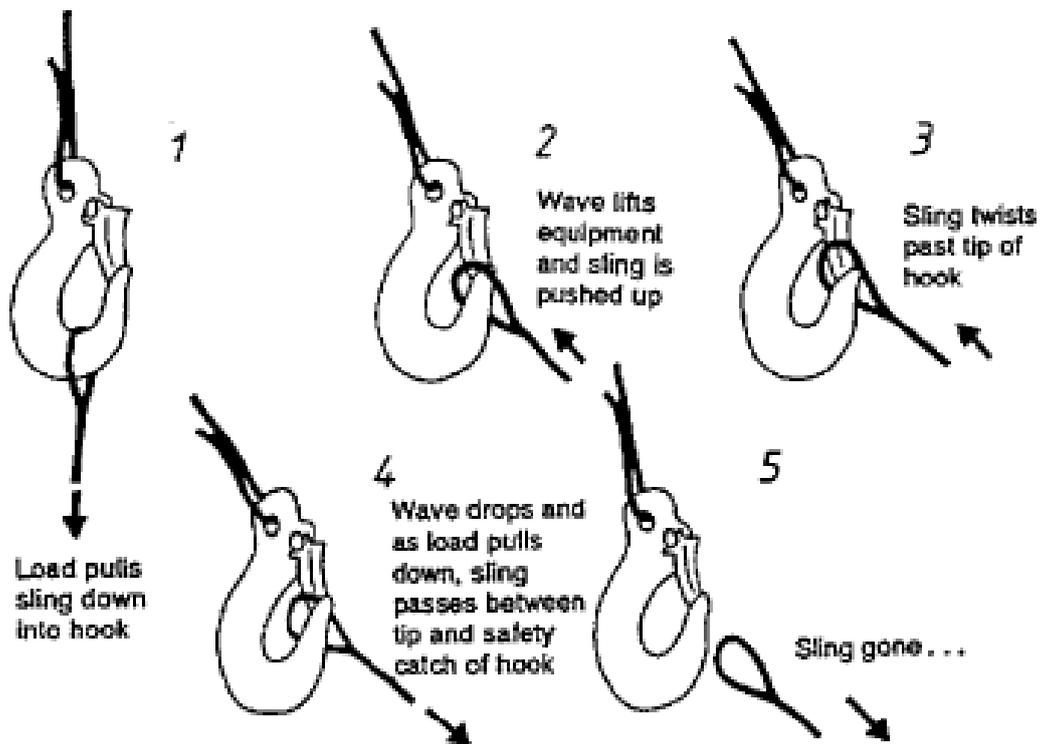
The most common incidents involve dropped objects. These occur because of the relationship between the surface area and mass of the object being lifted, combined with water resistance, as well other factors such as vessel movement and winch speed. When snap hooks are used in such circumstances, the gates or latches can be opened or broken by the rigging and the load is at risk of being dropped.

Illustration of how loads can be lost from snap hooks (AODC 18)

- ◆ All loads should be checked for the likelihood of this happening in line with existing industry-wide engineering and rigging good practice;
- ◆ Only suitably trained people should be used to select the appropriate rigging and sling loads for lifts;
- ◆ All non-engineered subsea load handling should use shackles or safety hooks rather than snap hooks;
- ◆ Snap hooks can be used for loads where there is no risk of the load becoming 'light' during the transit to/from deck. They should not be used unless the operation has been thoroughly checked and endorsed by competent personnel.

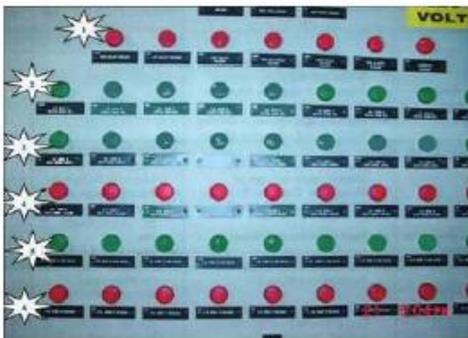
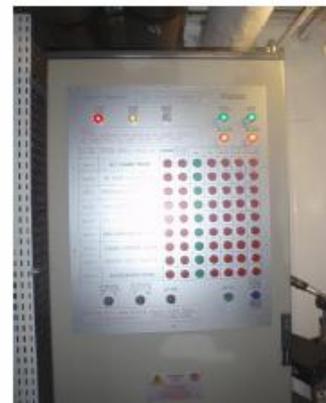
- Shipyard commissioning test procedures appear to differ from procedures documented in the vessel's Firefighting Instruction Manual (FIM). Commissioning procedures indicate that the discharge line selection to a specific protected zone should be made prior to releasing the gas contrary to the directions in the FIM.
- The FIM refers extensively to a Control Panel (left following image) that differs vastly from the one onboard the vessel (right following image).

- Ensure that all supporting documentation, piping schematics, plans, manuals, component labeling and instructions are consistent with each other and relevant to the systems, equipment, and components installed onboard the vessel.

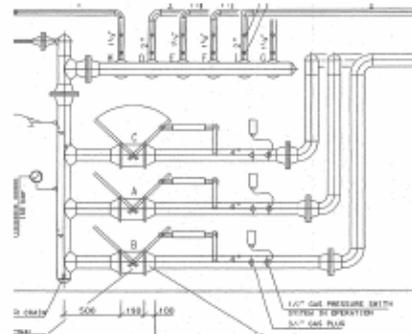
- Shipyard piping schematics and drawings do not appear to match the actual installation. The schematic at the right shows the "A valve" for the Aft Machinery Space in the center position vice the bottom position as it is installed on the vessel.

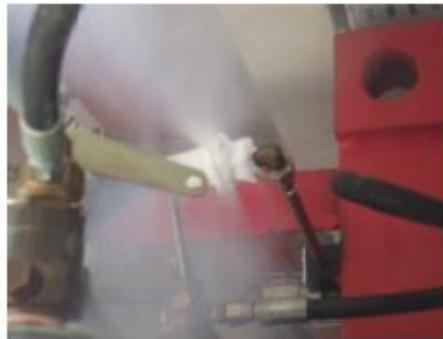
- Numerous piping and hose connections leaked extensively. When the system was activated, on scene video taken by the firefighters showed numerous leakages into the CO2 room. Post casualty, while pressure was still on the system, some of these leaks continued even after the connections were tightened. (Photograph at right.)

- Carefully and critically review, routinely inspect and maintain, verify and test their Fixed Fire Fighting installations to ensure that they will operate correctly during an emergency.

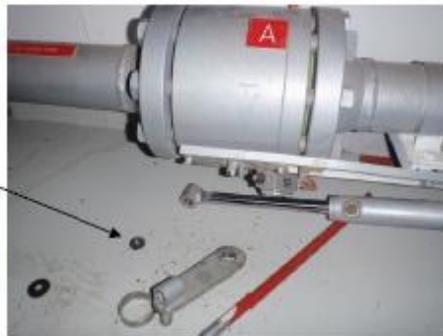
- The zone valve for the aft machinery space which admits CO2 from the bottle bank manifold to the space failed. Specifically, the ball valve's opening actuating arm fell off the valve when the gas powered piston actuator attempted to move it. The ball valve actuating arm was held in place by a very small machine screw and washer. When firefighters attempted to open the valve manually using the provided hardware it could not be moved. The valve was only able to be moved after the gas pressure was relieved from the inlet side of the valve. (Photograph at right.)

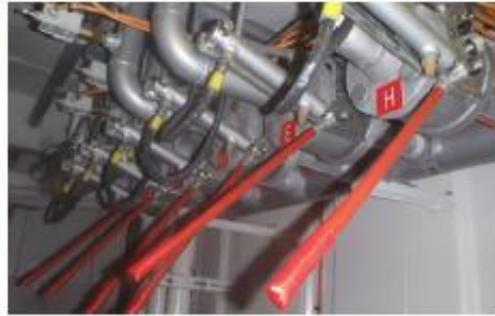
- Actuating arms to five of the six other zone valves were found loose. They were also attached by small machine screws. (Photograph at right.)

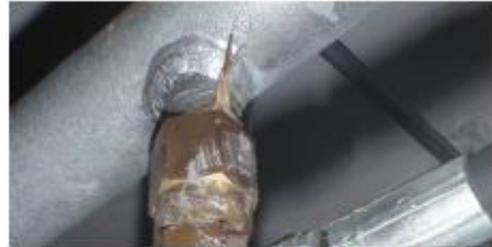
- Hemp type pipe sealant was used extensively on pipe threads throughout the system and in some instances seems to have entered the system. (Photograph at right.)

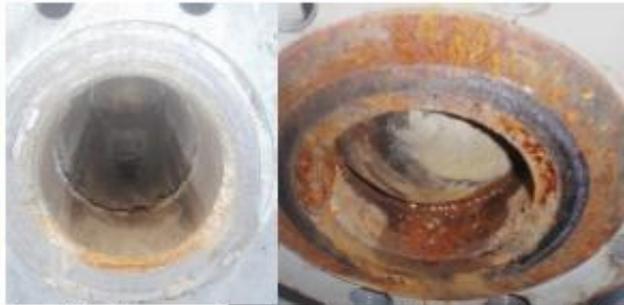
- Certain elements of the distribution manifold contained low points which allowed the accumulation of water within piping that could not be drained. Such a circumstance could cause corrosion that could possibly negatively effect operation of other components. (Photographs at right.)

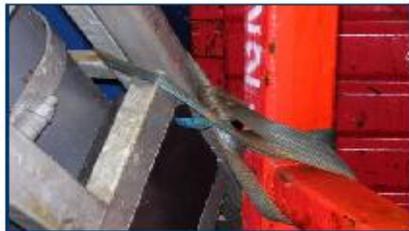
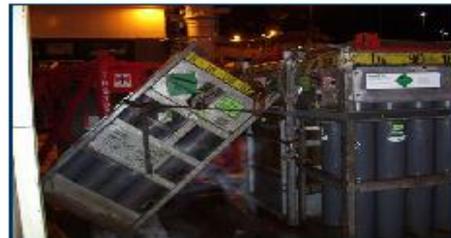
The cargo handlers arrived on the vessel and began the offload from forward to aft (on the blind side of the strapping), as they lifted the tank the gas rack also lifted and tipped over. The job was stopped immediately. (See pictures).

The main issues identified were inadequate communication between vessel crew and cargo handlers and a failure to identify potential hazards during lifting operations.

Communication – A toolbox talk and effective planning involving all personnel involved in the task (Vessel Crew and Cargo Handlers) should be used as a means of communicating any hazards or relevant information associated with the task.

Hazard Identification – Assessment and inspection of any loads prior to lifting should identify any hazards before the lifting activity begins.

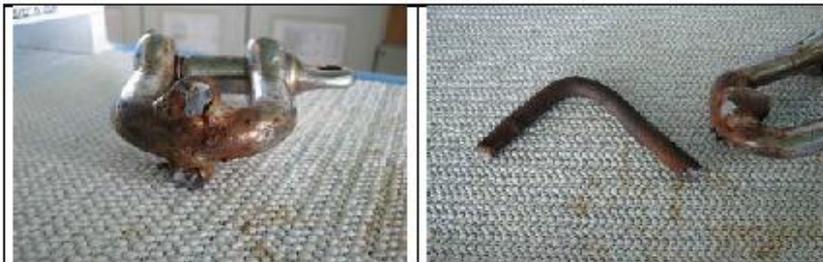
A supply vessel was instructed to return to port due to poor weather conditions at the field. The Captain instructed the deck crew to ensure the containers on deck were adequately secured using chain lashings. The chain lashings were put in place and the decision taken by the deck crew to use the tugger winch to tighten the lashings. When the tugger was tensioned up the chain lashing parted and a piece of flying debris struck and broke the bridge centre aft window. The investigation found that a home chain connection (a piece of chain welded to a stainless steel shackle) had at some stage been introduced into the cargo lashing system. This was probably done so the tugger wire hook could be quickly connected. Being home made it was not certificated and there was no way of knowing its breaking load. We do not like the expression but this was an accident waiting to happen. The deck crew are extremely fortunate not to have been killed or seriously injured.

- The main and overriding lesson from this incident is that home made equipment or tools can never be tested or certified appropriately and often fail sometimes with serious effects. They should never be made or used;
- Home made tools are often made for expediency. However almost always a proper tool or piece of equipment can be sourced from an appropriate supplier. In this case the ship could have requested an enlarged link and connector;
- When using a winch all parts of system being used (shackles, chains, wires, slings, etc.) must have a breaking load higher than the force the winch can exert and certificates to prove it;
