IMCA Safety Flash 01/13

January 2013

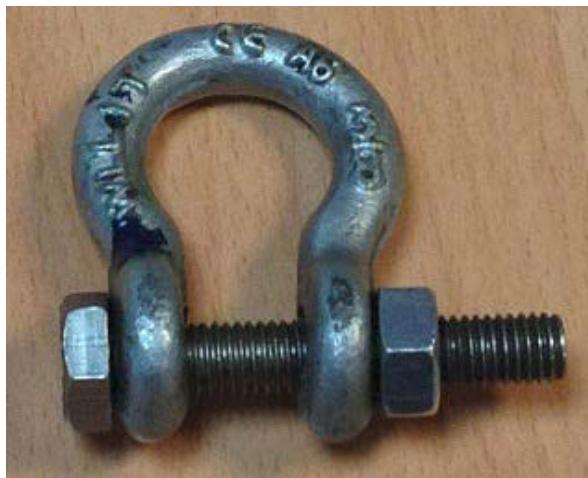
A member has reported finding shackles used for lifting equipment in an unsafe condition. A third-party lifting inspector was re-certifying lifting equipment when a 1 ton lifting shackle was discovered which had lost its pin, and the missing pin had been replaced with a standard bolt and nut which was not certified for lifting operations.

Additionally, the shackle was found to be pinched due to excessive pressure being applied when tightening the nut due to the bolt having thread along its entire length. It was not clear whether or not this shackle had been used for lifting but the potential for injury to personnel or damage to assets was high.

*Non-compliant shackle with nut and bolt
(note shackle lugs pinched)*

- ◆ Lifting equipment should be fit for purpose and certified by a competent authority for use;
- ◆ Replacement or repair of lifting equipment invalidates the certification;
- ◆ Lifting equipment should be reviewed regularly for non-compliance and any non-compliant items taken out of service;
- ◆ Where damage is evident or pins/bolts are missing, the equipment should be removed from service and either destroyed or new parts ordered;
- ◆ If new parts are ordered, the lifting equipment should be re-tested with a certificate issued prior to return to service;
- ◆ Lifting equipment should follow the current colour coding;
- ◆ Lifting equipment colour codes should be well communicated and displayed;
- ◆ Identifying and reporting faults in lifting equipment is a regulatory requirement in many places and should be seen as a first line of defence.

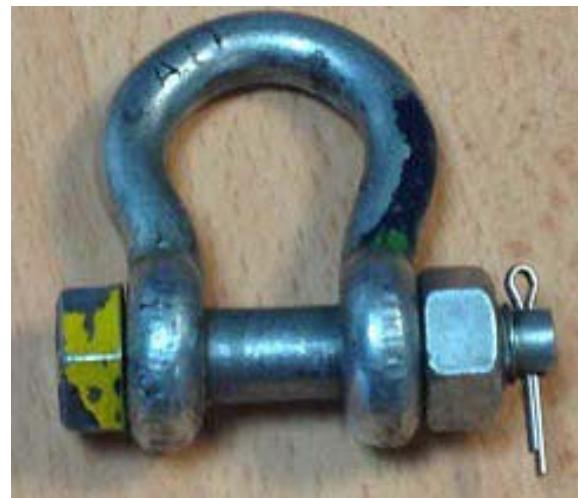
*Shackle with correct configuration and split pin
(but colour code unclear)*

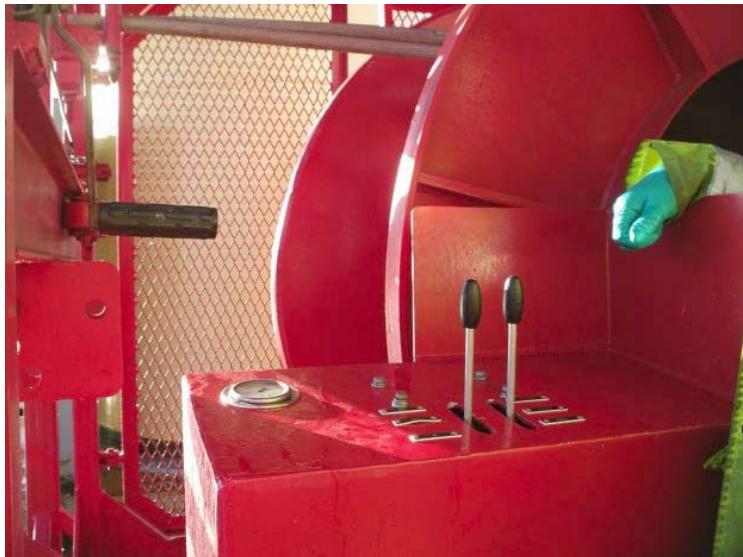
Figure showing spooler arm and hydraulic spooler controls where injured person was standing

- ◆ Insufficient slack left on the hydraulic hoses to accommodate the conditions/heave being experienced by the vessel led to the hoses becoming tight and the spooler arm handle to spin;

- ◆ The design/layout of the work area and location of equipment allows for hand/body positioning to get close enough to the spooler arm handle to make contact with it, in particular during times when vessel was experiencing a heave;

- ◆ Use of an automatic spooler would prevent the need for hand/body positioning so close to the spooler arm handle during recovery of the grapple;
- ◆ In addition to ergonomic issues, it was found that personnel were exposed to environmental hazards, i.e. the weather, when operating the controls. Adapting this area to include some form of habitat would mean operators were protected from the weather.

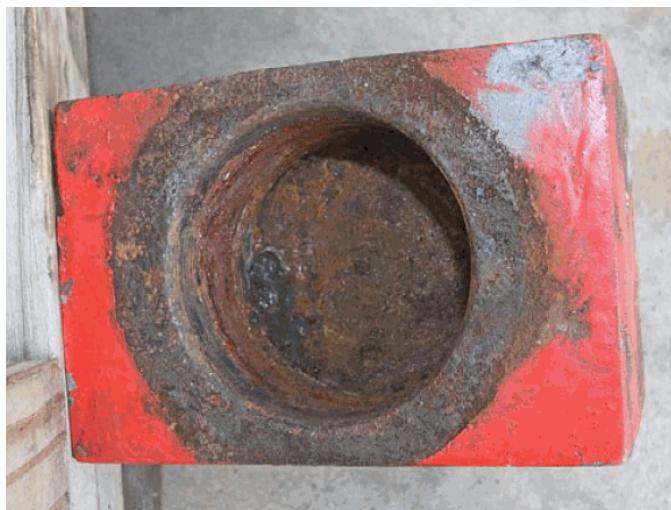
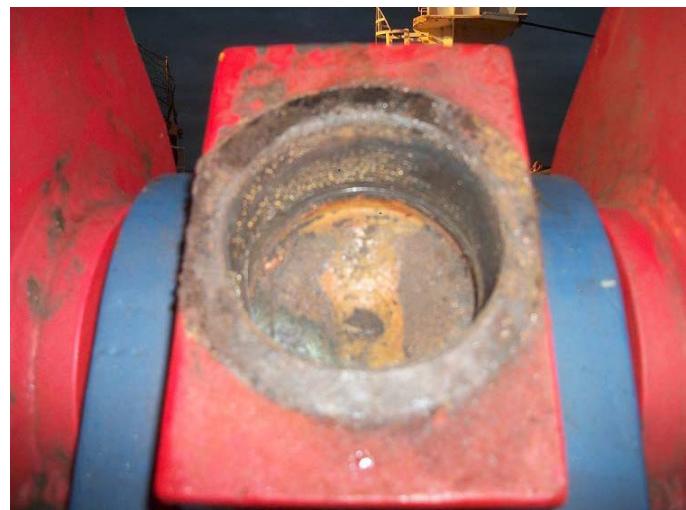
Clevis pictured after failures

- ♦ No evidence of anti-seize compound or other corrosion inhibitor in the rod end threads or on the rod threads;
- ♦ Dead space between rod eye and cylinder rod allows generation and collection of moisture/condensation.

- ♦ Excessive corrosion of each clevis (rod eye);
- ♦ Dimensional check shows clevis to be deformed.

The company notes that root cause analysis for multiple failures is on-going; however the causes of the corrosion are in part attributable to a missed step during the service and maintenance of the cylinders.

- ♦ Updated planned maintenance system with manufacturer's recommendations for inspection of cylinder rod eyes:
 - while A-frame foot is approximately 1" from the hard stop so the luff cylinders are in tension, use a feeler gauge to determine if there is any gap between the faces of the rod eye and rod. There should be zero gap. If there is a gap, the cylinder should be removed, rod eye removed and inspected
 - the counterbalance valves should be verified that they are adjusted properly
 - perform a visual inspection of the A-frame operation to focus on cylinder timing or excessive lateral movement
 - perform visual inspection of rod eye surface for excessive signs of corrosion at point of rod entry.
