## IMCA Safety Flash 01/15

January 2015

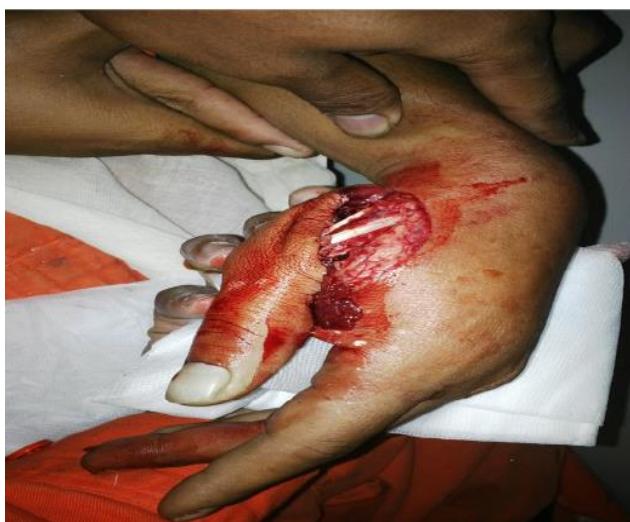
The crew of the bunker barge passed the “messenger line” to a crewman on the PSV, along with two mooring ropes. The crewman took the ropes and put the eyes of the two mooring ropes on each of the twin bollard on the aft and returned the messenger line to the bunker barge crew. The crewman on the PSV then considered that the mooring operation was over and started to walk away towards the accommodation. As he reached amidships the master of the bunker barge got his attention and indicated to him that he should go aft again and shift one of the mooring ropes to the other bollard. He returned to the aft bollard. The barge crew slackened the mooring rope a little and he tried to remove the rope. At that moment there was sudden tension on the rope (due to relative movement between the vessel and bunker barge) and his left palm got stuck between rope eye and bollard. He suffered severe laceration injuries to his left hand.

Figure: showing injuries to the crewman’s hand

- ◆ The incident occurred when the injured person agreed to shift the rope from one bollard to the other without insisting on the rope being sufficiently slackened. He failed to take into account the relative movement of the vessels, which led to his hand getting stuck between the eye of the rope and the bollard;
- ◆ There was no very high frequency (VHF) communication established between the bridge of PSV and the bunker barge;
- ◆ The injured person was not in VHF communication with the duty officer and was taking instructions directly from the bunker barge Master and crew;
- ◆ There was no effective toolbox talk;

- ◆ The injured person was attending to the moorings alone, which was contrary to the job hazard analysis, which required attendance in pairs.

- ◆ Vessel's bridge to establish VHF communication with other vessel before agreeing to start the mooring/unmooring operation;
- ◆ Both forward and aft station deck crew to be in VHF communication with duty officer on the bridge;
- ◆ Ship crew to take instructions from the duty officer regarding number of ropes being passed and shifting of ropes and not from the barge crew directly;
- ◆ Additional control measures during mooring and bunkering operations should include the importance of risk assessment taking place before work starts;
- ◆ Review the company Manual of Permitted Operations specifically with regard to weather conditions;
- ◆ To ensure Buddy System at workplace especially during night time operation to work as a team to spot dangers.

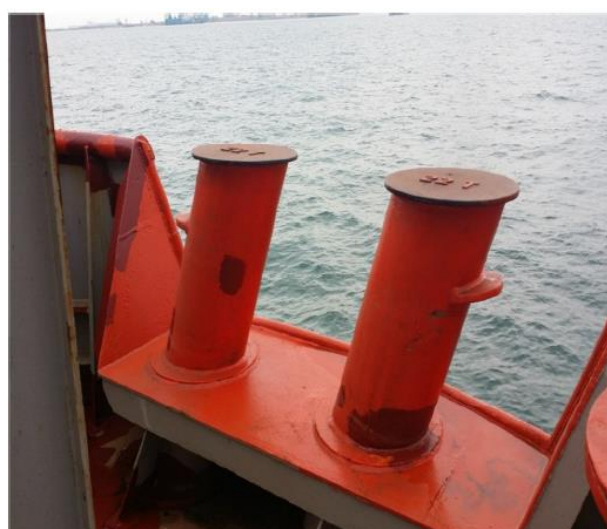
Figure: bollards where incident occurred

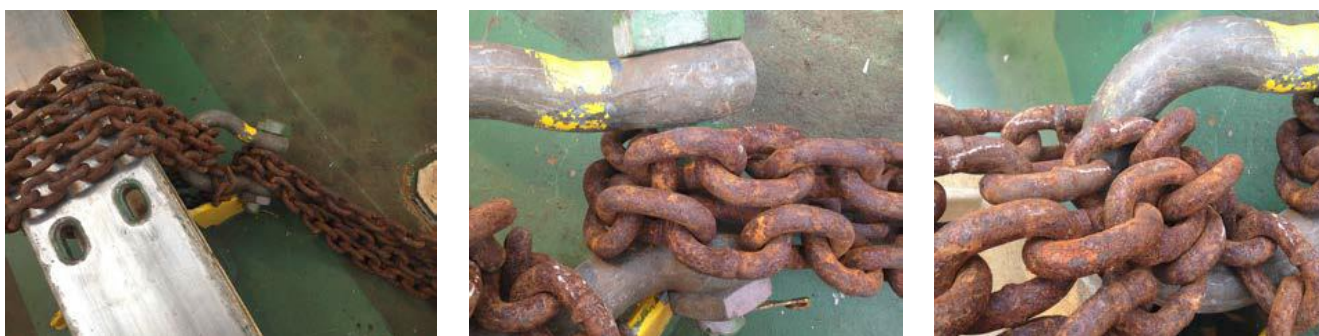
During the operation, a shock load was introduced to the chains, leading to a chain link parting and in turn to a catastrophic series of events.

*Figures: showing a reconstruction of how the chains were rigged*

- ◆ The chain was exposed to a shock load;
- ◆ The chains were wrapped around edges which were the incorrect radius for the chain diameter;
- ◆ As the chains overlapped each other within the shackle they had no chance of equalising the load when it was applied.

- ◆ Never wrap a chain around a diameter which is less than twice the diameter of the chain link;

- ◆ Never twist, knot or trap chain slings;
- ◆ It is recommended to use packing on edges to reduce the side loading on chain links;
- ◆ When attaching more than one chain to a shackle/hook always avoid overcrowding or use a master link;
- ◆ Never use a chain where there is potential for it to be exposed to dynamic or shock loads.

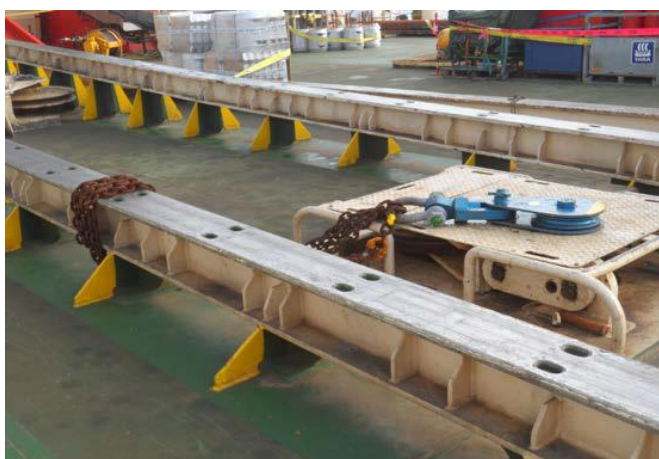
Figure: snatch block anchored to deck rail

- ◆ The deck rail was not designed to take side loading and as a result could have led to injury to personnel and/or damage to the equipment;
- ◆ The deck rail was not a certified rigging/lifting point; such lifting points are or should always be appropriately marked as such;
- ◆ The deck rail did not undergo statutory periodic thorough examinations as required by local regulatory requirement.

- ◆ Only certified rigging/lifting points should be used for this type of operation;
- ◆ Anchorage points should be clearly marked with the safe working load before they are considered safe to use;
- ◆ The use of existing ship structures for this type of operation should not be permitted.

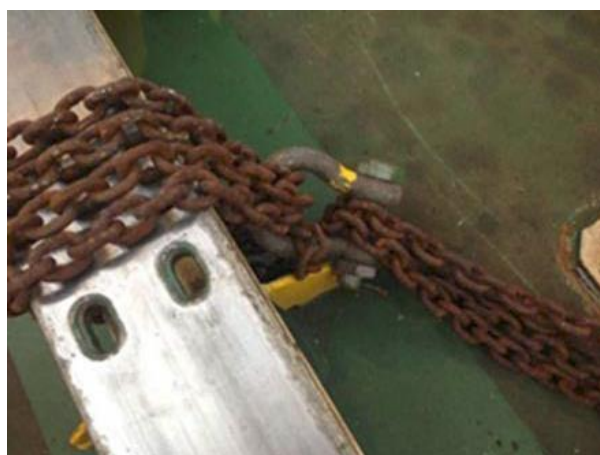
An unapproved anchorage point had the potential to lead to injury to personnel and/or damage to the equipment. Although this rigging arrangement did not, in this case, lead to an incident, our member considered that it was bad practice which could easily have done so.

Figure: chain secured inappropriately

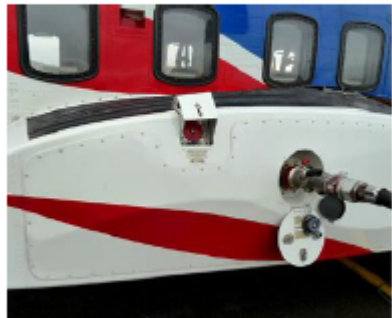
A recent Sikorsky S92A offshore re-fuelling event on the North Sea has served as a reminder for the potential issue that may occur during pressure refuelling when the fuel supply is interrupted and introduced fuel / air mix delivery to the aircraft causing the tank vent valves to close and build-up of pressure - causing the sponson to rupture.

- Helideck team observed fuel was not being delivered and took correct action by stopping the refuel and advising the pilots. The refuel was completed using gravity refuel.
- View below showing Sikorsky S92A to illustrate severe damage evident on sponson - which has buckled and ruptured.

- Closely monitor actual (not estimated) fuel stock levels in transportable & bulk tanks.
- Ensure that sufficient stock available prior to commencing the refuel to avoid losing suction.
- Remain vigilant that sloshing (movement of fuel in the supply tank) can cause loss of suction at a higher fuel level than normal.
- If suction is broken, ensure system is purged of any air prior to next or continued helicopter refuel.
- In all instances, if any anomalies are observed during refuelling operations, stop the refuel and advise the Pilots.

**CAUTION: TO PREVENT DAMAGE TO EQUIPMENT, MAKE SURE THE REFUELLING SYSTEM DOES NOT EXCEED 55 PSIG AND 120 GPM.**

**CAUTION: TO PREVENT AIR FROM ENTERING THE AIRCRAFT FUEL TANKS WHEN PRESSURE REFUELLING; VERIFY THAT THE FUEL SUPPLY TANK CONTAINS AN ADEQUATE AMOUNT OF FUEL PRIOR TO PRESSURE REFUELLING. IF THE FUEL SUPPLY TANK IS LOW OR RUNS DRY PRIOR TO FUELLING COMPLETION, THEN AIR MAY BE INGESTED INTO THE AIRCRAFT FUEL TANK AND CAUSE DAMAGE.**

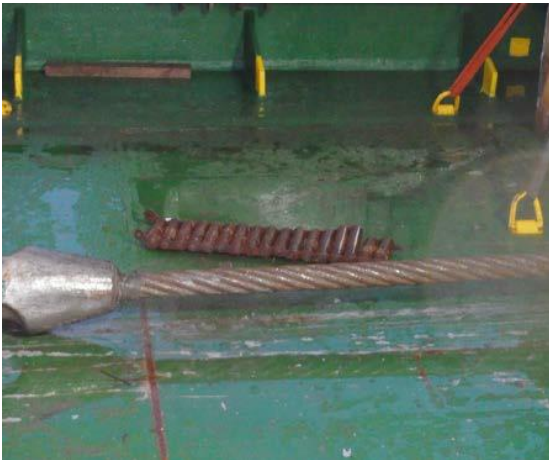
A member has reported an incident in which an object fell 10m onto the main deck of a vessel. The incident occurred during pipe spooling operations on a vessel. Deck crew observed the object fall 10 metres from the ramp structure into the barriered area of the main deck. An “ALL STOP” was called and the object was found to be a ‘Hilman Roller Chain’ which weighed 60kg. This incident has been classified as having high potential and was reportable under local regulatory requirements.

Figure: roller chain on deck

- ◆ Area was made safe and a DROPS sweep conducted for further potential dropped objects, in immediate area and vessel-wide;
- ◆ Rope Access Team deployed to check integrity and function checking of all Hilman Rollers;
- ◆ Review of maintenance and other procedures and working practices to be reviewed and updated as necessary;
- ◆ All personnel reminded that not only can anyone call an ALL STOP, but they are obliged to call an ALL STOP if they see any act or condition they consider is, or may be, unsafe;
- ◆ When positioning barriers, the 'Cone of Exposure' theory should be used to account for all DROPS potential (including direct drops, items rebounding items from structures, etc).

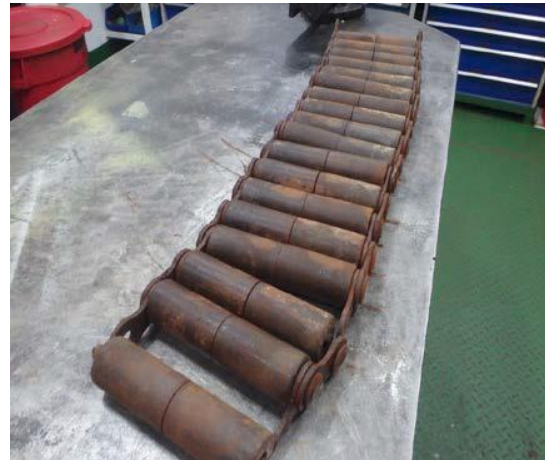
Figure: recovered roller chain

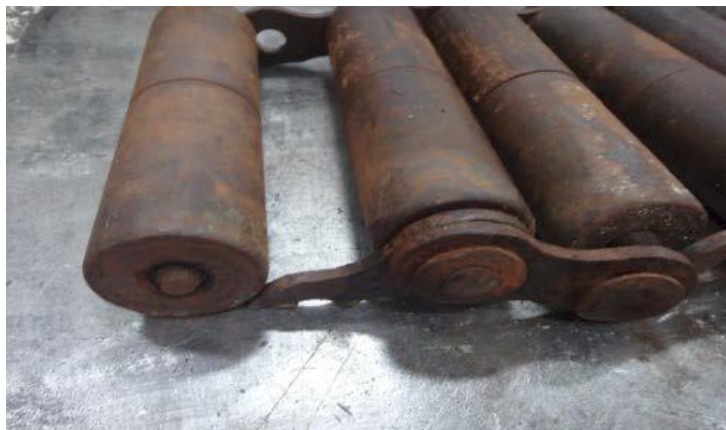
Figure: sheared '8' link plate

- ◆ The Hilman Roller Chain parted and dropped as a result of an '8' Link Plate failing and allowing the chain sections to part;
- ◆ A single roller weighing 2kg, dislodged from the chain assembly and was found to have landed outside the barriered area;
- ◆ The cause of the failure was not identified; however several factors including maintenance procedures, accessibility and seizure by corrosion may have been contributory factors.

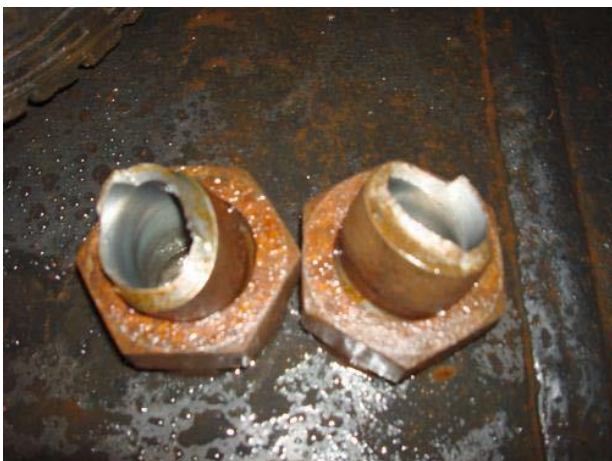
Figure: showing damage to couplings

Our members' investigation found that the crane driver had unintentionally activated the crane controls resulting in the crane paying out the hook at 10 metres per minute. This caused the hammer to lower and in turn tightened the hose/umbilical running from the vessel to depth. The effect of the hammer being lowered caused the hose to tighten and part from the hammer at the coupling and also snapped the restraint chain in the process. This resulted in the loss of 960 litres of hydraulic oil.

- ◆ Piling contractor to evaluate the use of biodegradable oil for future use;
- ◆ A standby switch for enabling crane controls to be activated when the crane was in prolonged periods of inactivity. Supervisor to inform crane driver when crane is likely to be inactive for a long period;

- ◆ During periods of crane inactivity random communications checks to be carried out with the crane driver;
- ◆ A reminder circulated that hydraulic hoses should be immediately isolated in the event of a loss in pressure;

- ◆ ROV to be effectively positioned to observe the hammer and hydraulic hoses;
- ◆ Clear and robust communications system installed to the pile spread control cabin (VHF and telephone back up);

- ◆ Pile spread supplier to investigate the use of a self-closing safety valve and alarm system;
- ◆ A sensor in the oil supply tank set to minimise the loss of oil (vessel movement taken into account);

- ◆ High-Vis tape/paint to be attached to the umbilical / hose to aid ROV visual identification.

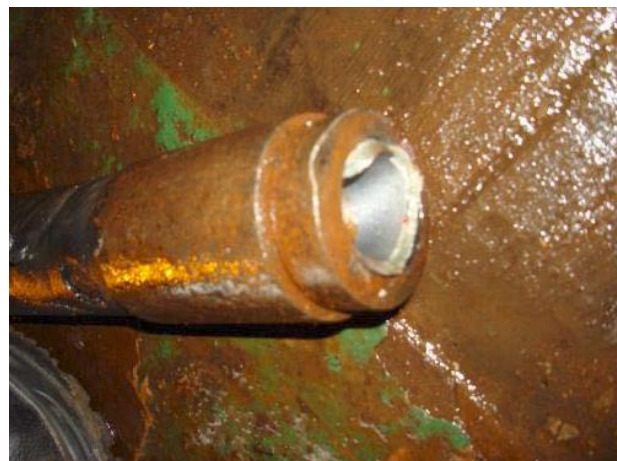
Figure: showing damage to hose
