IMCA Safety Flash 01/16

January 2016

I High Potential Near Miss: Failure of Both Divers Breathing Air Supply & Dive Stage Recovery Winch

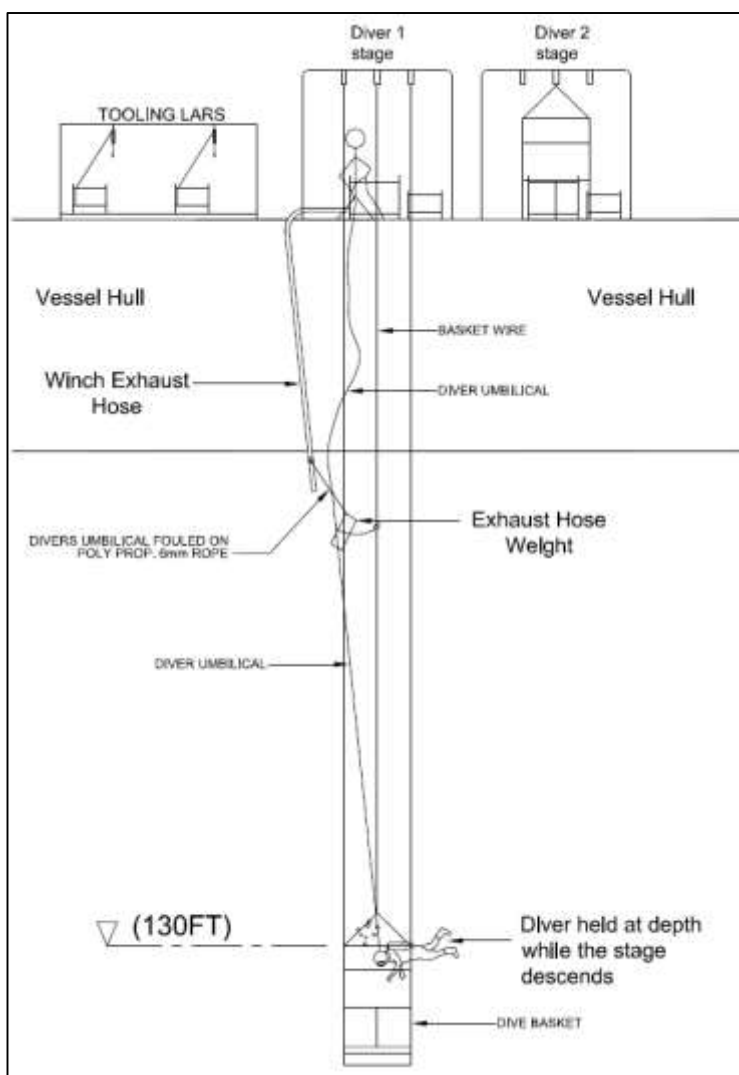
A member has reported a near miss incident in which a diver lost his breathing air supply and at the same time there was a failure of a dive stage recovery winch. The incident occurred on a Dynamic Positioning (DP) Diving Support Vessel (DSV) when a surface orientated air dive was planned for a depth of 160fsw. The dive stage was to be located at 130fsw. For reducing the noise exposure on deck, the LARS (Launch and Recovery System) air winch exhaust hose had been positioned in the water at the side of the vessel, close to where the diver 1 basket entered the water. A weight was attached by way of a lanyard at the hose end to prevent flailing while the winch was being operated (see diagram).

Whilst the diver was in the stage travelling to 130fsw, the running line connecting the umbilical to the stage wire became entangled with the winch exhaust hose weight. This entanglement was responsible for:

- ◆ Kinking of umbilical gas & pneumo hoses with subsequent loss of air supply to the diver;
- ◆ Kinking of the winch exhaust hose and subsequent failure of the winch;
- ◆ Prevention of free pay-out of the umbilical giving rise to the diver being held in position in the water column whilst the stage continued to descend.

The most probable immediate cause was a combination of sea state and thruster wash which caused the

suspended exhaust hose and weight to “wander” more than usual. This in turn led to the entanglement of the weight with the carabiner:

- ◆ Should a situation occur in which the winch’s air motor exhaust (of discharged pressurised air) is restricted or prevented from flowing freely through the control valves exhaust port, this condition will cause the air motor to slow to a stall, ceasing all rotation and operation. This is commonly referred to as “choking” the exhaust and is to be avoided in all cases as it will dramatically affect the performance of the air motor. The motor enters a “stall condition” as the inlet and discharge pressure balance against each other and the motor ceases rotating.

- ◆ “Safety Stand Down” with the entire diving team to discuss the incident;
- ◆ Winch hoses were removed from the proximity of the diving stage to eliminate the threat of entanglement;
- ◆ The weight keeping the exhaust hose submerged was secured directly to the hose end rather than by a length of rope, which had been instrumental in the fouling of the lines;
- ◆ Update of risk assessment for the positioning of equipment on deck - to include and reflect the situation that occurred;
- ◆ Diving umbilical was removed from service and pressure tested by the offshore technicians and checked for any defects;
- ◆ Review of deck risk assessment to incorporate the findings of the incident.

- ◆ Eliminate the use of in water hoses;
- ◆ Install silencers directly on the winches.

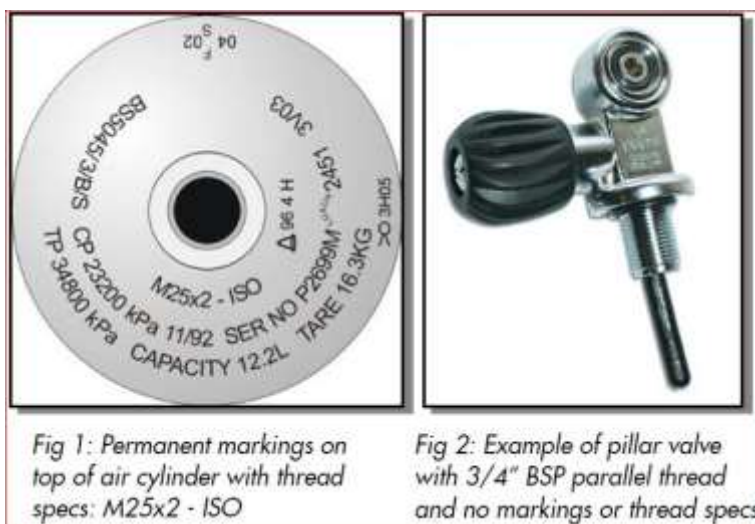
An International Association of Oil & Gas Producers (IOGP) member has passed to IMCA for circulation to members an incident in which a pillar valve forcefully parted from a High Pressure (HP) cylinder filled with 180 bar of compressed air. The incident occurred on board a DSV (Diving Support Vessel) whilst divers prepared for a dive and were putting on their diving suits. As a result of the failure, five divers were injured as the parted valve flew off the cylinder.

All these parallel threads are very similar but not compatible, as pitch, pitch diameter and thread forms are different.

- ◆ Investigation is still ongoing but preliminary assessment has confirmed that the inner thread on the HP cylinder was not compatible with the outer thread of the pillar valve;
- ◆ The HP gas cylinder inner thread was an M25x2 parallel thread, and the outer thread on the pillar valve was a 3/4"x14 BSP parallel thread (Whitworth);
- ◆ How the incompatible valve and HP gas cylinders came to be used together is still being investigated.

The incompatibility of the valve thread and HP cylinder thread led to a serious incident. It is therefore of great importance that all diving contractors perform an immediate check to confirm the compatibility of the HP gas cylinders and valve threads in use at their operations. They should also clearly mark and register both HP gas cylinders and valves separately, so that compatibility can be verified and assured.

- ◆ Check HP gas cylinder threads and pillar valve threads for compatibility, ensuring that auditable evidence is made available;
- ◆ Mark the cylinder thread size for all HP cylinders – mark the thread size for all pillar valves, applying a unique identification that will be permanently visible and traceable;
- ◆ Have a working procedure and instruction in place that includes the verification of the compatibility of both the pillar valves and HP gas cylinders;
- ◆ Include compliance with this working procedure in the DESIGN audits which validate the 6 monthly internal and external inspections of HP gas cylinders;
- ◆ Include the HP gas cylinder and pillar valve identification numbers in the 6 monthly inspection certificates.
