These flashes summarise key safety matters and incidents, allowing wider dissemination of lessons learned from them. The information below has been provided in good faith by members and should be reviewed individually by recipients, who will determine its relevance to their own operations.

1 Dive Dynamics AH3 Diving Helmet

Failure of Transmission Systems Components on Aler 50-15 Offshore Cranes

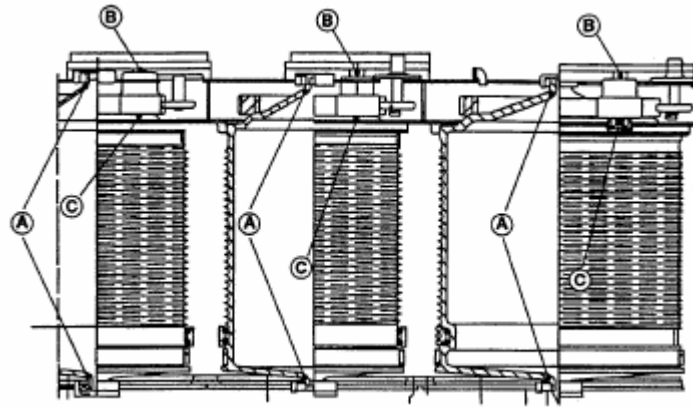
Figure 1: Main, boom and whip hoist transmission system Aker 50-15 cranes

The Health and Safety Executive has been advised of failures which have occurred in mechanical components of the winch hoist transmission system on Aker 50-15 offshore cranes. This has resulted in the load and boom going into uncontrolled free fall with consequential severe damage occurring to the crane and surrounding structure. There may also be implications for injury to attendant personnel.

Failures have occurred at the following areas:

- (i) the hubs of winch drum castings where the drum support bearings are fitted;
- (ii) the hydraulic motor shaft on which the drum drive pinion is mounted;
- (iii) the drum drive pinion tail support bearing.

Area A – covered by paragraph 2(i)

Area B – covered by paragraph 2(v)

Area C – covered by paragraph 2(iii)

You are advised therefore that if any crane under your control is of the manufacturer indicated, then the boom, main hoist and whip hoist transmission systems should be dismantled and inspected around the regions indicated in Figure 1.

Please be aware that other models of this crane manufacture may be of a slightly different design to that illustrated. However in the interest of safety, dismantling and inspection is also advised in these cases.
