1 Grinding Disc Failures

2 Emergency Communications System Incident

4 Electrical Flash Burns

5 Damage to Main Hoist Rope on Liebherr 1080/I Crane

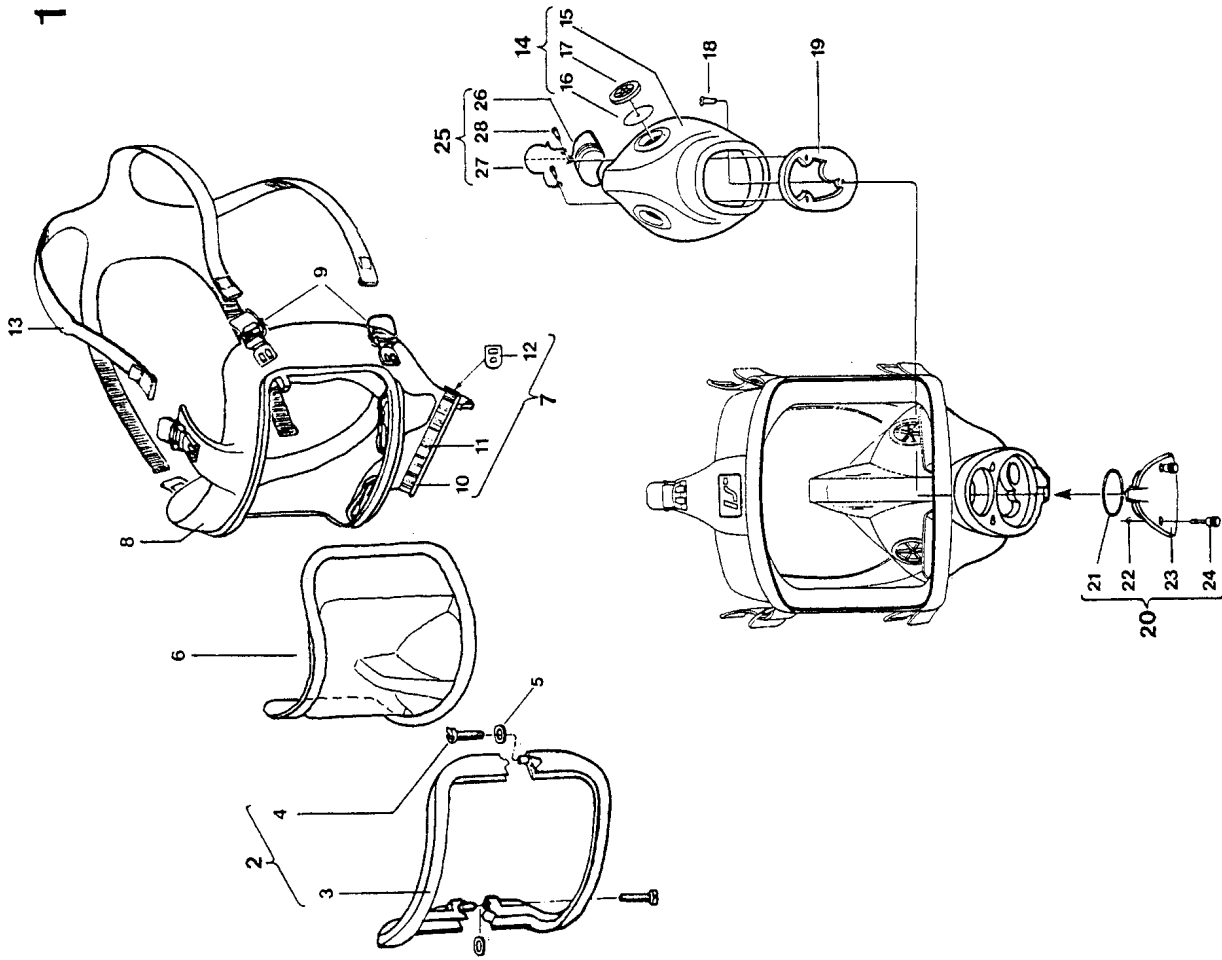
DIVING MASK MK II DYKMASK MK II

Interspiro has received isolated reports regarding a component of the dive mask assembly. The reports involve the stainless steel locking strap and clip, items 11 and 12 of facemask page of the appended spare parts list), that secures the connection block to the face piece shell.

Investigation has revealed that the stainless steel components have a tendency to exhibit oxidation when exposed to a salt-water environment if they are not properly washed with fresh water after use. A step-by-step guide to after use cleaning is included within the user handbook, which accompanies each Interspiro facemask.

WARNING: Failure to adequately maintain dive masks by washing thoroughly with fresh water after each use in salt water, can adversely affect the locking assembly, causing rust build-up, which if left unattended, may cause the lock to fail.

Interspiro requests that you examine masks under your control to ensure that the correct cleaning procedure has been followed. Any masks exhibiting obvious degradation should be forwarded to your authorized repair technician or to the Interspiro service and repair department for replacement of the affected component at commercial rates.
