## 1 Helideck Operations

## 2 Incorrectly Supplied Diving Equipment

## 3 Near-Miss Incident involving Insecure Load

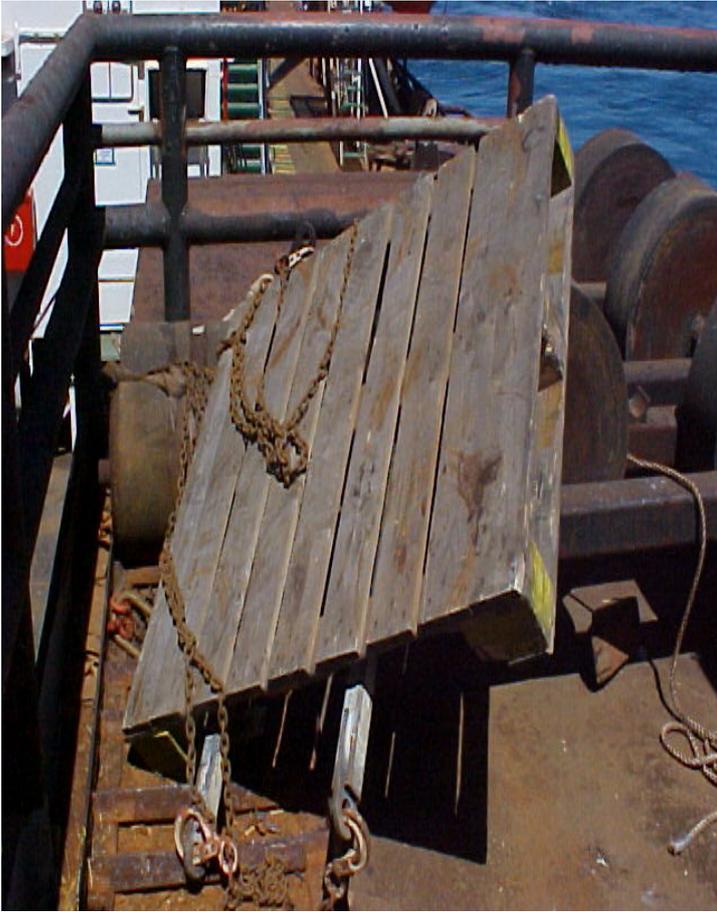
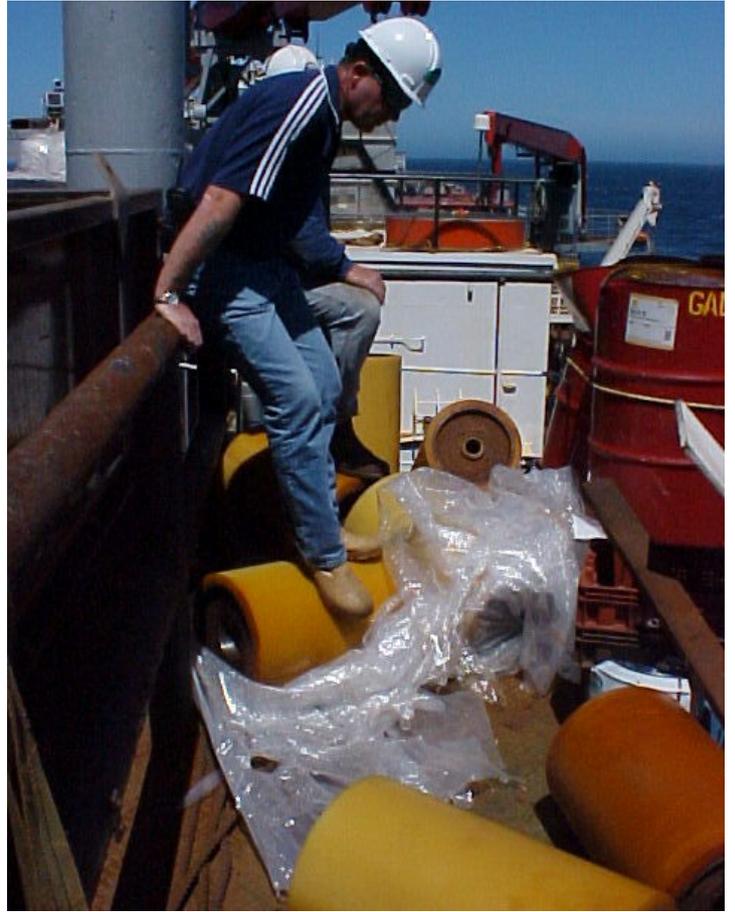
A member has reported the following incident which occurred on one of its vessels. A deck crew had picked up a pallet of rollers from the aft deck and was moving them to the designated storage area, above the welding fabrication shop. Whilst slewing the crane into the storage area, one of the pallet chains struck the crane boom rest, resulting in the rollers falling from the pallet. The rollers fell to 'D' deck level and one roller fell to the main deck level, just outside the fabrication shop area.

The pallet contained six rollers, each weighing approximately 80kg. The weather conditions at the time were a wind speed of 28-30 knots, with 2-2.5 metre sea swell.

Nobody was injured and no equipment was damaged.

The pictures overleaf show the result of the incident.

*When using cranes to move loads on pallets, the load must be checked to ensure that it is banded or strapped. If not, the load must be made secure by other means, or the loads should be split and lifted separately, using webbing or steel slings.*

*The area where the loads are to be lifted to is to be barriered off, with a crew member present to prevent unauthorised entry to the lifting area. Signs are to be posted in the relevant area, warning of overhead crane operations.*
