IMCA Safety Flash 02/03

February 2003

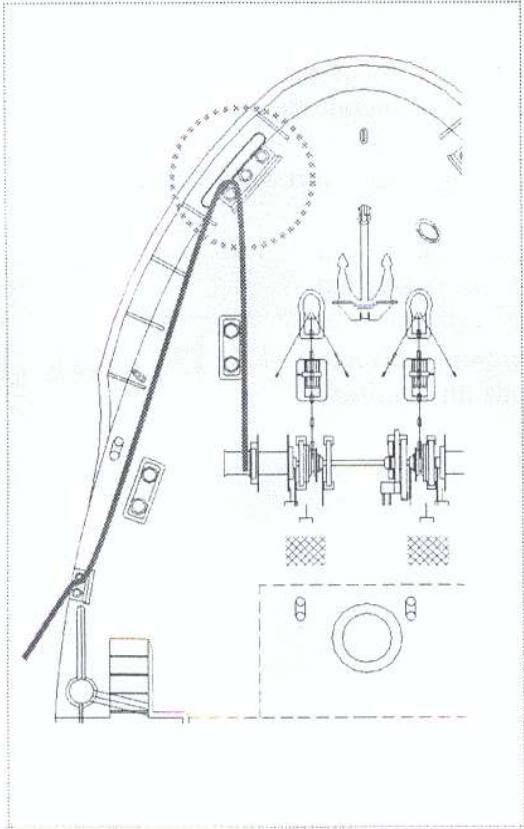
The vessel had berthed alongside a pier, letting go its starboard anchor with three shackles in the water to the direction of 3 o'clock. Every mooring line, except a bow spring line, was made fast to the shore bitts through each appropriate mooring hole or each fairlead. However, the bow spring line was connected to a shore bitt via two fairleads, in order to prevent the line from chafing against the shell plate, i.e. the spring line from the winch was taken forward to the fore fairlead, around a roller of the fore fairlead to the aft fairlead, then out to the shore bitt (see figure). The mooring lines were polypropylene fibre ropes with a diameter 65mm.

The spring line tightened and the ship moved away from the pier. The base plate of the fore fairlead (see inside dotted circle) was torn away from the forecastle deck because of the strong tension on the line. The spring line flew out of the fore fairlead, was catapulted back and hit a crew member on his head. He died quickly.

The torn base plate of the fore fairlead was inspected thoroughly after the incident. One third of the welded part was rusted and cracked, even though the apparent condition had been good.

Fairleads are generally used to change the direction of the mooring rope when there is an obtuse angle from a ship to a pier. However, any unconventional mooring line arrangement that shortens the angle creates much stress on the fairleads and causes potential hazards. Therefore, established rules regarding the proper use of fairleads and the strength of supporting structures are needed. Clearly, structural components subject to high stress loadings need careful and regular inspection and the design of mooring equipment should be arranged so as to prevent lines from chafing with shell plates.

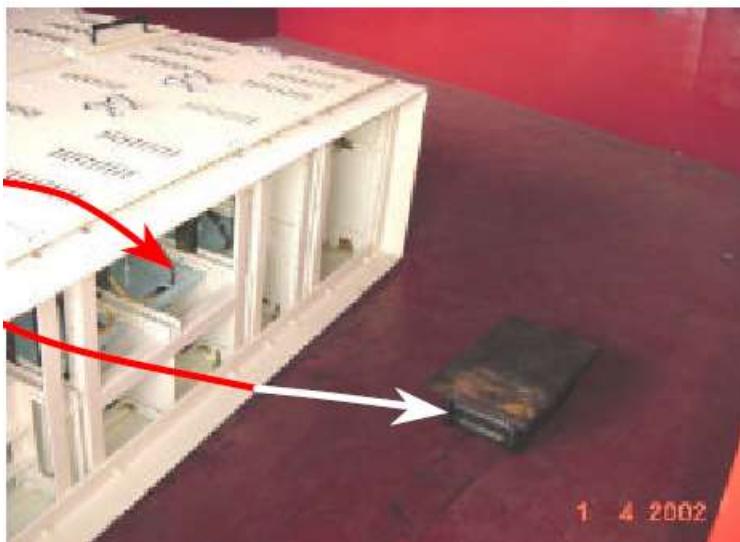
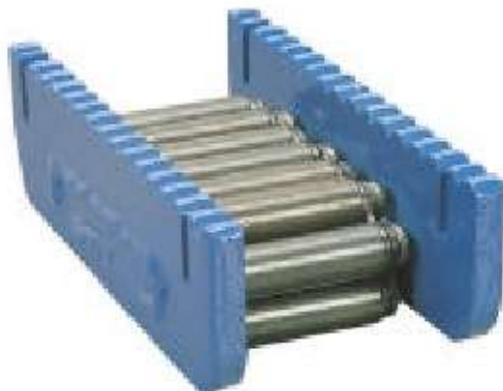
The electrical panel weighed 1.8 tonnes, was 2.5 metres high and had a base measuring 2.75m x 0.2m. The bottom was an open arrangement with a flat bar at its edge.

The method of movement was to put the panel on four independent rollers – one under each corner of the panel bottom.

After 3m transfer into the room, the panel bottom lost contact with one of the rollers, becoming destabilised. The panel toppled over and trapped one of the workers. He was crushed and died instantly.

- ◆ • The contact point on the roller was very small, with a high centre of gravity and a small footprint area;
- ◆ The rollers were independent and not guided, needing to be kept in position under the panel by the workers;
- ◆ The rollers had not been adequately maintained and some were not rolling properly;
- ◆ The workers were not experienced in use of the rollers;
- ◆ There was an apparently lack of safety awareness at each level of the shipyard's management.

- ◆ Adequate safety training of workers to be conducted and the importance of safety to be stressed to management;
- ◆ Preventive measures to be taken and adequate preparations made before the commencement of work;
- ◆ A procedure on the use of rollers to be inserted into the

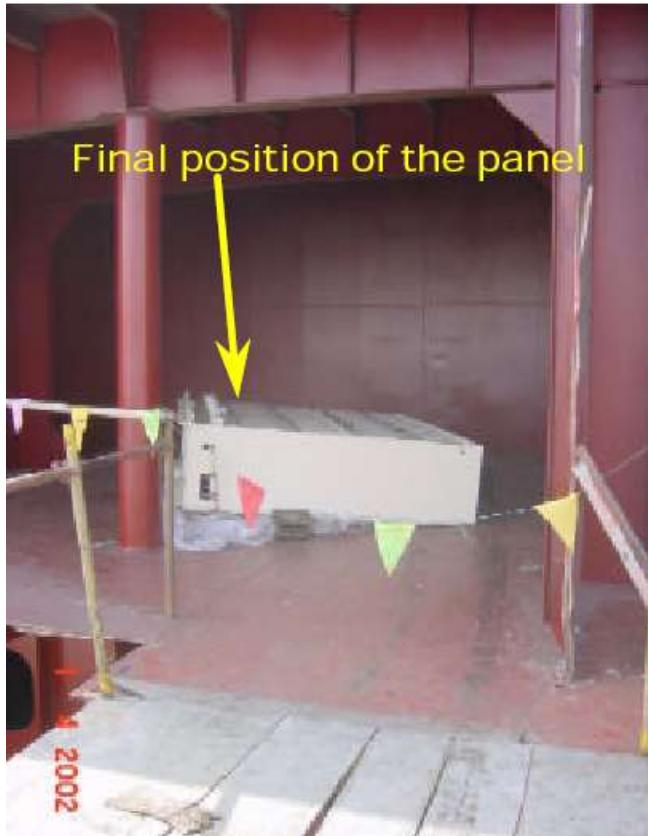
After lifting the panel onto a temporary platform and setting it on the four rollers, five workers started to push the panel into the switchboard room. The panel was still connected to the crane with workers positioned around the panel. After moving the panel about one third of the way into the room, it was impossible to keep the crane connected due to roof overhang. After removing the rigging, the work crew continued the transfer process.

company's operations manual;

- ◆ Tools and equipment to be checked before use and a preventive maintenance policy implemented to make sure that equipment and tools are in a good condition;

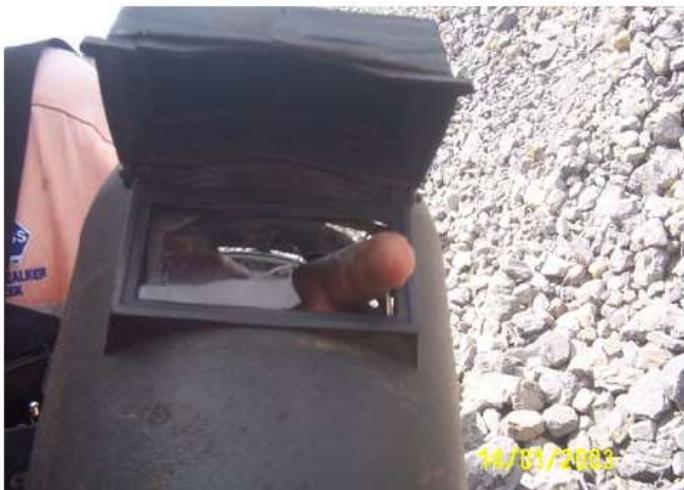
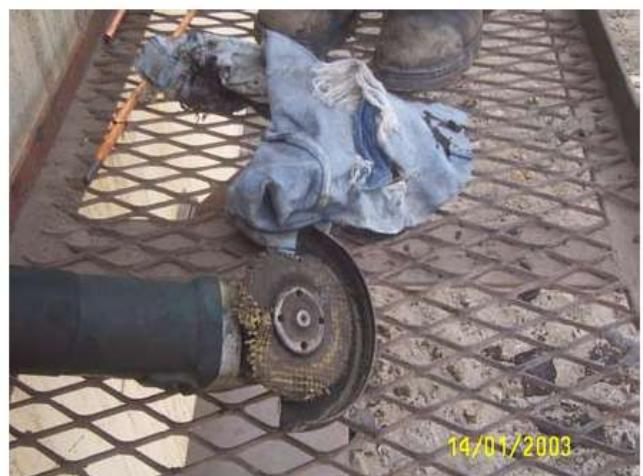
A boilermaker suffered a serious eye injury from a fragment of shattered grinding disc penetrating the inner lens of his welding helmet and subsequently his eye. He was grinding a repair weld on the lower stabiliser link of the dragline with a 5" electric grinder when it is believed that the tool jammed. It appears that when the grinder was released, the disc shattered and penetrated the eye protection.

- ◆ The work environment was restricted, necessitating the boilermaker being in close proximity to the area being ground;
- ◆ The jamming/stalling of the grinder and subsequent failure of the disc wheel;
- ◆ The inner lens of the welding helmet, which should be impact-resistant, may inadvertently been replaced with an 'anti-splatter' cover lens, which would have offered little impact resistance.

- ◆ Discussion of the incident, possible causes and interim preventative measures with worksite personnel.
- ◆ An interim measure of mandating a face shield and safety glasses to be worn whilst performing grinding, as opposed to welding helmets;
- ◆ Checking of all welding helmets to ensure the correct lens plates are installed and that they are in the correct position;

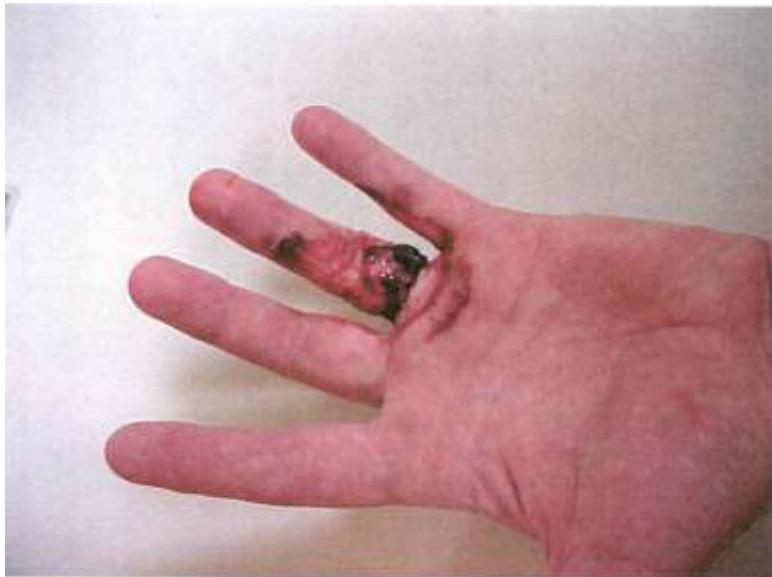
A 12 volt vehicle battery was being disconnected using a crescent wrench, which slipped and grounded out when it came in contact with metal. The person received a burn on his ring finger as his gold ring had come into contact with the wrench. The injury was completely around the ring finger and severe enough to cause concern about the loss of the finger from a lack of adequate circulation.

It has been pointed out that most vehicle batteries have 600-800 cranking amps, compared to 75 amps for stick welding and 300 amps for air arc welding. Severe burn injuries can occur and caution should be exercised when handling such batteries, including removing rings and other jewellery before starting work near or on a battery/connected wires and equipment.
