IMCA Safety Flash 02/07 (updated – item 2 deleted)

March 2007

Safety Bulletin #1 of 2007. March 1, 2007 Helmet Shell Repair Caution

HSE Alert No. HSE001-2007

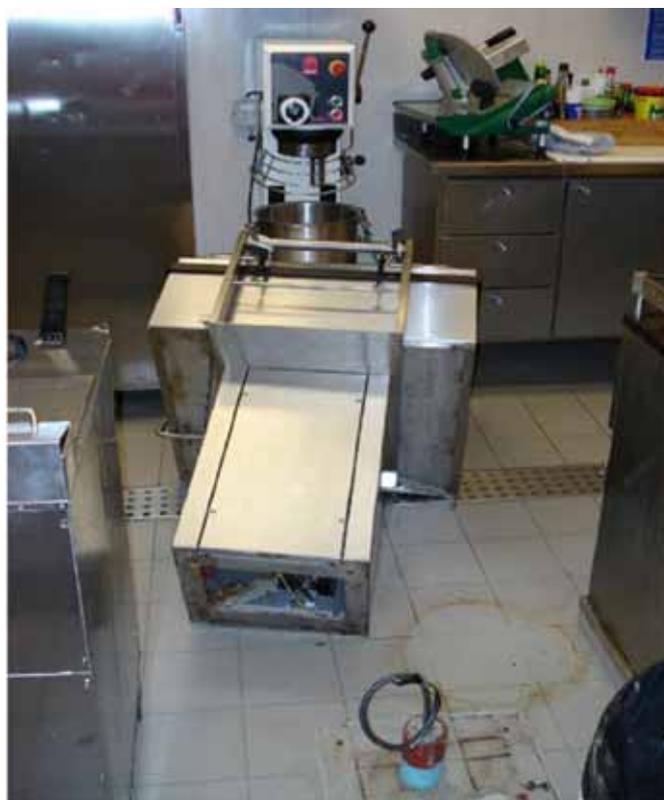
Grill fryer toppled over on floor of galley

During subsequent investigation, it was discovered that the grill fryer had been very poorly connected to the galley floor during the construction of the vessel. The securing bolts had only been screwed into the tiles and not into the steel of the deck.

- ◆ The galley was evacuated and the bridge was informed;
- ◆ An electrician was called to isolate the grill fryer;
- ◆ Following electrical isolation, the grill fryer was made safe by temporary sea-fastening until the weather abated and permanent repairs could be made.

The vessel crew subsequently checked all other galley appliances and found that they were all securely bolted to the floor. Once the weather had abated, the crew reinstalled the grill-fryer, ensuring that it was securely mounted on the floor.

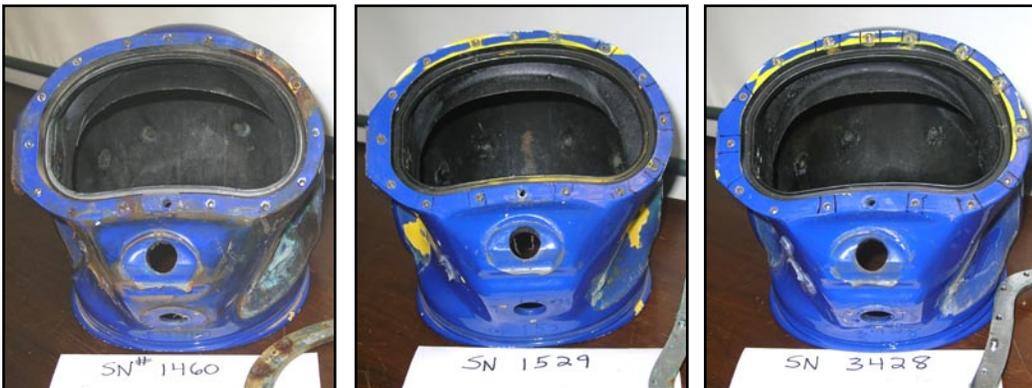
A visual inspection inside of all three helmets showed an obvious irregular finish around the regulator mount area. Once the paint was removed around the irregular area it was noticed that the whole lower section of the helmet had been previously removed and replaced with non-laminate filler.

This is how the three stripped helmets appeared when they were received by the repair facility.

These three helmets may not be the only ones that have been modified in this potentially dangerous way. Anyone noticing an irregular finish on the inside around the regulator mount as shown in the pictures, should not use the helmet and should immediately contact a KMDSI dealer or KMDSI. The helmets in question all came from the UK, however because of the international nature of commercial diving all users should use caution and carefully check any previously acquired used helmets.

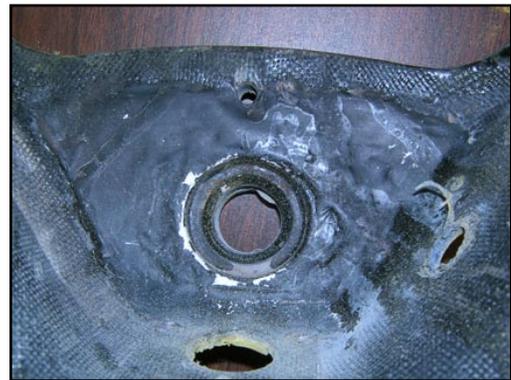
The interior of one of the painted helmets shows obvious sub-standard repair work.

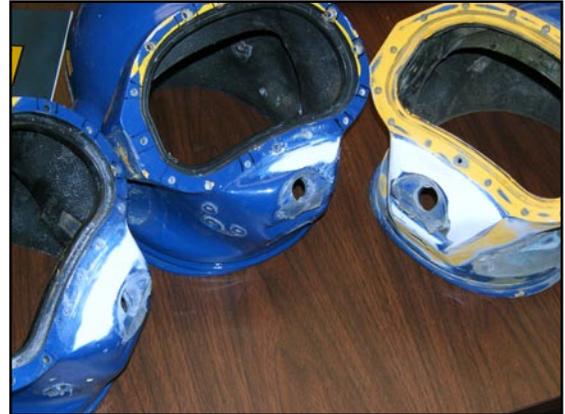
The unauthorized paint job on these helmets concealed repairs performed with sub-standard materials.

KMDSI has always discouraged painting of fiberglass helmets because there is no way of telling what lies beneath the finish. Refinishing should only be done by a specifically trained and certified KMDSI fiberglass technician. All repairs should be well documented, including pictures. Certified KMDSI fiberglass repair technicians will only use polyester gel-cote for refinishing and will only perform fiberglass repairs on helmets that have a record of repair, or only after removing any unauthorized coatings and performing a proper inspection.
