IMCA Safety Flash 02/12

February 2012

I Equipment at Height not Properly Secured

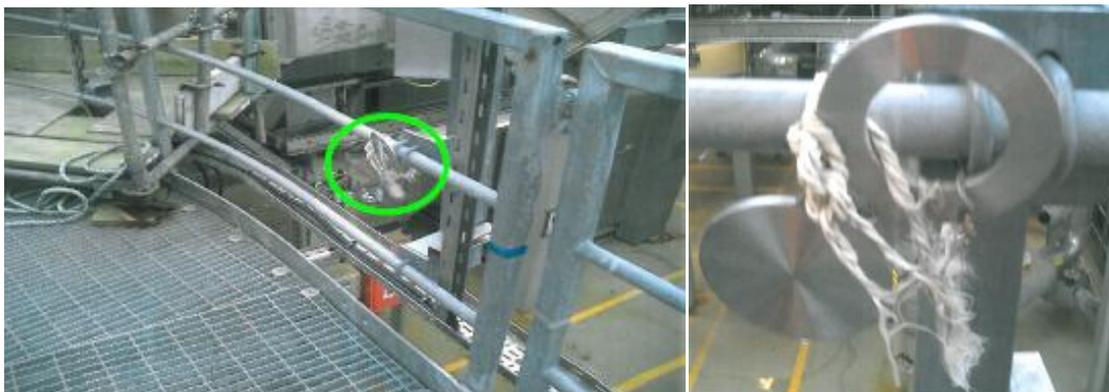
A member has reported an incident in which tools were found inappropriately secured above a pedestrian walkway. A slip-in spade was found tied to a hand rail with a badly chafed rope. A piece of thin copper wire had been used to compensate for the poor condition of the rope. At the time of the observation, the copper wire had started to corrode and did not appear to be a sufficient method for securing the spade.

The location of the handrail was outside the outer boundary of the decking. This overhang meant that the decking would have provided no protection had the spade become unsecured and had fallen. Directly below the spade was a pedestrian walkway as indicated by yellow markings.

Showing spade secured to handrail

The spade was removed immediately and the observation was reported. There were no injuries.

Members are encouraged to forward this information to offshore personnel as a reminder to properly secure equipment and tools when working at height.

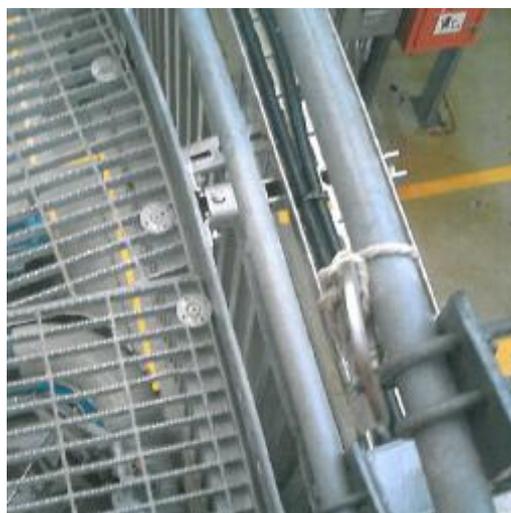
Showing spade secured to handrail and view to deck below

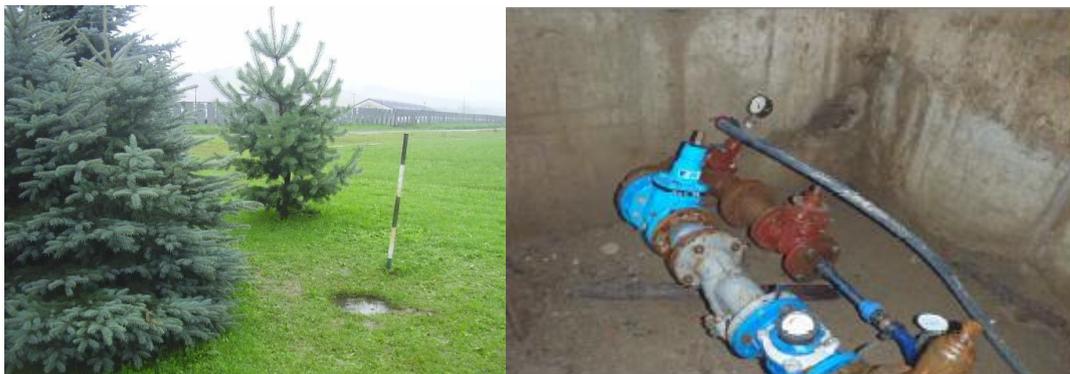
An incident has been brought to IMCA's attention in which a person suffered severe brain damage as a result of entering a confined space to read a water meter. He had not used his equipment to check whether the atmosphere in the chamber was safe, which was later measured as containing six percent oxygen.

Two water meter readers attended a water meter chamber some 1.8 metres deep to carry out a routine meter reading. They had carried out an atmosphere check using a single channel oxygen gas monitor of the previous chamber and as the atmosphere for this was found to be ok, they assumed that the existing chamber was also suitable for entry and did not carry out a gas check. The first meter reader entered the chamber and the second meter reader was distracted for approximately ten seconds and when he next looked into the chamber he observed his colleague slumped unconscious at the bottom.

Entrance to confined space and view into confined space showing water meter

Investigations into the circumstances of this tragic incident are still on-going and any further learning will be shared. This safety alert highlights the dangers associated with confined spaces and the critical importance of following appropriate confined space entry and rescue procedures and to always use relevant equipment.
