## IMCA Safety Flash 02/15

February 2015

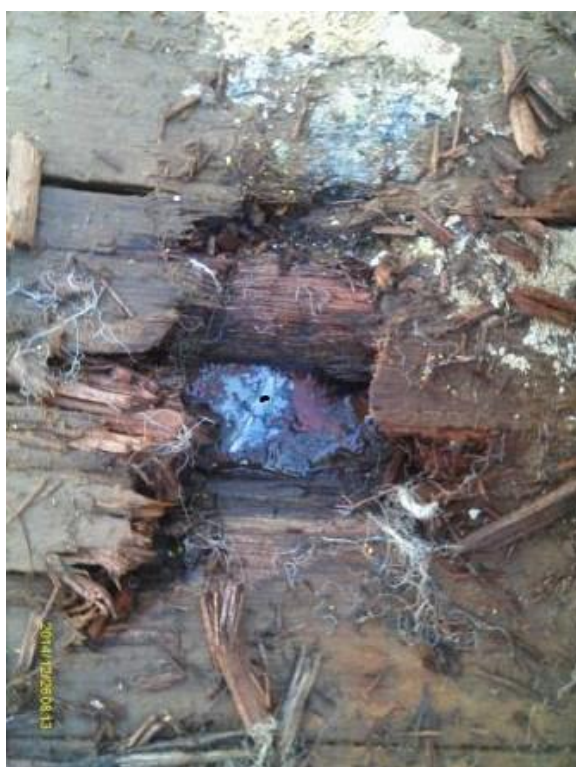
Figure: showing damage to deck

- ◆ Actual damage: the crane block destroyed sections of wood planks on main deck and damaged the bunker tank top underneath;

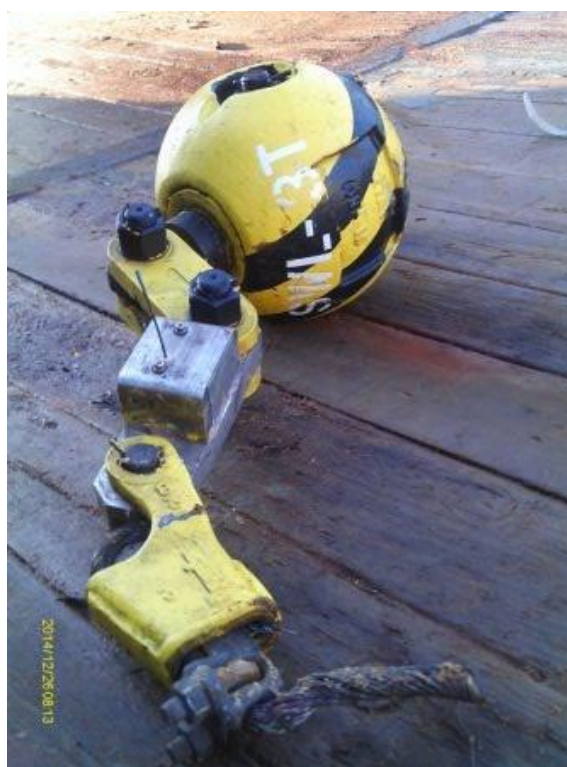
The rig crane attempted to lift the food container but the container was found to be too heavy, and was immediately returned to deck. Upon safe landing, the heavy duty wire was then disconnected by the deck crew. However, upon disconnection and before the deck crew had cleared the area, the crane driver started to retrieve the smaller wire instead of the heavy duty one. The smaller wire was heaved all the way up to the crane boom, at which point the hook block came into contact with the end of the boom, causing the smaller wire to part. The hook block then fell to deck and landed close to the crew on deck. There were no injuries.

Figure: crane block that fell

- ◆ The rig crane's limit switches/stops were apparently not fully operational, thereby allowing the hook block to be heaved all the way up to the boom.

- ◆ Further inspection and testing of limit switches to ensure that no similar technical failure exists onboard;
- ◆ Emphasised the need to prepare to exercise the Stop Work Policy if third party equipment is not safe, or there are concerns about its condition and/or operation;

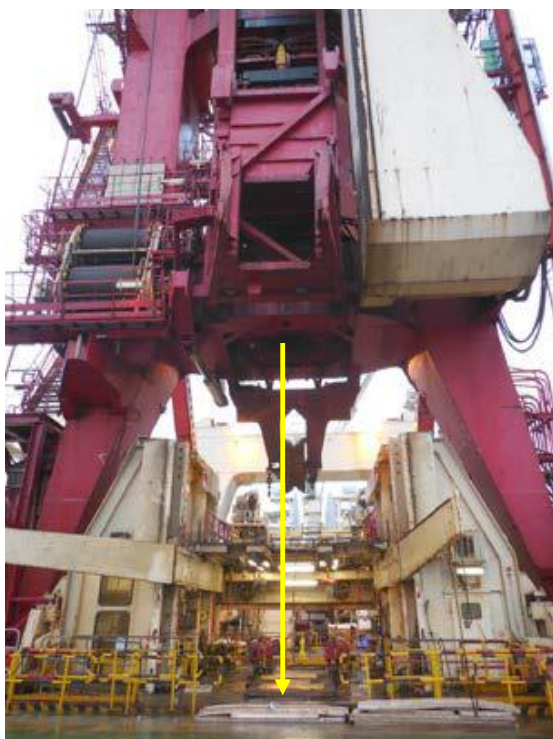
A member has reported an incident in which a wooden hammer shaft failed and the head fell to deck. Two personnel were located at the upper main tensioner level of a pipelay tower, removing dowels from the tensioner gear boxes using a spanner wrench, dowel removal tool and the 2kg lump hammer. During this process the personnel were striking the spanner wrench with the lump hammer. On a downward swing of the hammer and at impact with the spanner wrench, the hammer head detached from the shaft and fell approximately 25 meters vertically through the tensioner to the deck below. There were no injuries. Had the falling hammer head struck a person, according to the DROPS calculator it would have caused a fatality.

Figure: pipelay tower showing where hammer fell

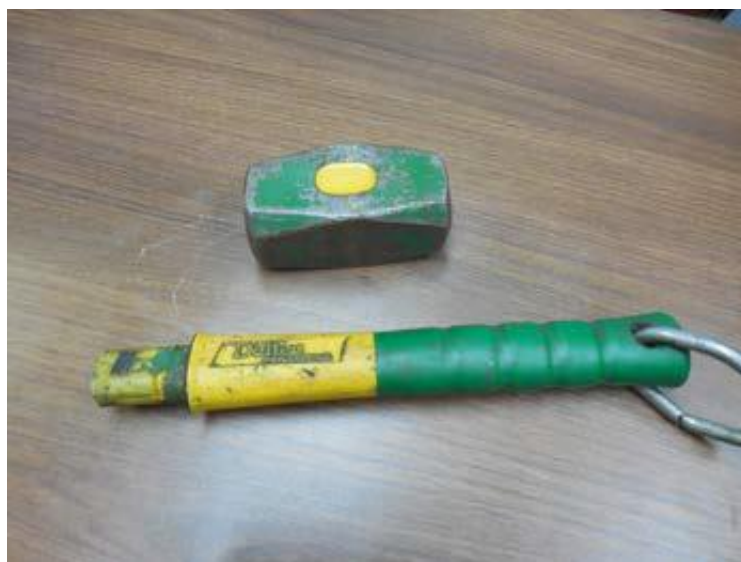
Figure: broken lump hammer

- ◆ The hammer was not specifically designed for use at height, and the head can (and did) separate from the shaft;
- ◆ The reason for the failure was not yet known, the manufacturer claimed to have a design that requires 20% more force to pull the head from the handle than a conventional wedged hammer, but it had nevertheless failed whilst in use;

- ◆ Despite inspection prior to use, the hammer showed no defects. A specifically designed hammer for working at height such as from Stop-Drop Tooling, would not have failed in this way as the head cannot come free from the shaft;

- ◆ The shaft of the hammer was fitted with a lanyard, there was however no way to prevent the head dropping with this type of hammer.

- ◆ Ensured that this particular brand of hammer was NOT used at height subsequently;
- ◆ Supervisors to ensure that tools used for working at height offer complete dropped object prevention, and liaise with their Health & Safety Executive (HSE) Superintendent for advice if new tools are required;
- ◆ Continued liaison with hammer manufacturer regarding the failure.

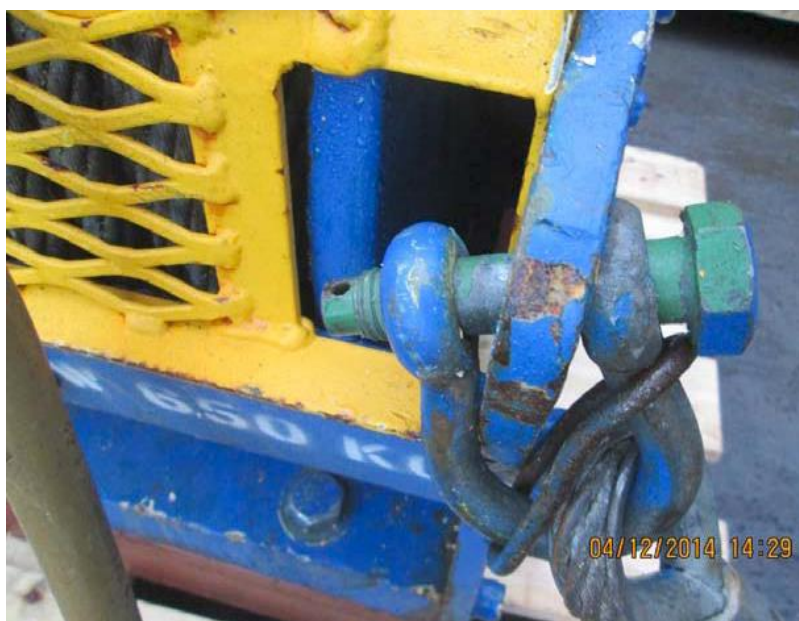
Figure: condition in which lifting equipment was left – showing missing nut and split pin

- ◆ There was no evidence that the rigging arrangement was incorrect during the demobilisation of the equipment from the vessel. However, this could not be ruled out and therefore it was vital that the importance of carrying out rigging checks prior to lifting is reiterated;
- ◆ It was possible that the split pin and nut worked themselves loose as a result of vibration on the back of the truck during road transportation. This would indicate that either the split pin was incorrectly fitted, or was missing.

- ◆ Subjected all rigging arrangements to a thorough visual inspection prior to carrying out any lifting, ensuring that split pins are securely in place to prevent nuts and bolts from working themselves loose;
- ◆ Ensured that lift supervisor inspects all loads thoroughly for potential dropped objects and to ensure correct rigging and slinging arrangements are in place and correctly secured;
- ◆ Reiterated importance of thorough visual checking of lifting equipment before use, before mobilisation and demobilisation.
