## IMCA Safety Flash 02/16

January 2016

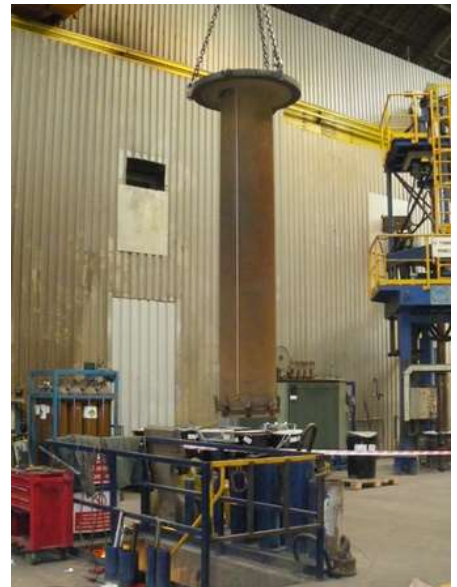
The UK Health & Safety Executive (HSE) has published the following information regarding an incident where a worker was killed when he was struck on the head by a load on a moving crane. The incident occurred in a foundry when the worker was helping move a crucible from a re-melt furnace. The crucible had been lifted using an overhead crane and moved approximately 10m to where the worker loosened the bolts around the crucible. The crane operator waited for acknowledgment to proceed and lifted the load around 60cm higher before continuing movement. The crane operator saw the worker in the path of the load and shouted a warning while stopping the movement of the crane. The crane stopped but the load swung forward hitting the person on the right side of the head, causing fatal injuries.

The image to the right (UK HSE) shows a similar load.

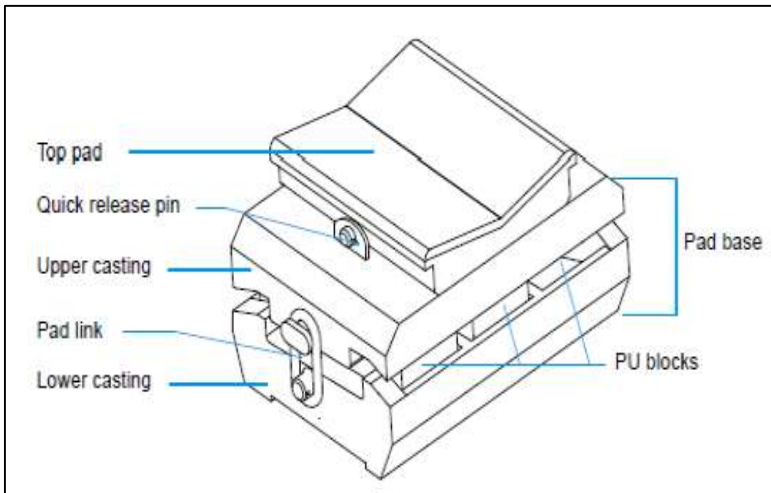
Tensioner pad diagram

During the removal of a tensioner pad upper casting on track 4 of the upper tensioner section, one of the PU (polyurethane) blocks (there were three PU blocks per pad configuration) slipped out upon removal and fell between the track guide, falling approximately 36m to the deck below. No personnel were nearby at the time; the nearest person was 10-15m away. Had the PU block (which weighed 1.24kg and fell 36m) hit someone, the outcome had the potential to result in a fatality.

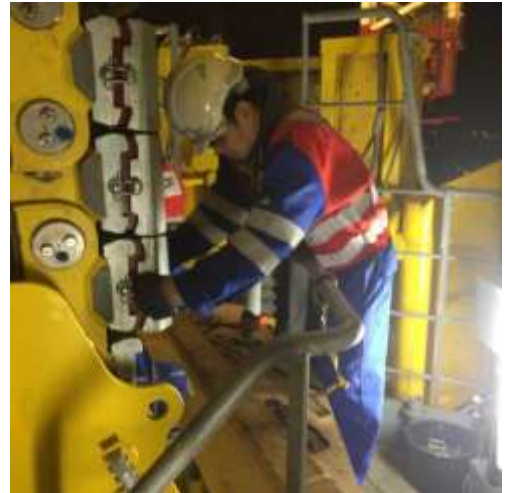
In situ showing actual size

The approximate point of contact – where the PU block made contact with the deck

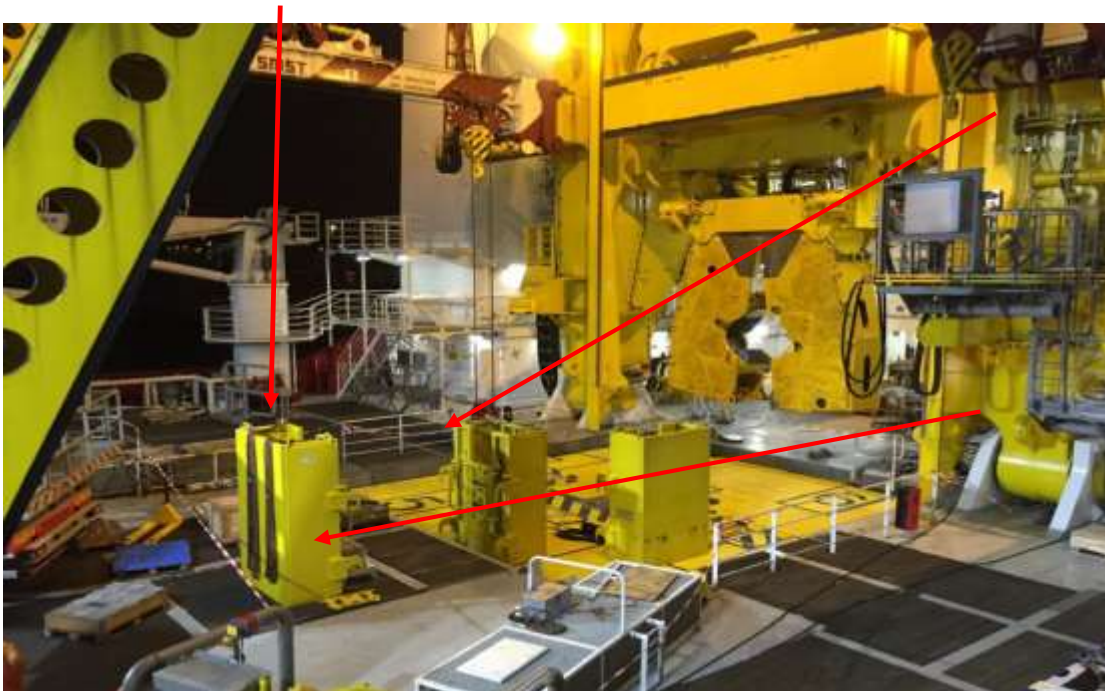
Photograph of worksite

PU block final resting position on deck

Crew were working here at the time of the incident

- ◆ The PU block landed on the deck outside of the safety barriers put in place for this task and finally came to rest approximately 7m away from where it first landed;

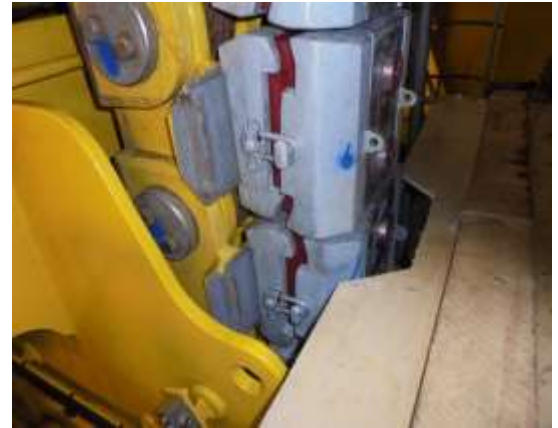
**BEFORE Incident**

*The initial set up of temporary timber designed to prevent objects dropping. However once the upper casting is removed there is a gap sufficient for an object to fall in between the tracks*

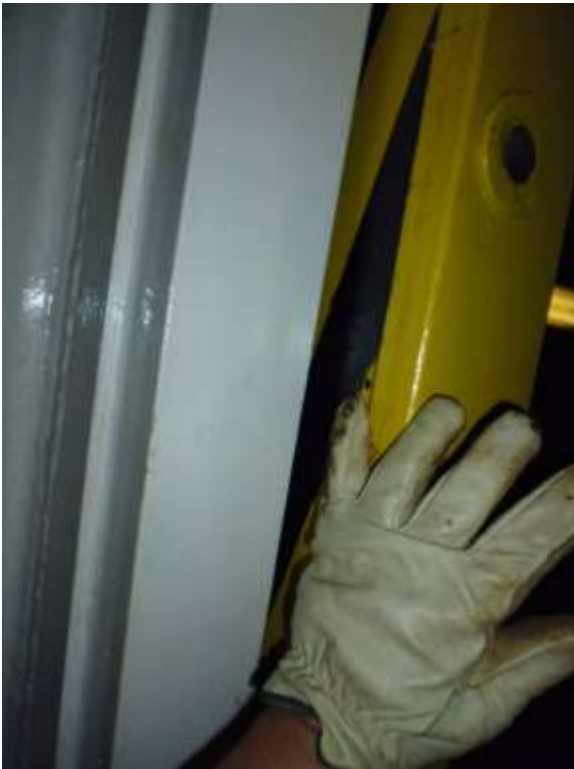
The immediate cause of the incident was that the injured person made an improper effort to save time – whilst passing the watertight sliding door, he supported himself by placing his left hand on the still moving sliding door, which then trapped his finger.

*Position of the hand with little finger in the pinch area.*

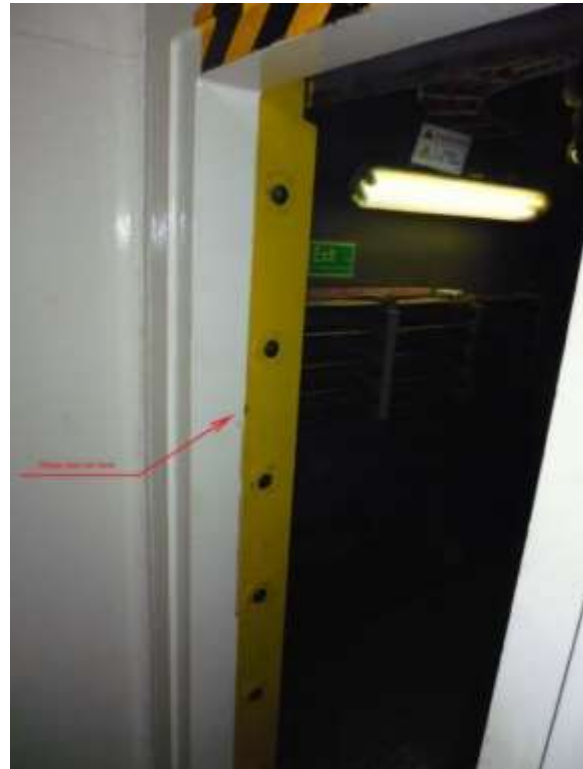
*Watertight sliding door in the fully "open" position (red arrow indicating the pinch area.)*
