## IMCA Safety Flash 02/20

January 2020

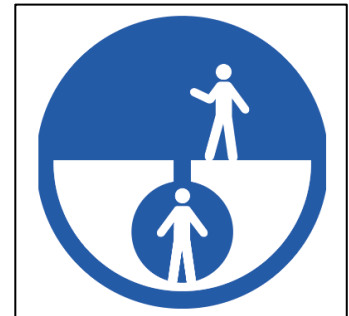
A crew member felt faint and subsequently collapsed after working in a confined space. The incident occurred following the work of a four-person team on rust removal maintenance of the water ballast tanks. The team spent the day removing bottom sediments and rust scales in a tank and came out in the late afternoon for dinner. One crew member stated that he felt dizzy and was experiencing a headache and blurred vision. The team assumed dehydration was the cause and proceeded to return to their cabins in preparation for dinner. During the elevator ride to the upper deck, the crew member fainted.

The team contacted the Master and Chief Officer who administered medical oxygen before transferring the crew member to the ship's hospital for further observation. After regaining consciousness, the crew member reported that he had smelled a strong odour after dislodging a large caked piece of sediment from the bell mouth.

Following medical advice, the crew member was treated for suspected Hydrogen Sulphide poisoning as a worst-case scenario. The crew member recovered quickly and returned to full duties two days after the event.

- ◆ Immediate causes:
  - enclosed space atmospheres are hazardous as a result of a combination of potential conditions even after full ventilation and atmosphere testing has been completed
  - physical discomfort caused by lack of airflow, warmer temperatures, awkward positioning, slippery surfaces and lack of illumination can lead to personnel feeling unwell, dehydrated and fatigued
  - ballast tanks can contain toxic gases – Hydrogen Sulphide can be found in tank sediment as a result of decomposing sea life which may enter the tank;
- ◆ Causal factor – lack of knowledge; the tank team were not fully aware of the hazards associated with the task and the crew member did not recognize the potential danger when he smelled the strange odour;
- ◆ Root cause – the risk assessment did not adequately address the hazards and severity of the task.

Immediate action taken was all maintenance work in the water ballast tank was halted until the atmosphere was confirmed as safe for entry. The Chief Officer entered the tank in SCBA and conducted repeated tests after deliberately agitating the tank sediment. However, no evidence of hydrogen sulphide or any other harmful gases were noted.

- ◆ Review the risk assessment for enclosed space entry and ensure that the hazards identified are specific to the tank/spaces being entered;
- ◆ Ensure effective toolbox talks (TBT) are carried out; discuss the hazards identified in the risk assessment and ensure the team fully understands the need to take regular breaks, the importance of staying hydrated and what to do in an emergency or if the tank atmosphere is compromised;
- ◆ Ensure the team on-board are aware of the potential gases which could be found in such tanks and how they behave and can be recognised. Hydrogen Sulphide is heavier than air so tends to collect at the tank bottom as a colourless gas that at low concentrations smells like rotten eggs;
- ◆ At higher concentrations it will deaden the sense of smell – and the person!

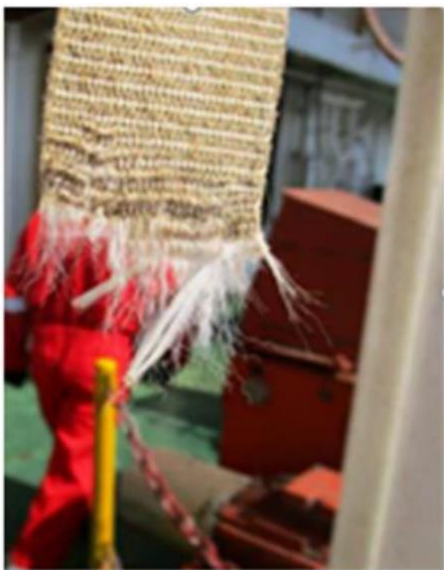
Photo 1  
Image of sling after the life raft deployment, as found.

There was a failure of the securing straps designed to hold the life raft in place. This allowed one life raft to deploy into the sea. The securing straps had only been installed one-year prior to failure.

The hold back strap, used to retain the life raft in place, was found to be degraded to the point of failure. This appears to have been caused due to the extremes of temperature and ultraviolet light.

Inspection routines for life rafts and associated lashings should consider the environmental conditions, and all parts of the equipment should be visually inspected and maintained at appropriate intervals.

- ◆ Conduct immediate inspections of life raft securing straps and associated equipment;
- ◆ Replace any items which are of concern or appear to be faulty;
- ◆ Verify manufacturer's instructions with regards to the service life of the securing straps;
- ◆ Any temporary secondary securing arrangements should not affect the ability to launch any life raft – as per SOLAS requirements.

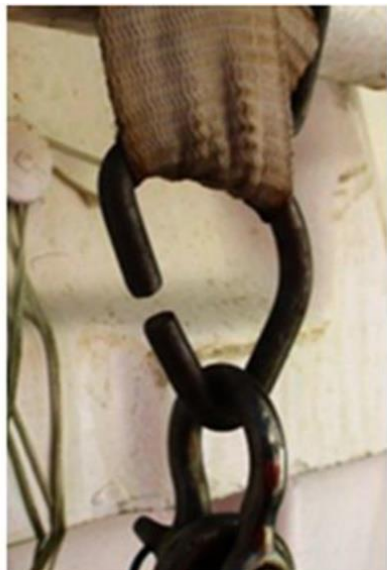
Photo 2  
The sling parted in the buckle at its weakest point.

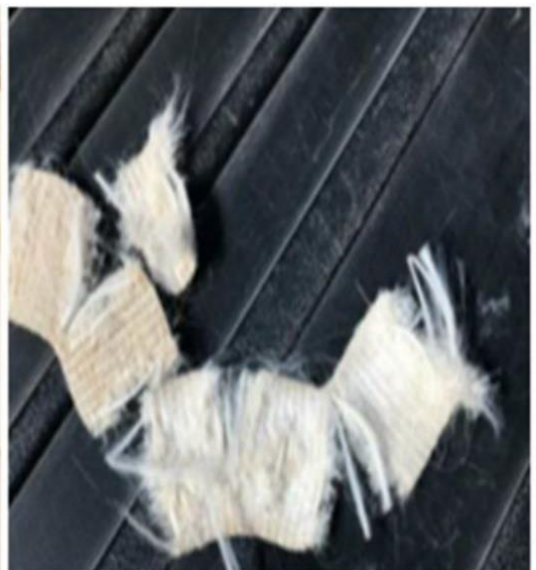
Photo 3  
The sling material was found to be fragile and parts easily, suggesting UV degradation.

The vessel was in operation in the Middle East, with high temperatures and high UV levels.

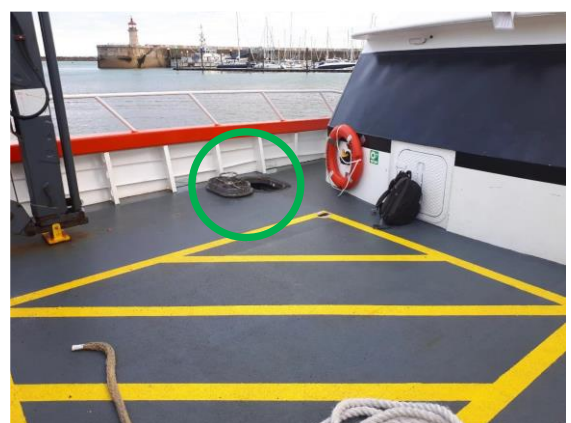
Before the incident the CTV was on standby in the field and the two-man crew were doing maintenance in the starboard hull, with the forward and aft hatches open. As the handheld VHF signal was obstructed inside the hull, the call for personnel transfer was not heard. The CTV crew were informed by another CTV and made aware of their call. The crew finished their maintenance and mobilized for the personnel transfer. At this point, only the aft hatch was closed.

Just after the personnel transferred aboard, the deckhand, who was receiving the cargo transfer of luggage, stepped backwards into the open hatch with one foot. In order to try and save himself from falling into the void space, he used his right arm/shoulder on which he landed, resulting in his injury.

The direct cause – what went wrong – was that the deckhand stepped backwards and did not see, and thus fell into the open hatch.

- ◆ Underlying causes identified:
  - because of miscommunication between the two crew members, only the aft hatch was closed;
  - the forward hatch was left open when the lifting operations started. There were no barriers around the hatch. The outside of the hatch was marked yellow and was clearly distinguishable from the deck when closed. However, there are no proper markings or distinct colour on the inside of the hatch and as a result the hatch is less clearly distinguished when opened

- ◆ Amend risk assessments to include all relevant preventive measures (including responsibilities for lifting, and deck checks prior to lifting operations and clear means of communication);
- ◆ Provide distinct (colour) marking on the inside of the hatches to make them easily distinguishable when open;
- ◆ During 24hr operations, time for maintenance should be scheduled in;
- ◆ Investigate improvement measures for radio communications when working in the engine room;
- ◆ Reiterate lesson ‘*time pressure should be prevented and in case it does occur unexpectedly; this should not lead to rushing or taking short cuts*’;
- ◆ Reiterate ‘stop work authority’.

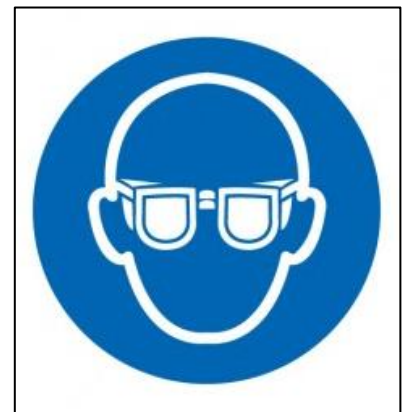
- ◆ Inadequate attention to surroundings;

- ◆ Inadequate PPE.

Weather influence – the wind blew a bit of dust from the face or hair into the eye.

- ◆ Pay attention to your surroundings;
- ◆ Wearing of full PPE may not be enough; care should be taken to ensure that it is worn properly and provides full protection for the eyes.

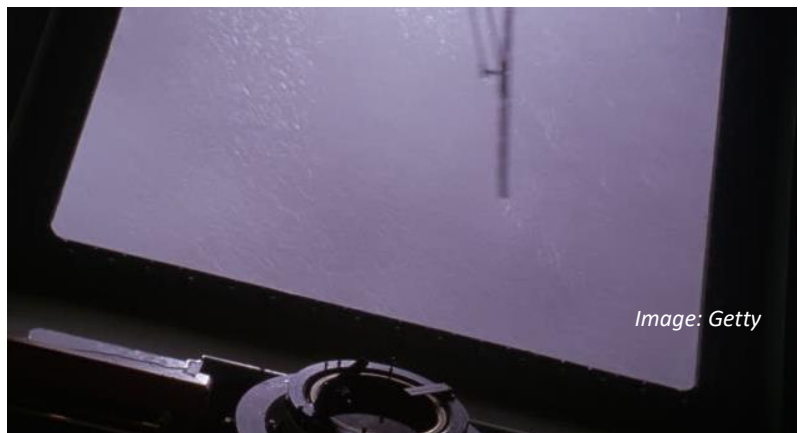
A vessel took on a significant amount of rainwater on the upper tween deck during an intense tropical storm. At the time of the storm, the forward crane could not be seen from the bridge. At 0645, it was noted there was water ingress at the upper tween deck. Water ingress came via the starboard stores hatch on the main deck. Immediately after notifying the bridge, more crew were called to contain the ingress.

The vessel was deliberately listed to starboard to prevent the water from entering the corridor in the accommodation. Unfortunately, some water did enter the corridor before the vessel was listed sufficiently. The vessel was slightly trimmed by the bow.

- ◆ The hatch was closed but not properly secured. After the vessel left port, no one thought about properly closing the hatch;
- ◆ Due to the weight of the hatch, the hinges were slightly deformed and pushed the hatch about 5mm out of true, and therefore the hatch did not rest correctly on its rubbers and it was very hard to turn the clamps.

- ◆ Lack of seamanship and inadequate attention on securing that the hatches are closed;
- Inadequate design.

Ensure that hatches are properly closed and secured and that the hatches and clamps are checked regularly and carefully and will receive preventive maintenance.
