1 Recall Notice Divex L.P. Hoses

2 Transport of Welding /Burning Gas

3 Parting of a Crane Lift Wire

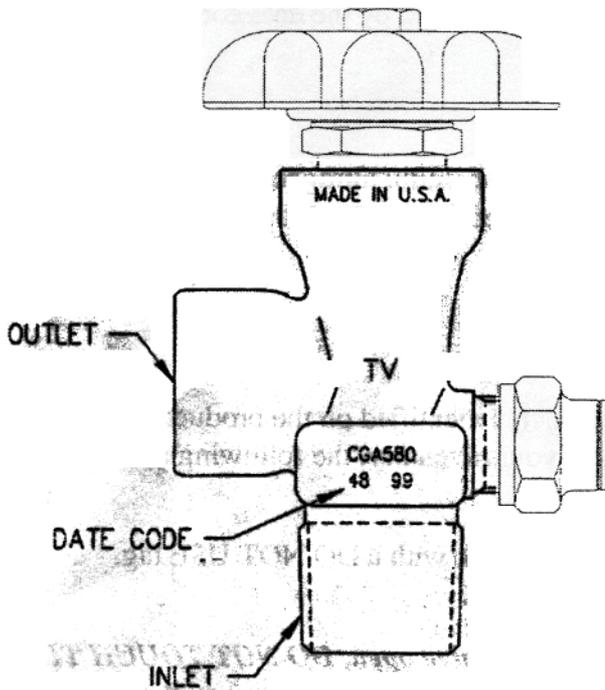
Illustration No. 1

Sherwood has received three reports involving Sherwood TV 5861 valves in which the bonnet, upper stem and hand wheel assembly reportedly ejected from the valve body on the first filling event of the cylinder in which the valve was installed. Sherwood's initial investigation has revealed that the bonnet thread strength may have been compromised.

In the interest of safety we are requesting that our customers quarantine the following valves with the date code of 48-99 and 03-00 (location of date code on Illustration No 1).

Sherwood will repair or replace quarantined valves as warranted.

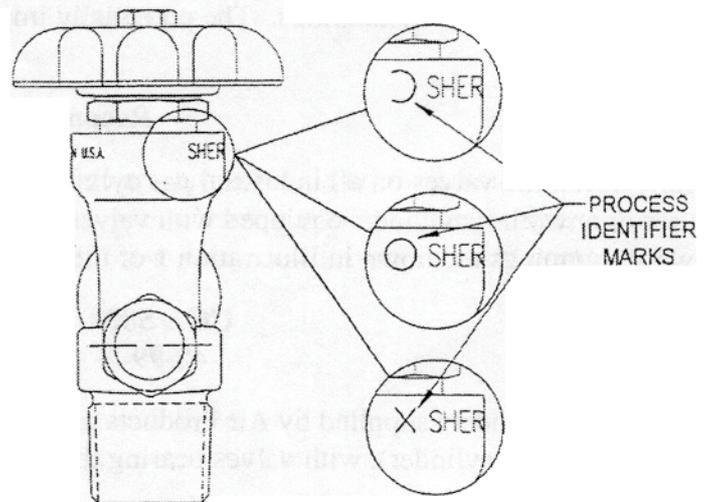
Illustration No. 2

Sherwood does not believe that the reported phenomenon involves TV series valves listed above with a manufacturing process identifier mark "▷"; "O" or "X" and it is NOT necessary to quarantine TV series valves listed above with the specified date codes which have the manufacturing process identifier: "▷"; "O" or "X" (Illustration No. 2).
