These flashes summarise key safety matters and incidents, allowing wider dissemination of lessons learned from them. The information below has been provided in good faith by members and should be reviewed individually by recipients, who will determine its relevance to their own operations.

I Fatality and Serious Injuries During Heavy Lift Operation

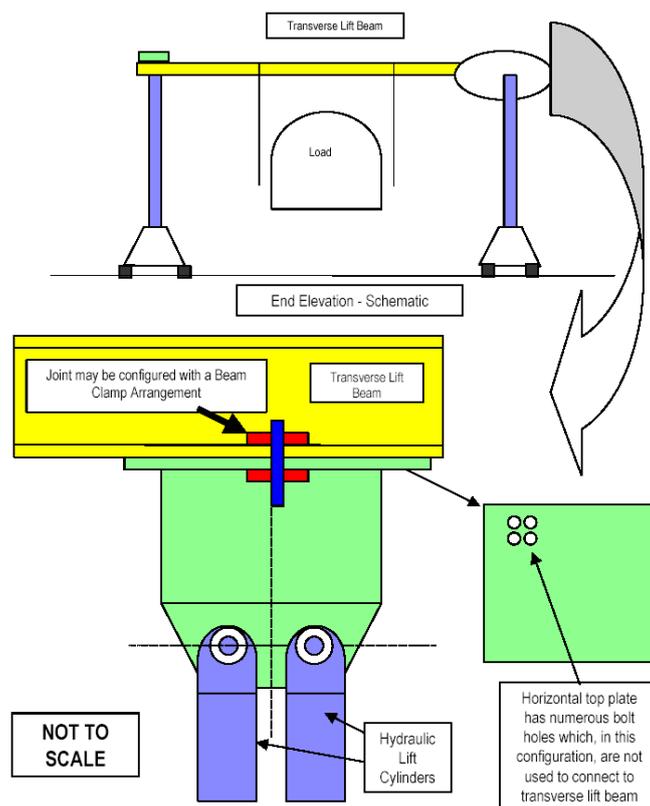
Figure 1 - Schematic

One man was killed and nine others were injured at a construction site during the lift of a 300 tonne alternator. The lift, using hydraulic jacks and beams, was nearing completion when the equipment collapsed for unknown reasons.

The system may be assembled as shown schematically above in figure 1. In this configuration, the horizontal top plate, which forms part of the connection to the vertical lift cylinders, is connected to the flange on the underside of the transverse lift beam via a 'beam clamp' arrangement.

- I A suitably qualified and competent person should check the stability of any lifting arrangements which incorporates similar vertical lift systems. This review should address the following issues:
 - ◆ All possible conditions which may result in a differential deflection between the inner and outer guide rails at the base should be considered and their impact on the overall stability of the system fully evaluated;
 - ◆ The permissible out-of-level tolerance between the inner and outer guide rails and the permissible tolerance for the vertical alignment of the lift units should be derived by calculation for all stages of the operation;

- ◆ All permissible tolerances should be included in the method statement and clearly communicated to all those involved in the operation.
- 2 A system which is capable of monitoring the vertical alignment (in two orthogonal planes) of the hydraulic lift cylinders should be devised and used during the operation.

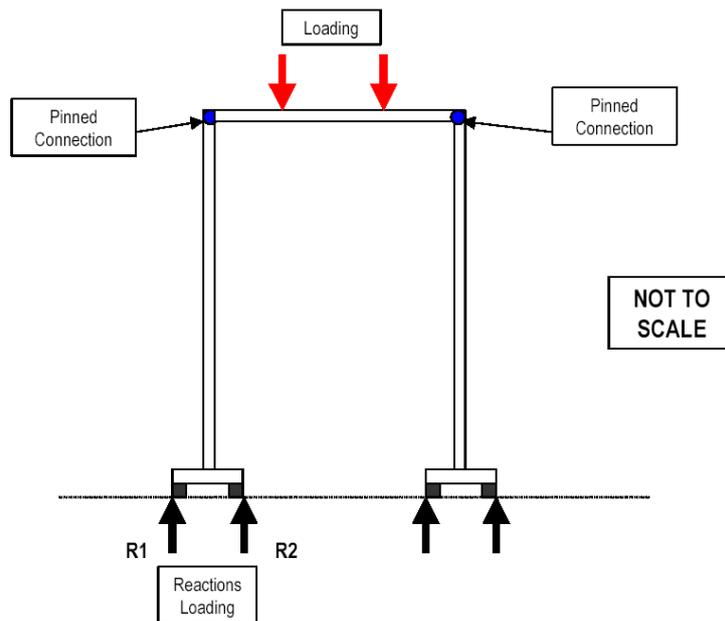
Figure 2 – Structural idealisation

If it is configured in this way, the lifting arrangements may be represented by the structural idealisation shown in figure 2. In this case, the transverse stability of the system is derived from the moment generated by the difference in vertical reactions (at points R1 and R2) between the inner and outer guide rails. However, this may be limited as the supports may have no capacity to resist an uplift or tensile load.

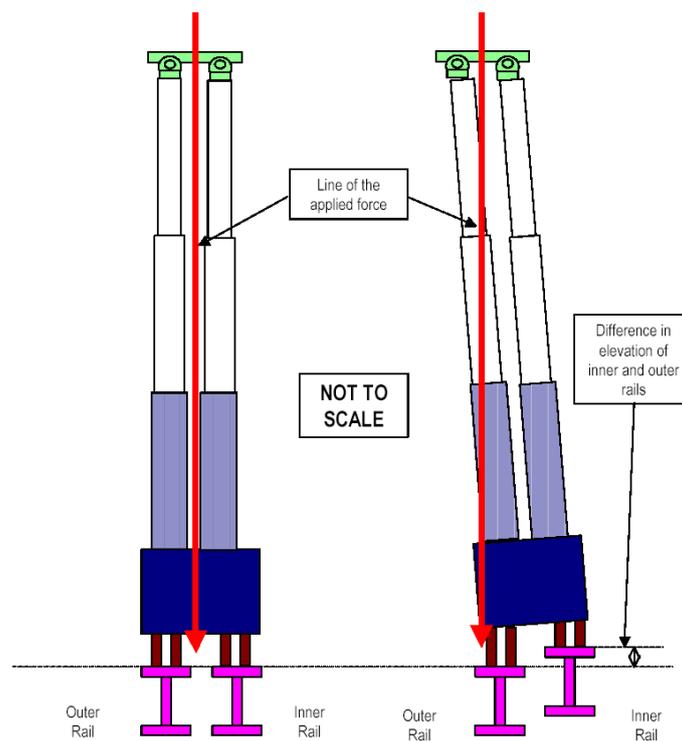
Figure 3A – Inner and outer rails level

When the inner and outer guide rails are level, the line of action of the force is between the guide rails, as shown in figure 3A. If there are differential levels between the inner and outer guide rails, this may result in the line of action of the force moving outside the base, which in turn may impact the stability of the entire system, as shown in figure 3B.

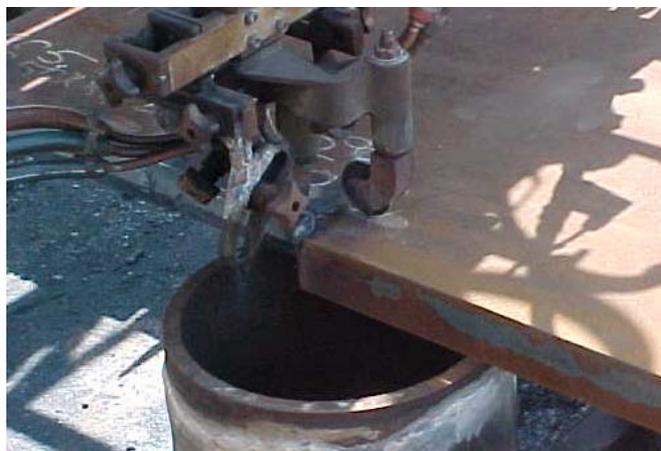
A member has reported a serious incident where a plate was being supported on a small length of tubular, which was mounted vertically. The tube was sealed at the bottom, but open to the atmosphere at the top end. The plate was about to be cut using an oxy-acetylene cutting torch mounted on a jig. The torch had been positioned at the side of the plate and was energised by the gases, in preparation for being ignited. This arrangement is shown below.

Gas was allowed, inadvertently, to flow freely into the open pipe. When the spark was struck to ignite the torch, entrained gas at the top of the open pipe alighted, causing a small explosion which resulted in a burn to the operator's hand.

The member involved has noted that positioning a plate over a support which does not allow free dispersion of volatile gases "is not good practice". Normal good practice is to support the work piece on supports that specifically avoid the build-up of a volatile mixture by, for example, the use of open trestles with sacrificial lugs.

It has reminded all those involved in metal fitting activities that they should assess the arrangements they have in place for cutting metal, to check that volatile gases are allowed to freely disperse. The member concerned has instructed its personnel to replace any arrangements that do not allow this before further cutting operations are conducted.

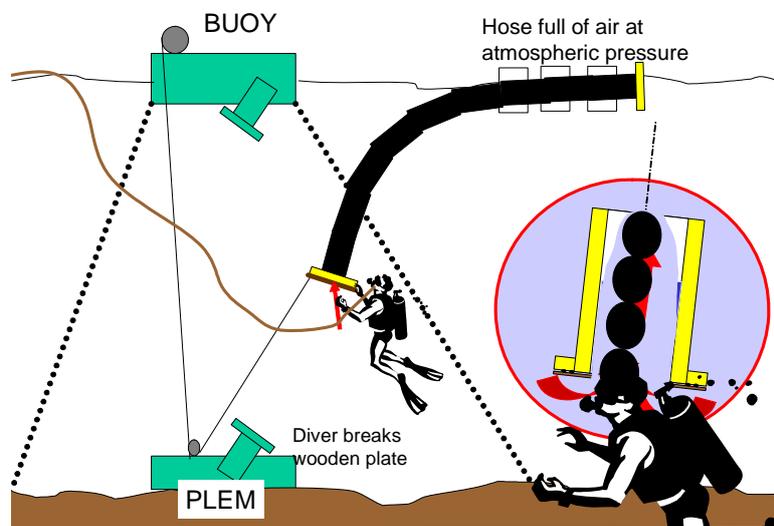
Meanwhile the diver took his broken knife blade and with his hammer he punched the plate. At this stage there was a loss of communication with the diver and there was a fast payout of his umbilical. See sketch.

The umbilical was recovered to the surface along with the diver's Kirby Morgan 18 bandmask. The bandmask was damaged but intact except for the video camera which had been smashed off. Also hooked to this equipment was the ring shaped remnant of the wooden plate. Diver rescue procedures were then launched. After a little time searching the diver was found. He had massive head injuries. Death was evident.

Management and SHE-Q representatives from the client group and the contractor immediately launched a detailed investigation into the accident, and produced a joint report. The immediate cause of the accident was the loss of integrity of the wooden plate which then allowed a sudden flooding of the flexible hose. The diver was sucked into the pipe end by the rapid inflow of water.

- ◆ Deviations from the operational procedures (no flange with valve for flooding)
- ◆ Human error, such as the misperception of risk and the eagerness to correct an error, that caused a delay.

- ◆ ensure that company and IMCA guidance are implemented as a basis of any local procedures and contractual arrangements;
- ◆ review current or recent diving practice against company procedures and the IMCA International Code of Practice for Offshore Diving. Modify current practices and procedures accordingly to be in line with these two standards;
- ◆ perform job safety analysis before all diving operations.

- ◆ ensure that the modifications or changes to working procedures are covered by defined rules and steps;
- ◆ ensure that the level of supervision is adequate and well defined;
- ◆ that a culture of get-the-job-done on time and on budget does not exist to the detriment of safety.
