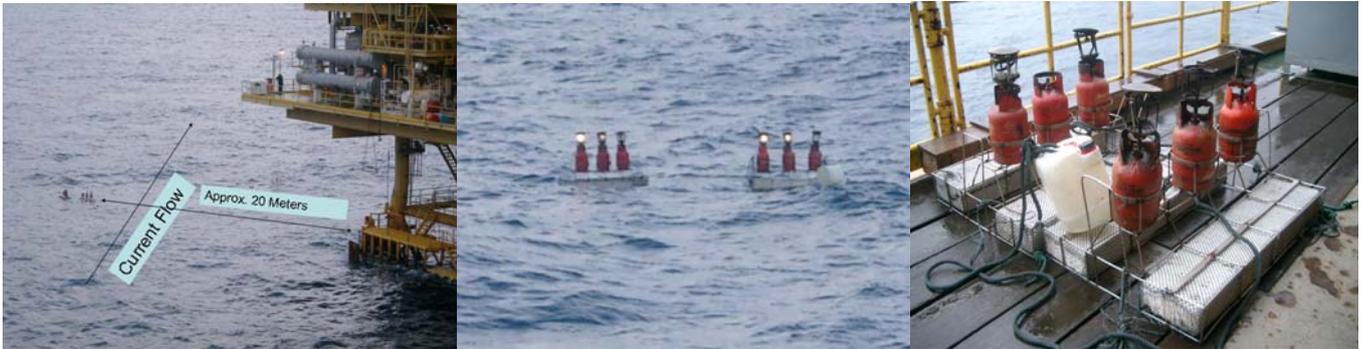
IMCA has received a report of a very serious threat to the safety of a gas production platform, caused by rafts containing bundles of lit cooking gas tank sets. These had been deployed by fishing boats to attract fish and drifted toward the gas production platforms. Such floating lights are an ignition source potentially hazardous to oil and gas operations.

The company involved reports that fishing boats violating the 500 metre safety zone have become a significant problem, increasing the risk of collisions, and endangering the security and safety of personnel and equipment. It has suggested the following possible solutions:

- ◆ a continuation of monitoring and reporting of safety zone violation incidents;
- ◆ an increased security watch;
- ◆ alerting other locations to ensure that they are aware of such potential floating ignition sources;
- ◆ continuing PR and friendly communication with fishery groups to make the fisherman aware of the potential danger to themselves and to gas production operations;
- ◆ discussion with authorities to find appropriate ways to solve the problem and enforce the law.
