## IMCA Safety Flash 03/07

April 2007

### I Near-Miss: Hyperbaric Fire Extinguisher Incident

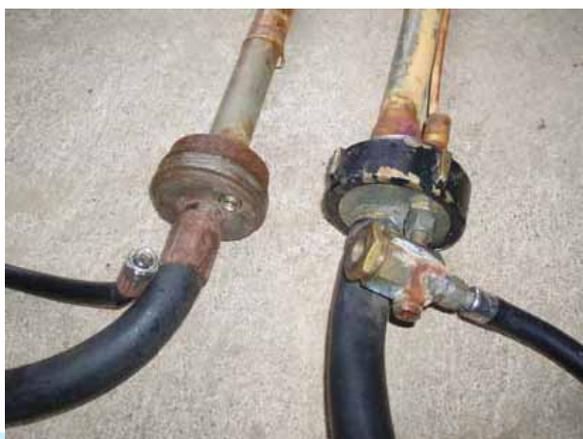
A member has reported a near-miss incident in which the safety valve assembly of a twin cylinder hyperbaric fire extinguisher blew off during routine checks. A mechanical technician was carrying out regular six-monthly checks on the fire extinguisher in the base workshop. The technician opened the high pressure cylinder valve with the intention of checking the function of the unit. As per the design and functionality of the extinguisher, the gas from the high pressure cylinder passed through a step-down regulator set at 9 bar and entered the low pressure tank, which contained the fire-fighting medium, in this case an emulsifier. At this point the entire safety valve assembly blew off the top of the low pressure tank at the point of the penetration fitting. The safety valve assembly was not recovered after the incident. No-one was injured.

Upon checking the first stage regulator it was found to be faulty. The burst disc on the safety valve assembly was also found not to function as pressure built up due to a faulty first stage regulator.

Damaged safety relief valve assembly

- ◆ It has introduced a policy of phasing out twin gas cylinder extinguishers and replacing them with single bottle hyperbaric cylinder extinguishers, which are considered safer and are widely used in the industry;
- ◆ The burst discs on safety valves are to be replaced on yearly basis;
- ◆ It has noted that equipment tracking needs to be good enough to enable tracing back of particular pieces of equipment such as fire extinguishers.

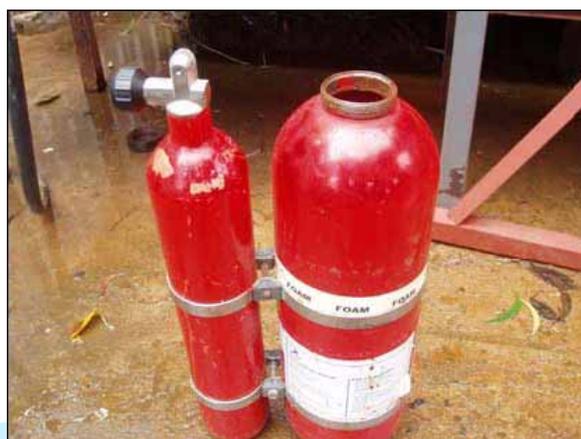
Fire extinguisher
