IMCA Safety Flash 03/08

February 2008

1 ROV Pilot Injured by Fibre Optic Glass

2 Lifting Incident

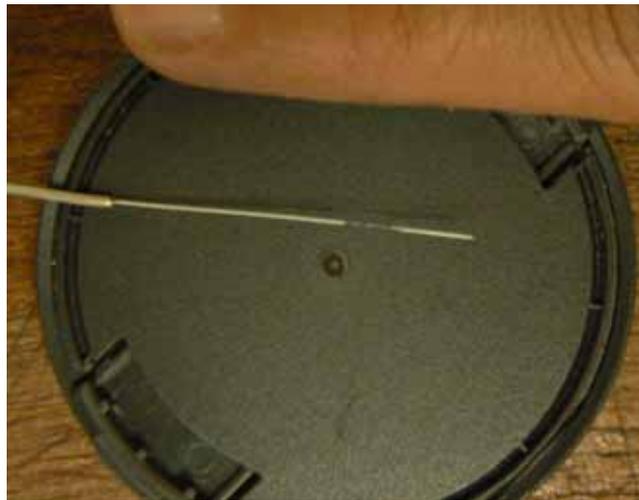
An incident has been reported to IMCA in which an ROV pilot working on an umbilical tether was injured by a shard of fibre optic material. Work was being conducted in a workshop on the umbilical tether of an ROV. Measurements and repairs were being undertaken on the fibre optic cables inside the tether. The pilot leaned forward, close to the fibres, and one of the fibre-optic cable ends pierced his skin at the shoulder and broke off.

Approximately 12mm of glass fibre entered the skin of his left shoulder at an angle and was just under the surface of the skin.

Investigation revealed that there was a lack of awareness of the danger caused by sharp fibre-optic cable ends and consequent at-risk behaviour.

Fibre optic material that caused the injury

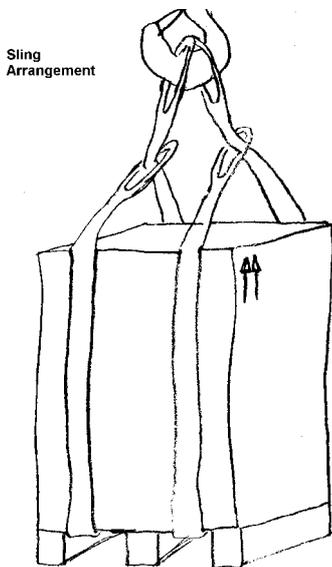
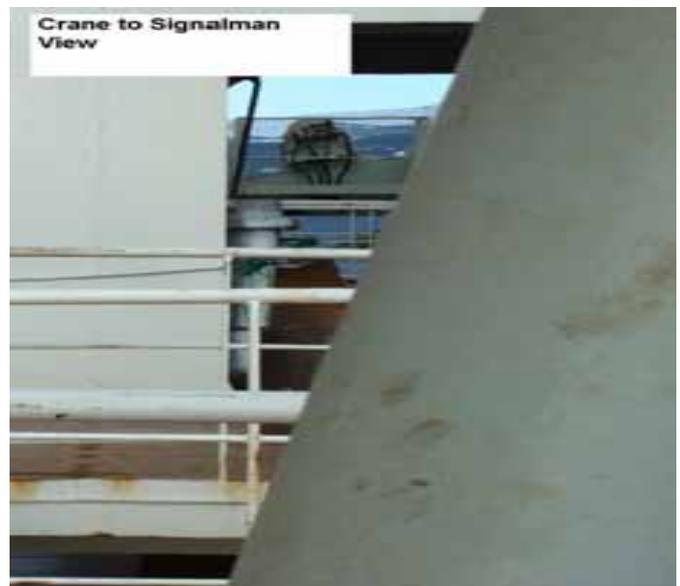
The aft port stores crane was utilised, lifting the crate from the port side towards and into the port side engine room stores hatch located inboard from the crane. The crate was secured to the crane using two slings rigged as chokers (see sketch below). There was a single tagline in use and the crane operator and signalman were in full view of each other throughout the operation.

The crate was secured to the crane hook using two 20 ft straps, described to be of SWL 8250 lbs when used as choker. The crane operator proceeded to lift the crate, holding it suspended for 20-30 seconds to ensure it was balanced properly. The crane operator received instruction from the seaman acting as a signalman while the other seaman controlled the tagline. An ERA was stationed in the engine room at the workshop deck preparing to receive the crate onto this deck. The crane operator proceeded to swing the lift inboard over the port hatch and began lowering the crate into the engine room.

All personnel noted that the lift was swaying slightly due to vessel movement, but no more than they had experienced with previous similar lifting operations. As the lift came horizontal with the ducting immediately below the coaming/deckhead the vessel experienced a larger roll and the crate swung to port and made contact with the ductwork. The signalman both signalled and verbally told the crane operator to stop lowering, which he did. The crate suddenly tipped to one side and the lifting sling on the high side of the crate slipped off, resulting in the crate tipping suddenly and falling to the deck below.

- ◆ improper slinging, no method of preventing the slings from slipping – the crate measured 50” L x 35” W x 54” H so it was a very high load, subsequently likely to be more subject to tipping/tilting if not balanced and rigged properly. The choking method was used to lift the crate, but there were no securing points to prevent the slings from slipping off if the load did become unbalanced;

- ◆ As failure to conduct/review a formal risk assessment prior to the lifting operation led to this incident, it was recommended that a formal risk assessment is to be conducted for all lifting operations;

- ◆ Investigation to be carried out regarding improved ways of caging lifts to prevent loss by inadequate slinging;
- ◆ Formal supervised risk assessment to be conducted for all lifting operations;

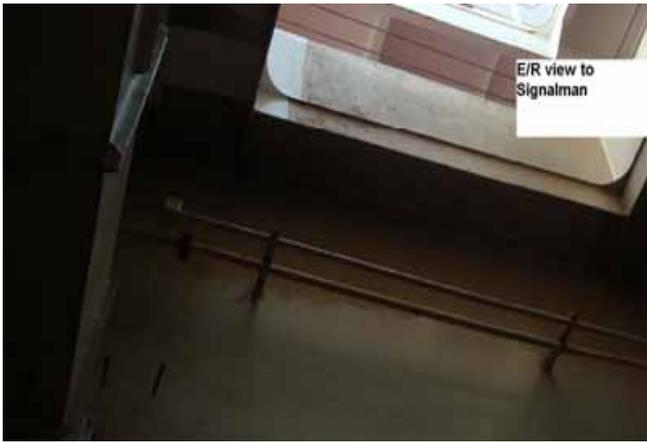
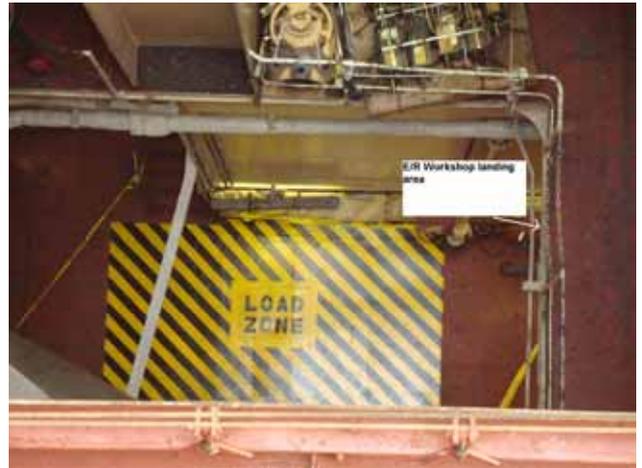
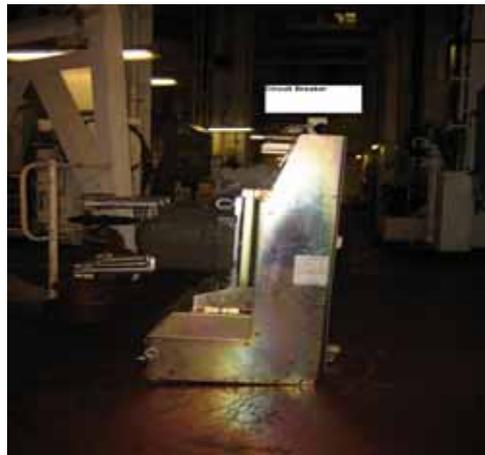
When the crate landed on the deck it broke open and the contents, an electrical high voltage circuit breaker weighing 250 kg., was damaged. There were no injuries, but the damaged circuit breaker had to be taken ashore to ascertain and repair the extent of damage incurred.

Circuit breaker out of its crate
