## IMCA Safety Flash 03/09

March 2009

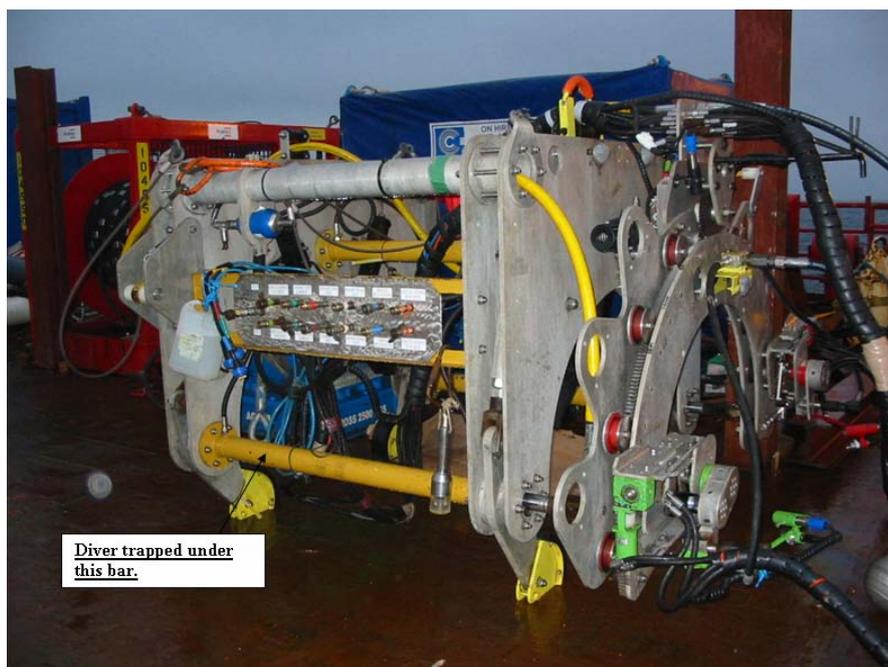
A member has reported in incident wherein a diver became trapped by a water jet weight coat removal (WCR) tool, which he was attempting to secure to a twenty inch subsea pipeline.

The WCR tool had been landed directly onto the pipeline, rather than the seabed as had been originally planned. During operations to secure the WCR tool, the tool moved on the pipeline, trapping the diver.

The resulting investigation identified the immediate cause of the incident being the failure to adhere to the prescribed task plan/operational risk assessment, with underlying causes identified as follows:

- ◆ The management of change procedure was not followed;
- ◆ There was a lack of understanding of possible hazards related to positioning of the WCR tool;
- ◆ The task plan was not followed;
- ◆ The risk was not fully assessed.

Members are reminded of the importance of following procedures; taking time out for safety and following management of change procedures.

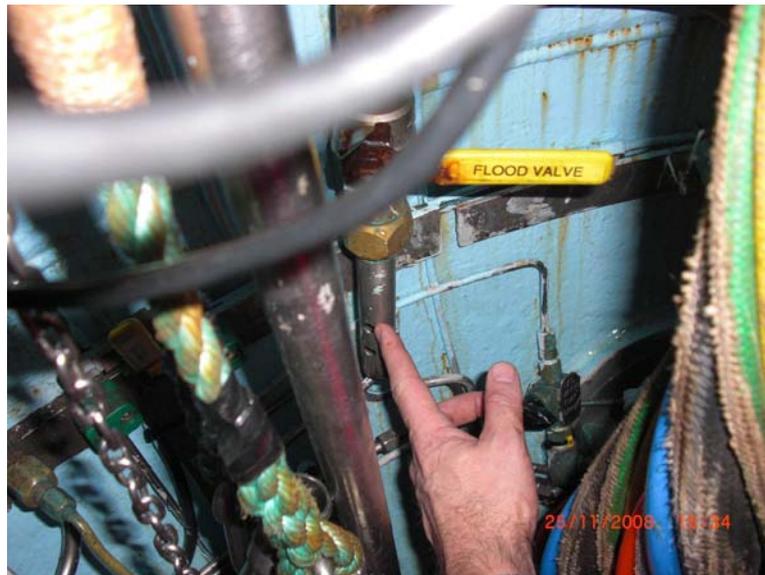
One diver (the bellman) was carrying out the bell checks while two of his colleagues remained in the compression chamber. During the internal checks, a bell flooding valve was accidentally opened as the diver's umbilical made contact with it, allowing dive gas to escape from the dive bell. The dive bell pressure dropped from 75 msw to 52 msw. The diver (bellman) managed to locate and close the open flood valve.

After investigation by the company involved, the immediate cause was attributed to a sudden gas loss and decompression of aft dive bell caused by the flood valve being accidentally opened allowing gas release. Underlying causes were identified as follows:

- ◆ Confined and restricted space when carrying out dive bell internal checks;
- ◆ Valves, valve panels, gauge panels in dive bell difficult to access;
- ◆ Bell ergonomics unsatisfactory;
- ◆ Secondary hull penetration valve left open;
- ◆ Flooding valve sensitive to touch;
- ◆ Dive bell interior cramped and short of space;
- ◆ Dive umbilical heavy and difficult to move;
- ◆ Heavy condensation and high noise when gas escaping making finding of the open valve difficult and the dive bell interior hazardous;
- ◆ Diver's familiarisation should be more structured and vessel specific;
- ◆ Bad practice of leaving bell internal penetration valve open.

The company has put procedures in place to ensure that the flood line is fitted with two valves, that both are closed and that the hull stop has a securing mechanism to avoid accidental opening (the securing mechanism also goes to the bilge drain in the bell).

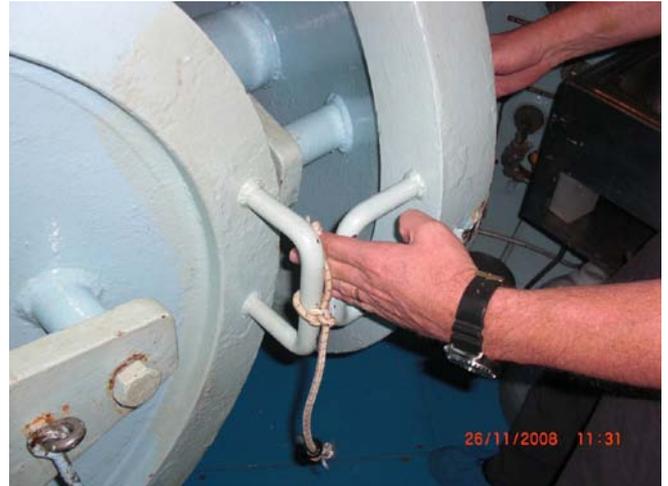
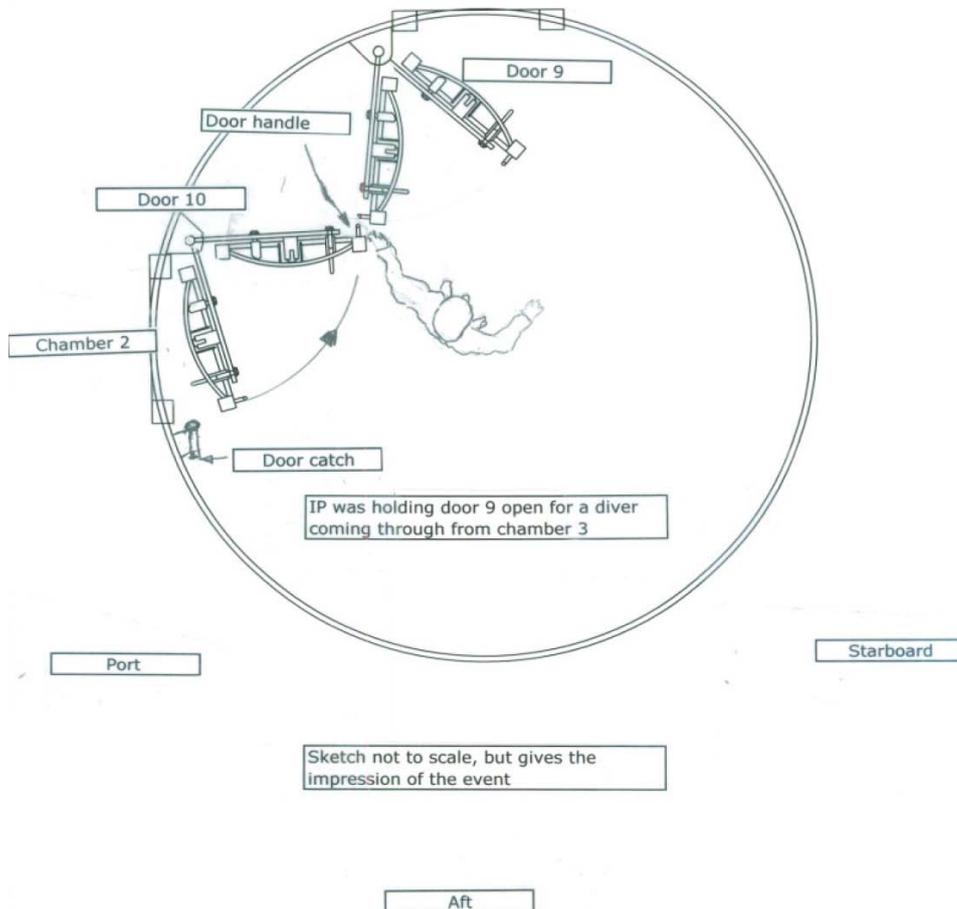
The diver was in the aft transfer lock and was holding a chamber door open to allow a colleague to transit between the chamber and transfer lock. When holding the door open, another door in the aft transfer lock swung open, trapping the diver's fingers between the two doors.

After investigation, the immediate cause of the injury was attributed to uncontrolled opening of chamber door, trapping and crushing diver's fingers between the two doors (refer to above schematic), with underlying causes as follows:

- ◆ Door spring tension was not enough to hold against uncontrolled door movement;
- ◆ No hooks were used; no door dampers were in place;
- ◆ No risk assessment had been carried out for the chamber with regard to a rough weather transit;
- ◆ The chamber door design and securing arrangement for chamber doors were poor;
- ◆ Chamber doors are heavy and cumbersome;
- ◆ Safety observation should have heightened diver awareness of hazards in chambers.

- ◆ Carry out a risk assessment on all chamber door systems for potential uncontrolled movements;
- ◆ Test and set latching devices, particularly spring loaded latching devices, to an optimal tension for safety and ease of use;
- ◆ Be aware of the inherent dangers associated with operation and transit during bad weather;
- ◆ Adhere to diving chamber transit procedures.

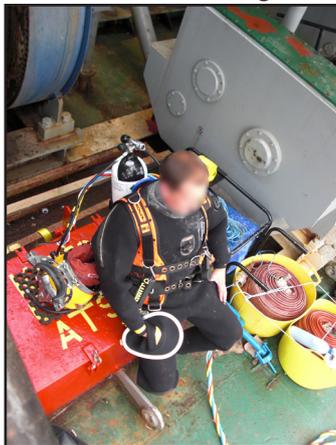
Figure 2

The diver (**Figure 2**) entered the water and, during his descent to a depth of about 20m, the umbilical containing his air supply and communication links was set towards the aft propeller by the tidal stream. The umbilical, along with a polypropylene rope the diver was carrying, then became entangled in the propeller and the diver was pulled rapidly towards its rotating blades. Although spinning, the diver managed to switch to the air supply provided by his 'bail-out' bottle.

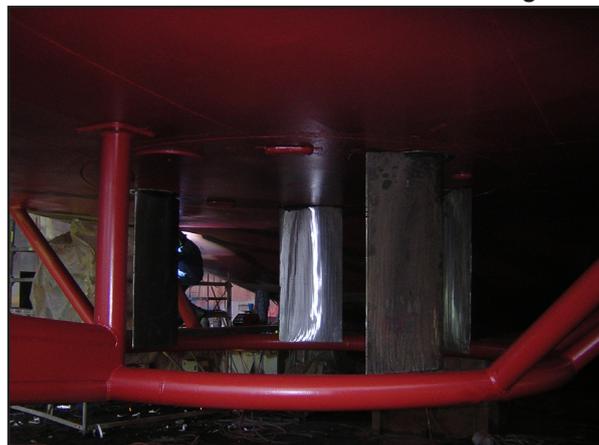
Figure 3

The umbilical was also pulled from *Norma*'s aft deck and severed. The diving supervisor immediately contacted the bridge and the master quickly determined from the engine room that the propeller units were still running. The electric motors were stopped with the diver only about 3 metres away from the propeller (**Figure 3**). The diver then managed to free himself from the entangled mass of umbilical cord and rope and make his way to the surface, where he was safely recovered.

- **The operation of machinery which poses a risk to divers should be prevented by physical barriers such as the removal of fuses whenever possible.**
- **A master should authorise the commencement of diving operations only when he is satisfied that the required control measures have been taken and all key ship's personnel, such as the chief engineer, have been informed.**
