IMCA Safety Flash 03/11

April 2011

I Failure of Hydraulic Fitting at Pressure

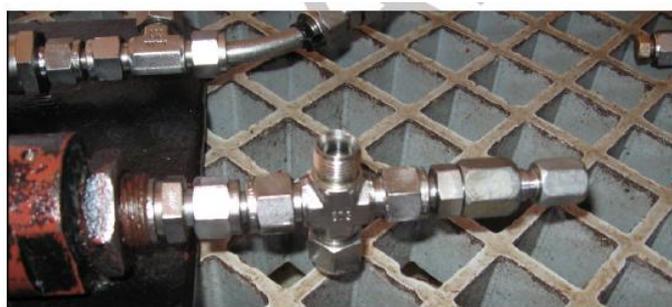
The fitting that failed connected a pressure gauge to the high pressure (output side) side of the intensifier and was an integral and permanent component of the equipment. The gauge was being used to monitor output pressure on the circuit while the cutter test was performed. This connection failure resulted in the high velocity ejection of the gauge under very high pressure. There were no injuries. The intensifier in question was removed.

Figure – Open fitting that held the gauge

- ◆ The hydraulic fittings that connected the gauge to the intensifier were not 690 bar rated;
- ◆ The other hydraulic fittings in this part of the circuit were not 690 bar rated;
- ◆ Urgent checks revealed that there were several intensifier panels with non-rated fittings in service elsewhere.

- ◆ All on-deck testing involving high pressure intensifiers was stopped immediately and any required testing was conducted in the water with a wire sample, until confirmation of correct fitting was made;
- ◆ All worksites checked intensifiers and verified the specification with tooling department(s) and arranged for replacement or upgrade as necessary;
- ◆ Steps were taken to upgrade affected units held onshore and these were systematically changed out with affected units offshore until all panels had the correct fittings.

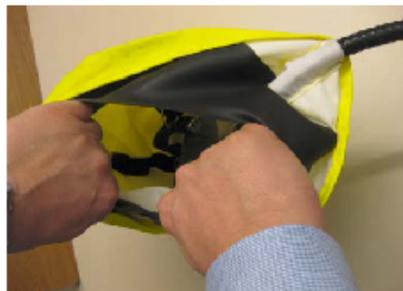
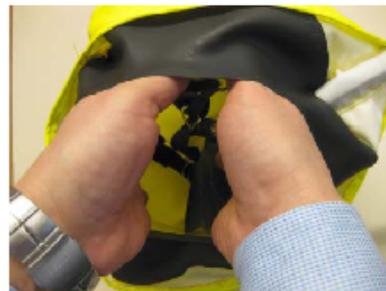
- The mask hood is impossible to get over your head. This is the most serious identification; The neck tightening rubber membrane is not flexible enough to be able to pass a normal head size, and it is sewed to the hood with one single seam – not welded as an original Unitor hood.
- The bag has similar print as the WSS original: "UNITOR UNISCAPE 15H" and "Safety by MSA" is printed on the frontside (together with 4 sketches of how to use).
- The bag material is different; Unitor: shiny PVC. Fake: Dull canvas-like material.
- The zipper is opened from right to left, which means that we evaluate the functionality of the automatic release mechanism to be doubtful. When the zipper is opened, it moves towards the cylinder valve – not away from it/pulling also the air release line.
- All sets that are discovered per now has a company label/service tag, with the following information:

Unitor EEBD copies in circulation

IT IS OF UTMOST IMPORTANCE THAT THESE FAKE SETS ARE TAKEN OUT OF SERVICE WHENEVER DISCOVERED – AND THE OWNERS ARE SERIOUSLY INFORMED. THESE FAKE COPIES DO NOT WORK AS THEY ARE SUPPOSED TO, AND WILL CREATE AN EXTREMELY DANGEROUS SITUATION FOR THE USER WHEN IT IS NEEDED FOR ESCAPE.

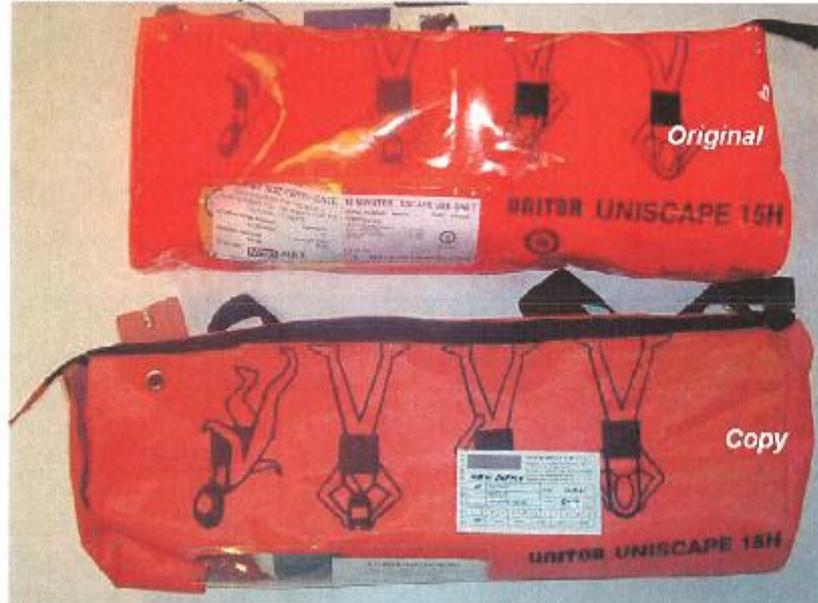
Upper:
Original Unitor EEBD with shiny PVC bag

Lower:
Copied equipment, with dull canvas-like material

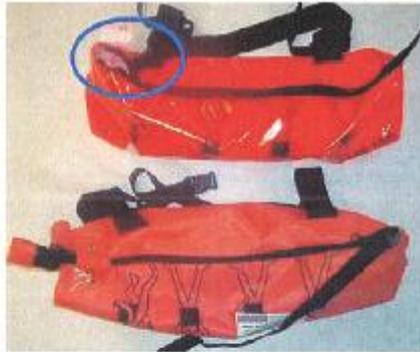
Original Unitor EEBD:
Zipper has 2 cm opening on the teeth
Zipper closes from right to left

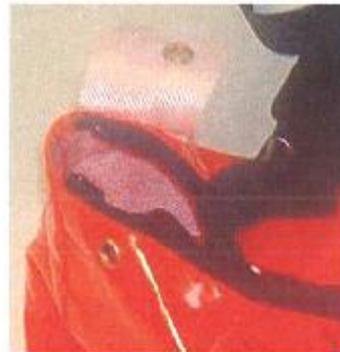
Copied equipment:
Zipper has no opening
Zipper closes from left to right. Air-release cannot be activated automatically.
