IMCA Safety Flash 03/14

March 2014

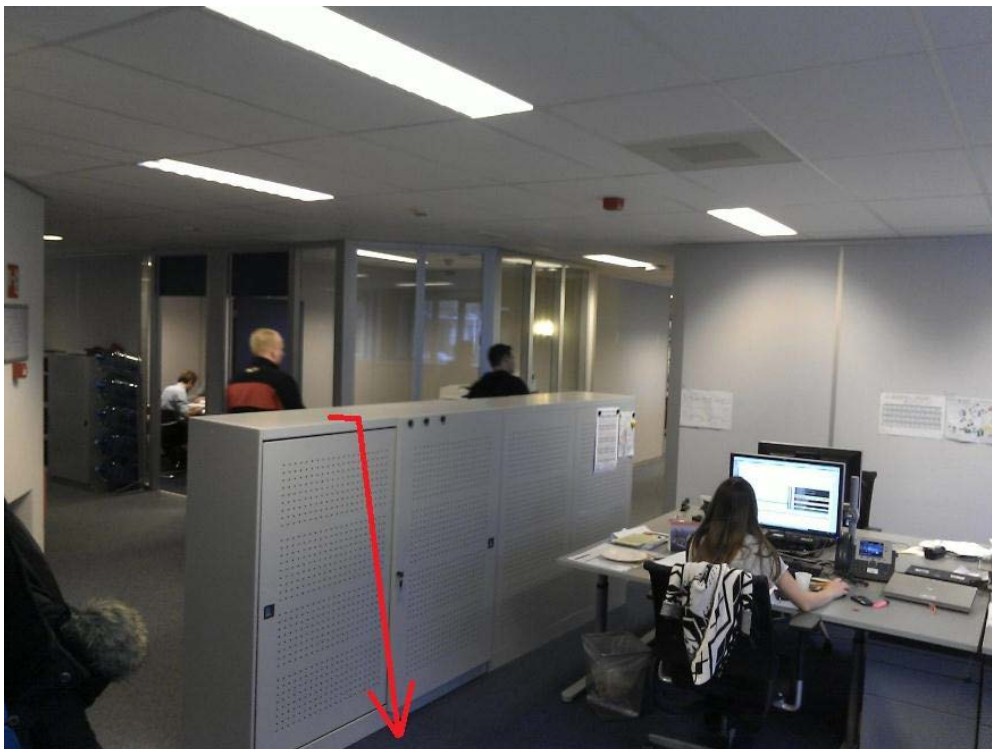
A member has reported an incident in which carelessness resulted in minor damage to equipment. During the replacement of old fluorescent light tubes in an onshore office location, a new fluorescent light tube dropped down from the cabinet (1.6 meters) to the ground and smashed. As a result, glass and particles from the fluorescent light were flying around and landed on various places (in a radius of around 5 meters). Nobody was hit or injured. At the time of the incident the person involved was climbing the ladder to remove the old light tube.

Direct cause: Failure to secure loose object. The fluorescent light tube was able to roll from the cabinet to the ground, because it was not in a secured position.

Root cause: Inadequate assessment of needs and risks. No-one seriously considered the possibility or assessed the risk of the fluorescent light tube rolling from the cabinet and smashing.

Our member took the following action to prevent re-occurrence: transport trolleys to be made fit for purpose to store and secure the fluorescent light tubes, ladder, related personal protective equipment (PPE) and other items required for the repair or renewal of light fittings.
