IMCA Safety Flash 03/16

January 2016

I Lost Time Injury (LTI): Stored Pressure Release - Crewman Lost an Eye

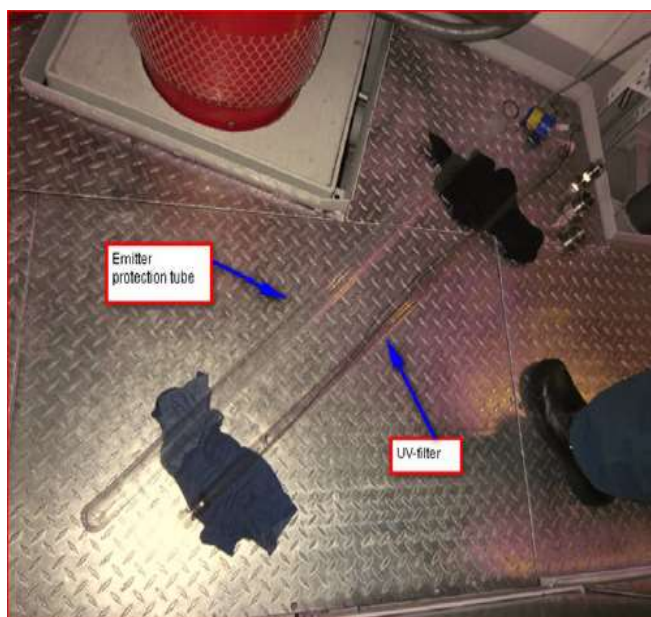
Emitter tube and UV-filter ready to be inserted

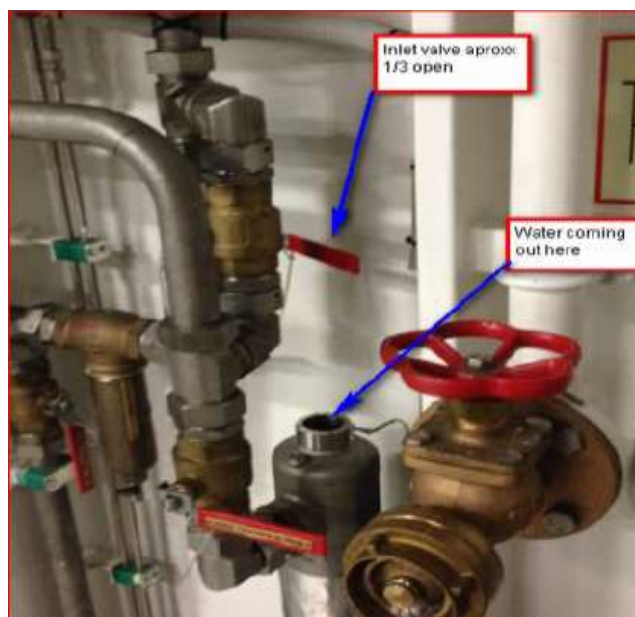
Investigations revealed the inlet valve was approximately 1/3 open

- Type of valves – It was possible to open the water inlet valve by accident due to the type of valve handle, which led to water running into the UV disinfection unit and building up a pressure below the emitter protection tube. This resulted in the emitter protection tube being forced out through the opening in the tension screw with high speed, hitting the 2nd Engineer in the face;

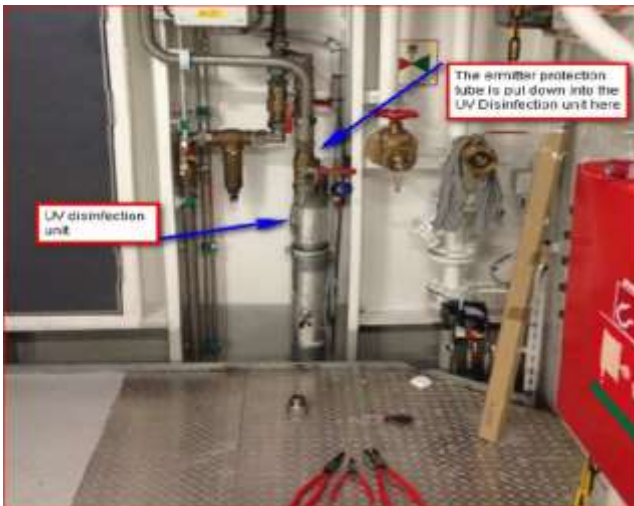
Actual system on-board.

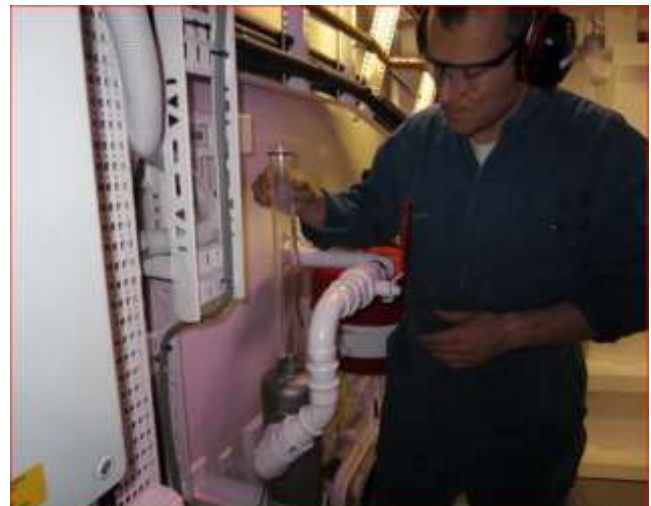
Emitter protection tube lowered into the filter (picture from another vessel).

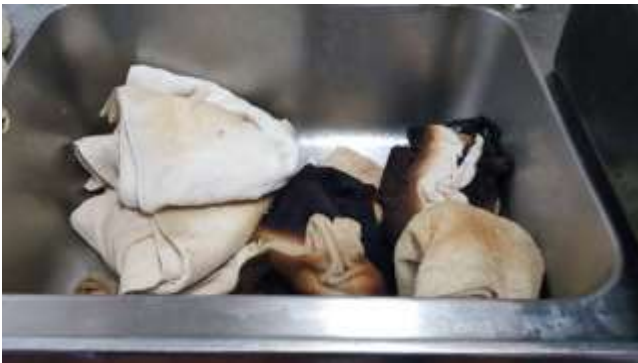
The galley crew decided to wash & dry dirty, greasy towels. As soon as the laundry was removed from tumble dryer, it was folded and placed inside a stainless steel cupboard in the galley area. A few minutes later, smoke was noted coming from the cupboard. When the door was opened, the towels were found to be on fire due to self-combustion. The fire was rapidly extinguished with no injuries or further damage sustained.

Spontaneous combustion occurs when a flammable or combustible substance (in this case, the oil or grease in the towels) is slowly heated to its ignition point through oxidation, and many substances will begin to release heat as they oxidise. In this incident, the process was sped up through heating in the tumble dryer. If the heat has no way to escape (such as with a pile of laundry within a closed cupboard) the temperature will raise to a level high enough to ignite the oil and cause a fire in the laundry.

Photograph of the burned towels.

- ◆ Galley staff briefed on laundry procedures – all laundry clothes should be checked prior to washing and tumble drying – greasy cloths covered in vegetable or animal oils should not be dried at high temperatures;
- ◆ Implemented daily toolbox talks specifically related to daily tasks for catering team;
- ◆ Ensured that the sub-contractor providing galley staff was advised of the incident and was asked to brief all employees on these hazards.

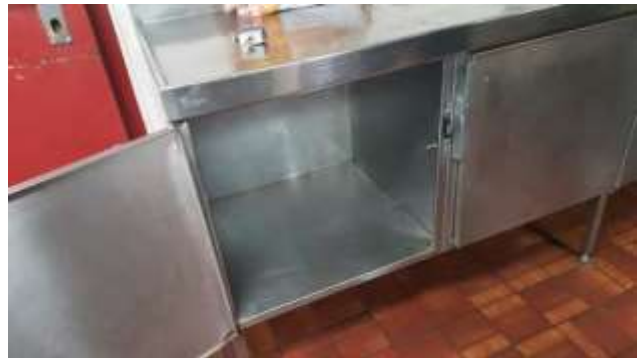
The stainless steel cupboards where the towels were kept.

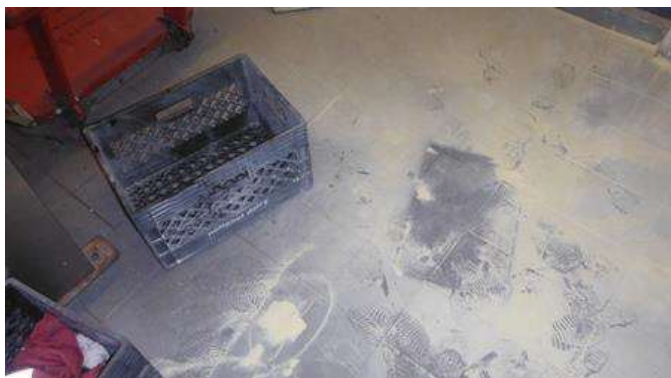
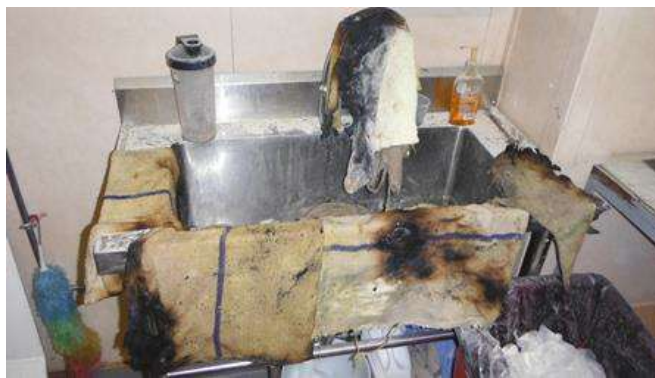
Showing the scene of the fire and the damaged towels.

- ◆ The steward reported that the towels had been removed from the dryer and placed in the basket approximately two hours before the smell was noticed;
- ◆ The towels had been used to clean up a cooking oil spill in the galley prior to being washed. After washing, the towels had been put in the tumble drier for approximately 45 minutes before being removed, folded and put in the basket.

- ◆ Cooking oil contaminated materials should be treated the same as all other “oily rags” – if disposing of these, use a metal drum with a self-closing lid;
- ◆ If such materials must be washed, ensure that items that were contaminated with combustible substances such as solvents, grease, oils and fats are washed in very hot water with adequate detergent and rinsed thoroughly to completely remove the contamination;
- ◆ Ensure that the ‘cool down’ cycle of the tumble dryer is adequate to reduce the temperature of the items and that the items are cool before folding;
- ◆ Ensure that the lint filters in the tumble dryers are cleaned before use and that lint is not allowed to accumulate in and around the appliance;
- ◆ Articles should be removed from the dryer as soon as the drying/cooling cycle is completed.

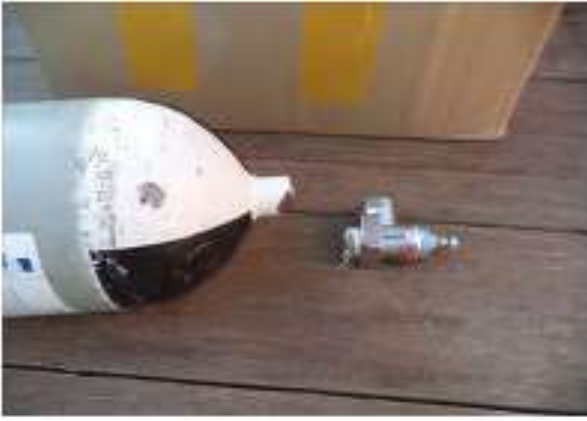
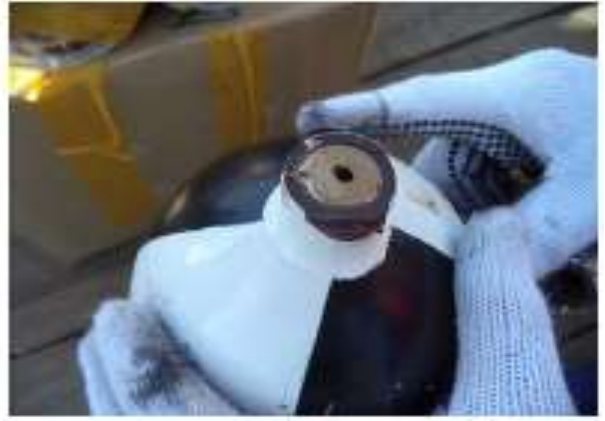
A member has reported an incident in which, during transportation of breathing air cylinders by a third party vessel, one of the air cylinder valves was broken off, resulting in a sudden release of air pressure. There were no additional damages or injuries caused.

- ◆ The cylinders were transported in the horizontal position and were not properly fixed or enclosed in a box or crate of substantial construction in order to prevent damage;

- ◆ All cylinders were stowed in a correct manner and returned to shore for inspection;
- ◆ Local safety professionals conducted a joint investigation with a third party UK Health & Safety Executive (HSE) team, to agree finds and improvements;
- ◆ Subsequently an appropriate storage basket was made available for future use, to prevent further damage and improve safety.
