IMCA Safety Flash 03/17

February 2017

1 Near Miss: Unidentified Differential Pressure Led to Divers' Umbilical Getting Trapped

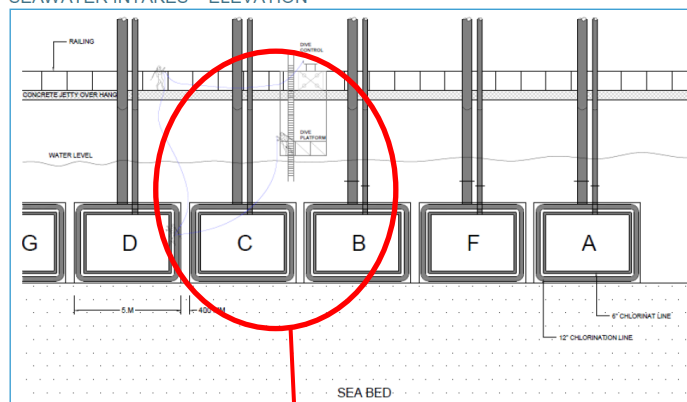
SEAWATER INTAKES – ELEVATION

Each of a number of culverts at the location contained a seawater intake fitted with an automated grating and trash cleaning system recessed 5m from the main opening. The diving operation necessitated moving repeatedly back and forth across the 5m wide intake opening between the clamps. This allowed some slack to be unintentionally introduced into the divers deployed umbilical. After an extended period of incident free operations, one of the divers' umbilicals became entrapped with the automated trash cleaning system, resulting in the diver being pulled towards the intake. The 2nd diver cut the umbilical to facilitate escape and both divers ascended to the surface in a controlled manner without injury.

- ◆ The presence of an automated trash removal system was not communicated by the asset owners to the project team;
- ◆ As a consequence of this omission there was no system in place to ensure the automated trash removal system was effectively isolated;
- ◆ There was a "lock out/tag out" system in place for the seawater intake valves;
- ◆ The project risk assessment was not effectively reviewed on site to identify appropriate controls for site-specific hazards;
- ◆ The position of the dive tender was not relocated as the dive progressed across the face of the multiple intakes, meaning that excess umbilical was deployed in the water, increasing the potential for snagging.

IMCA notes that this was actually a **differential pressure incident** where the divers' line was drawn into the gravity fed seawater intake by the suction generated. This is an excellent example of the very serious (and often potentially fatal) risks faced by divers in differential pressure situations. In this case, the important point is that the pressure differential was *not identified*. Differential pressure situations are subtle and difficult to spot, widespread, and potentially deadly to divers. Vigilance is key to the prevention of such incidents.

- ◆ Improvements were made to the project start up process to ensure that critical information related to automated systems is properly passed on;
- ◆ Physical barriers to be placed across the intakes;
- ◆ Lock out/tag out confirmation of the automated systems to be verified before resuming diving activities. This is captured in the Pre-dive checklist;
- ◆ Project manager to verify and confirm that the activity risk assessment has been reviewed on site by the team before resuming operations;
- ◆ Dive tender to be repositioned throughout the diving operations to ensure that the optimum amount of deployed umbilical is in the water column to minimise the likelihood of snagging.
