I Diving Fatality

I.1 Incident Overview

Installation Instructions

Divex Superlite 17B Jocking Harness Assy. Part # DD011101

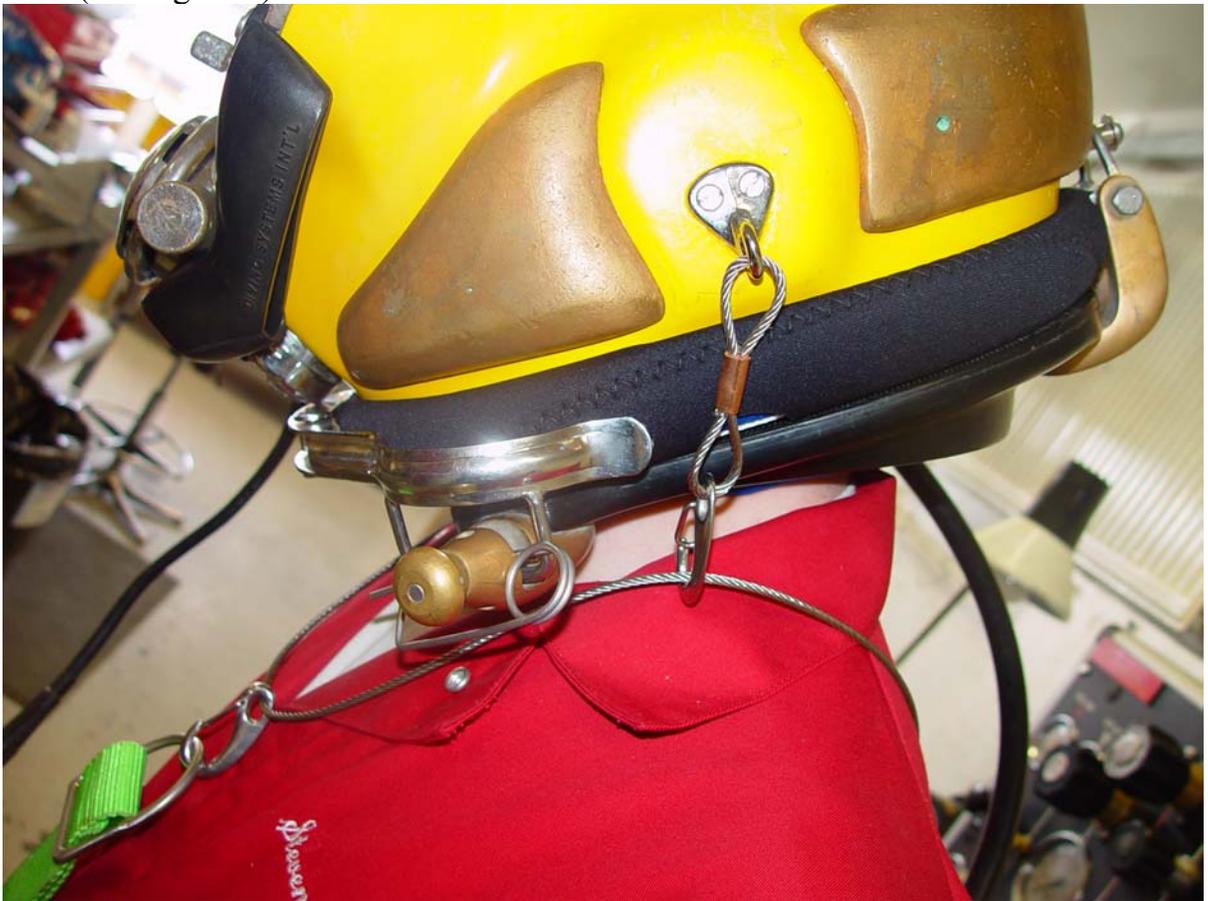
Figure 1

The eye plate should be positioned as low as possible but ensuring all the mounting surface of the plate lies upon the external flat surface of the shell (see figure1)

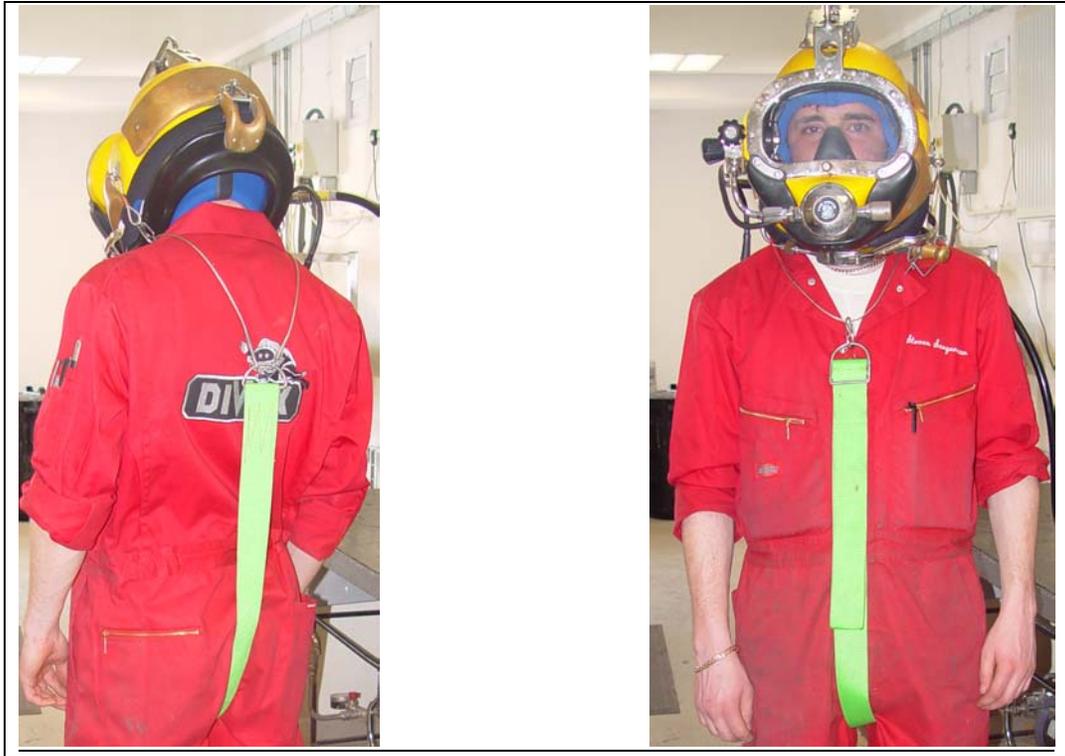
figure 2 showing front & rear view with shoulder wires located in helmet side strop assy hooks and jock strap adjusted to be comfortable.

Fit helmet to neck clamp assy. as per manufacturers instructions and check in accordance with Dive company pre dive checklist(if applicable) Once OK & checked, engage the wire strop which passes over each shoulder into its helmet side strop "carbine" hook and then adjust jocking strap for comfort and security.(see figure 2)
