I Fatality – Falling Object

2 Wrist Injury Sustained During Vessel Maintenance

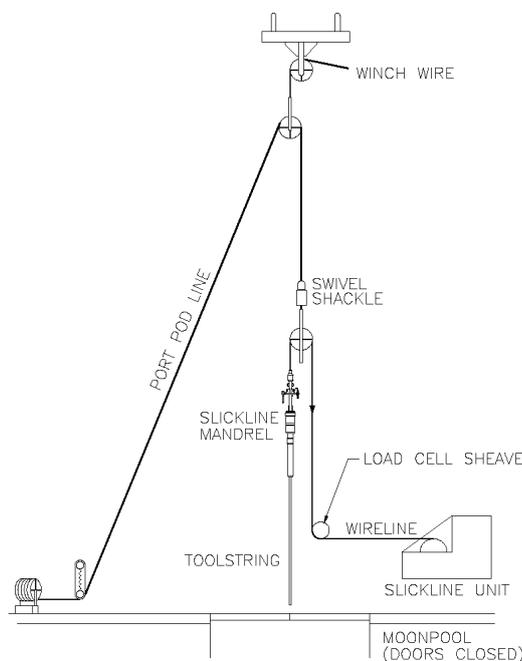
GENERIC SLICKLINE RIGGING SET UP

During wireline toolstring recovery, accidental contact with the wireline sheave was made, causing the assembly to fall to deck, fatally injuring a crew member. This occurred when the port pod line was raised to allow visual inspection of the bottom of toolstring and to break tool down without wireline being paid out first.

- ◆ The common industry practice of working in close vicinity to suspended wireline tools presents a dropped object hazard that should be recognised and eliminated;
- ◆ Communications between all team members involved with lifting operations needs to be improved;
- ◆ In lifting operations, all necessary steps should be taken to ensure that tools/devices are not drawn into any sheave;
- ◆ Risk assessments of wireline lifting operations must identify such hazards;
- ◆ Written work procedures must clearly state how risks will be managed;
- ◆ Common work practices and contingency activities must be subject to risk assessment and documented as a written procedure.

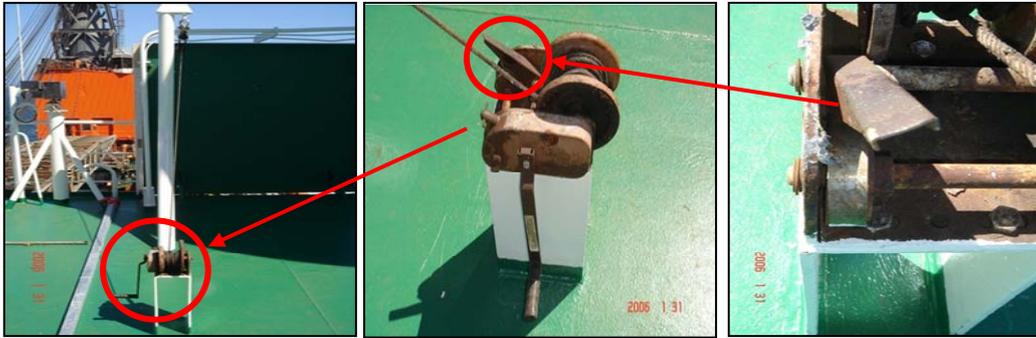
IMCA has received a report on an incident wherein a member of a vessel crew sustained wrist injuries during maintenance activities. Two crewmen were raising a small landing platform from one deck to another using a small hand driven winch. One was operating the hand-driven winch, turning the handle in a clockwise direction. As the handle approached the 2 o'clock position, the crewman's hand slipped off the handle. There being no ratchet mechanism fitted to the winch, the handle spun around in an anti-clockwise direction, striking the crewman hard on the left hand at the top of the forefinger and thumb. He suffered some bruising to the left wrist and was taken to hospital. Subsequent x-ray examination of the wrist revealed that no bones had been broken.

- ◆ the winch handle was too small;
- ◆ the manual brake system was not fit for the purpose;
- ◆ the existing winch was primitive and overdue for replacement;
- ◆ the winch had been relocated due to accommodation installation and its proper use had not been tested;
- ◆ the other crewman, who had been operating the manual brake, had been unable to apply it immediately.

- ◆ order and fit a newer and better winch, more fit for purpose;
- ◆ appropriate pre-testing of equipment after relocation;
- ◆ perform job safety analysis before the specific operation;
- ◆ review configuration of winch wire set-up;
- ◆ as an interim measure, until the existing winch is replaced, lengthen winch handle on existing winch.
