IMCA Safety Flash 04/07

May 2007

I Forklift Truck Incident

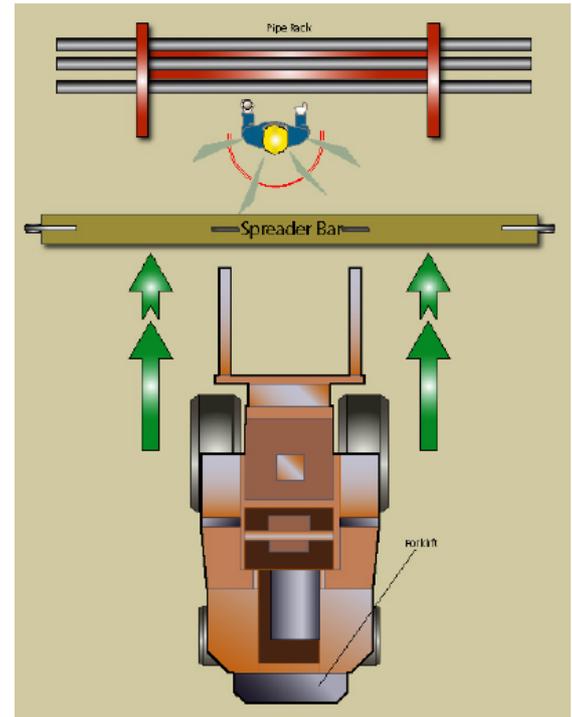
The forks hit the spreader bar and moved it toward the rack, catching the individual's left calf between the bar and the rack and causing severe bruising. He subsequently had to visit the doctor and the injury led to a time lost from work of around two weeks.

Figure 1 - Scene of incident

- ◆ The inexperienced crew member did not appreciate that he was putting himself in a hazardous situation; nor did his co-worker take action to prevent this unsafe act;

- ◆ The mentoring program had not worked as intended. The mentoring program and a proper explanation of work procedures should be emphasised in pre-shift meetings and during vessel orientation;

- ◆ If the mentor had to leave the immediate work area during lifting operations, work should stop until that they returned;
- ◆ Personnel should inspect their work areas and identify hazards that need to be removed;

- ◆ Mentors should to emphasise work procedures in a toolbox talk whenever there are changes to the circumstances of the work being conducted;
- ◆ Mentors should identify the risks associated with a task to short service employees and explain the hazards and preventative measures;

- ◆ All workers should remember the saying "never place yourself between a rock and a hard place" and beware of potential crush zones!
