## IMCA Safety Flash 04/08

March 2008

### I Unauthorised Modification to Electrical Plant Equipment

## **2 DDC Chamber View-Port Catastrophic Failure**

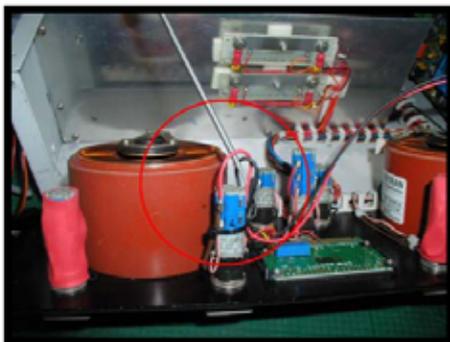
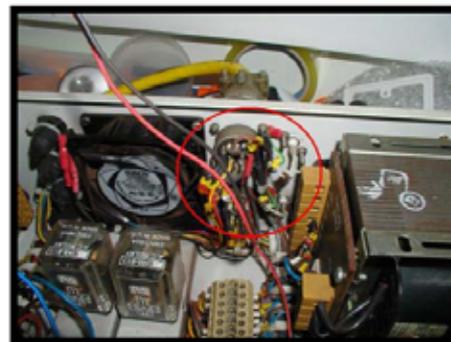
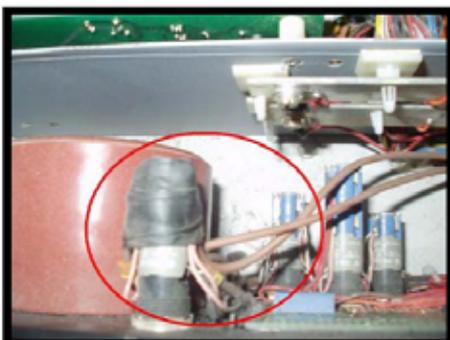
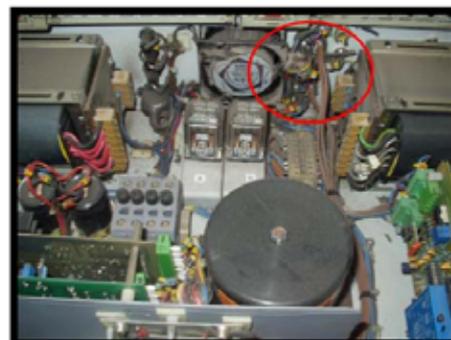
A member has reported the discovery of unauthorised modifications to electrical equipment used by divers. During the onshore refurbishment of two dual diver CLP (camera, light and power) surface control units it was noted that these had been modified offshore to enable the diver's hat light to be switched on and off remotely from the unit, presumably by the diving supervisor standing at the dive panel. The modifications involved adding wires to the back of the hat light on/off switch on the front panel of the CLP and wiring this through to a pair of unused pins on an output socket on the back of the unit.

The modifications to each of the two CLPs were carried out using a different colour and a different gauge of electrical wire and resulted in 220-240Vac being routed to the output sockets where there is normally only relatively low DC voltage (30-55Vdc). The modifications also changed the connection pins used, altering an internal company standard that has been in place for 20 years. Diver CLP surface control units are intended to be universally interchangeable; these modifications made them suitable only for the job they were used on. Also, the wiring drawings for the units became incorrect as a result of these unauthorised modifications.

*Unauthorised modification to electrical equipment*

The company involved recommended that offshore dive technicians and chief engineers be reminded that no modification to any item of plant is attempted without first asking for and receiving the express permission of the appropriate company authority onshore. The units were rewired back to the company standard and the onshore electronics technicians were warned to be aware of the modifications seen and include this as something to verify during all future checks.

The company also recommended investigation into whether or not there is a common requirement to switch on and off the divers' hat lights remotely and also to investigate the possibility of retro-fitting of a low voltage remote to the diver CLP surface control units to permit this.

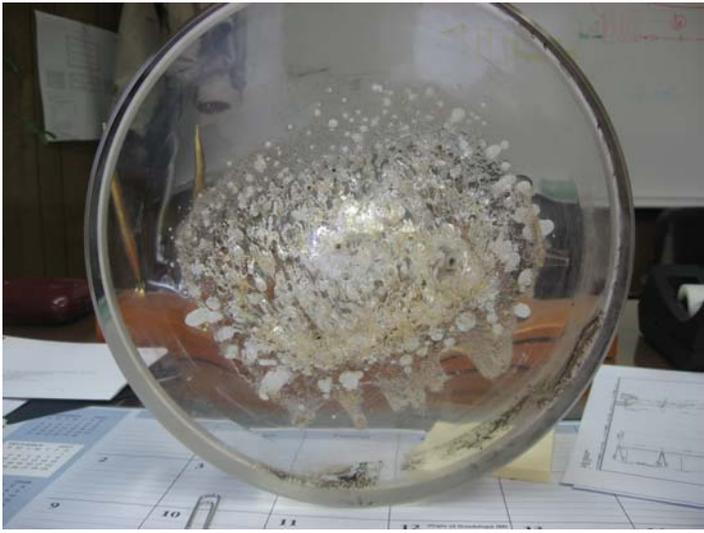
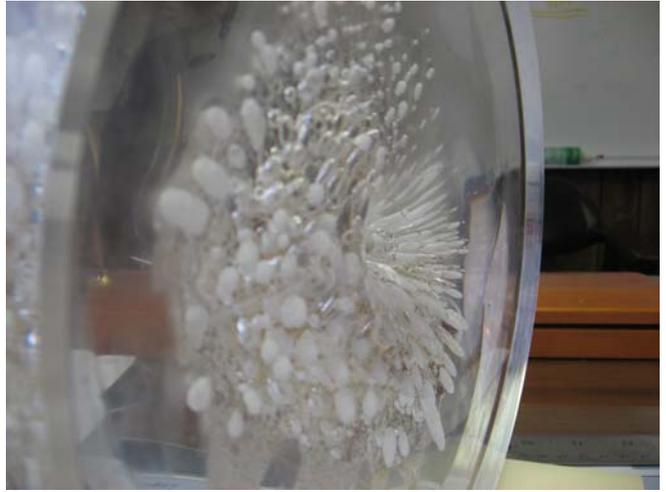
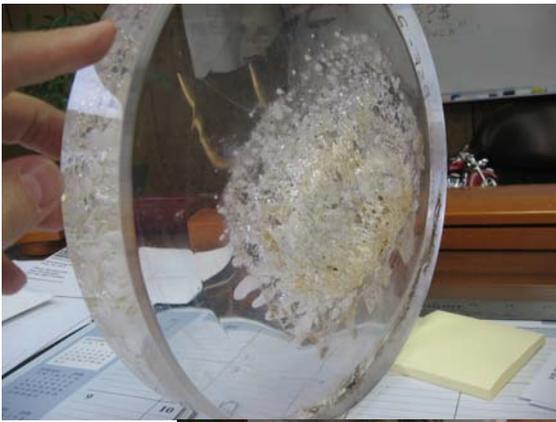
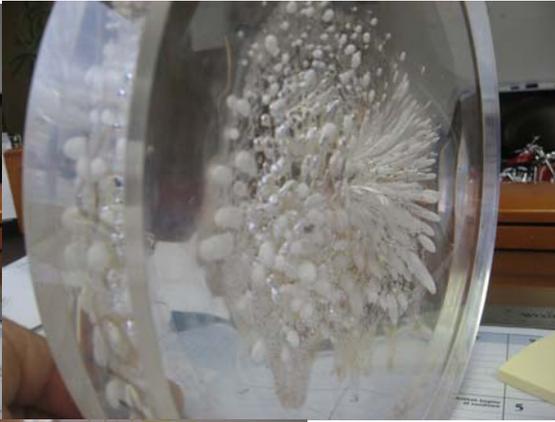
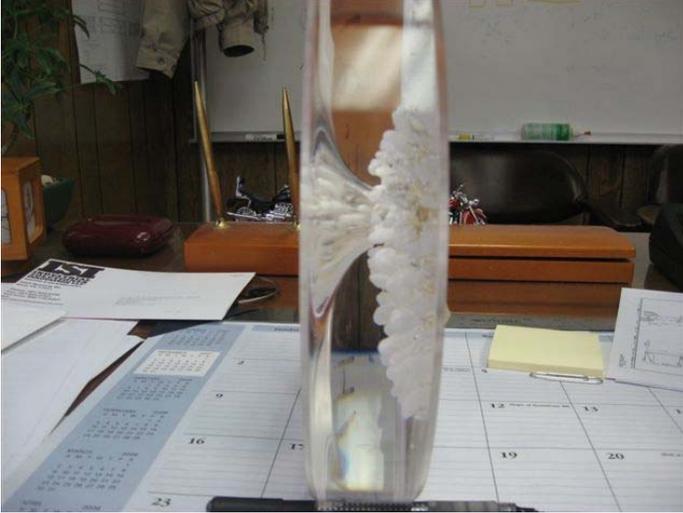
This view-port was in a deck chamber where someone had placed droplight too close to the port. The resulting radiant heat from the lamp exceeded the design temperature of the view-port (125 deg. F / 51.6 deg. C.) Enough heat was generated to allow the view-port to become soft and pliable enough to allow the pressure in the chamber to flow towards atmospheric pressure. (See pictures attached) The pressure boundary was breached and the chamber vented through the view-port to atmospheric pressure. No further information on this incident is available. The danger of incandescent light bulbs in close proximity to chamber ports is well known in the diving industry. To mitigate this danger, many diving contractors have changed to the fluorescent bulb drop lights, with the understanding that they operate at a lower temperature. **WE HAVE NOW DETERMINED THAT FLORESCENT LAMPS CAN ALSO GENERATE HEAT IN EXCESS OF 140 DEGREES!**

Measured temperatures from florescent drop lights have averaged 145 deg. F / 62.7 deg. C. (20 deg. F / 6.6 deg. C. over maximum design temperature)

Do not put drop lights in contact with chamber view-ports, even florescent drop lights can generate enough heat to cause the view-ports to overheat. You must always assess the heat generated from any bulb and make sure you position the bulb a sufficient distance away from the port to eliminate the possibility of any heat build-up on the face of the port. If the port feels warm to the touch, the bulb is too close!!

LED lamps are under close investigation and will most likely replace the commonly used florescent droplight.
