I Person Injured by Mooring Lines

Marine Safety Forum – Safety Flash 10/12

MAIB SAFETY BULLETIN 2/2010

Failure of fixed high expansion foam system to
extinguish fire on board the passenger ferry *Oscar Wilde*

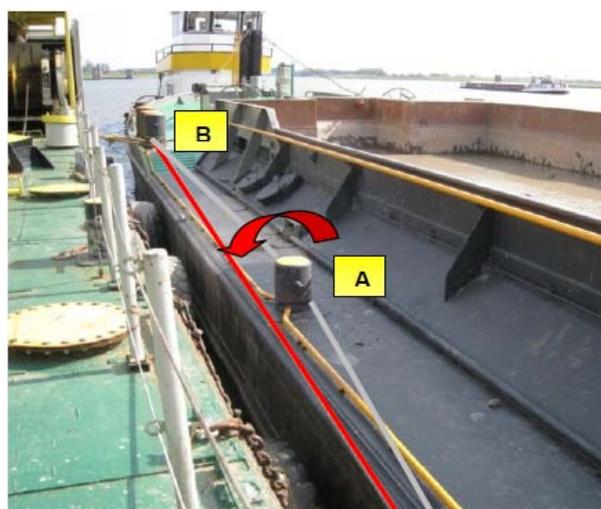
Figure 1 - Hopper barge seen from crane barge (mooring line shown in grey and red)

A member has reported an incident in which a person was hit by a wire of a warping winch, causing bruises to both legs. On the port side of a crane barge a hopper barge was moored with a spring and two winch wires. During the loading of the hopper barge, the winch wire crawled up along the bollard (see A on Figures 1 and 2).

During this process an employee wanted to transfer on foot from the hopper barge to the crane barge and stepped over the winch wire, whilst conducting a conversation on a mobile phone, at a point between A and B. At that instant, the winch wire jumped over the bollard (see red arrow) and hit the person's legs. The person fell over and was able to grab the railing of the crane barge, which prevented a fall between the crane barge and the hopper barge.

- ◆ Personnel should remain alert and watch their surroundings at all times when working on deck;
- ◆ Do not use mobile telephones while embarking/disembarking;
- ◆ Connect the winch wire only via bollard A (rather than via bollards A and B) to guarantee it is secured and cannot slip over;
- ◆ Transfer between vessels moored alongside one another should be conducted in a safe and controlled manner;
- ◆ Ensure safe walkways on deck are properly marked;
- ◆ Do not stand in loops of wires and ropes.

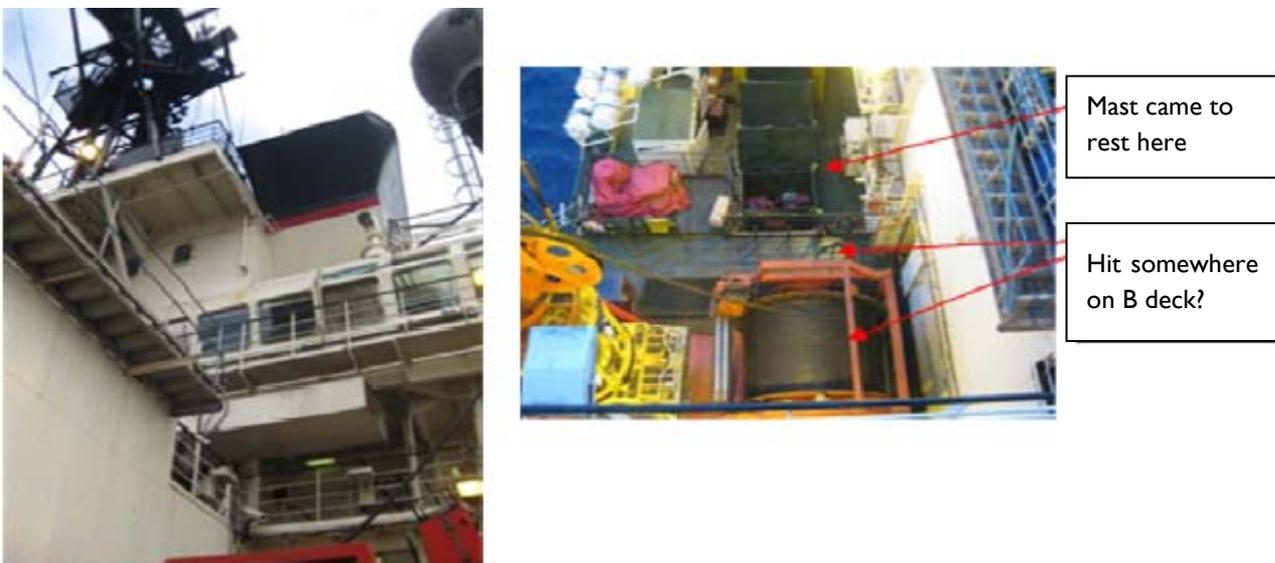
Figure 3 - Area from which antenna part fell

A member has reported an incident in which a large piece of equipment fell over 20 metres to the deck. A top section of an antenna, approximately 4m in length and weighing around 3.5 kg, fell 24m to the main deck. No one was in the vicinity at the time, however, this incident had the potential to result in a fatality.

While the vessel was in transit a bang was heard above the bridge and immediately after, a long white pole was seen falling past the bridge window. The pole came to rest on A deck, after first hitting B deck (3.5m above A deck). On inspection it was found that the pole was the top section of the non-directional beacon (NDB) whip antenna.

It was discovered the threaded connection on the end of the section that fell was undamaged and was not corroded. The connection consisted of a threaded inner which screwed on to the lower section of the antenna; this was then retained by 2 grub screws. These were found to have come loose.

There was no evidence of any mitigation against the effects of vibration on these grub screws, such as anti vibration washers or 'loctite'. Investigation suggested that vibration over the period since the antenna was last removed (approx 2 ½ years) had caused the grub screws to come loose and the top section of the antenna was able to unscrew against gravity.

- ◆ The location of the antenna connection was not readily accessible and, as such, limited routine inspection had been undertaken;
- ◆ The potential for the mast to vibrate loose was not recognised during installation, resulting in a failure to mitigate the effects of vibration;
- ◆ Securing of masts and antennas should be checked with additional and/or secondary securing measures implemented where required.

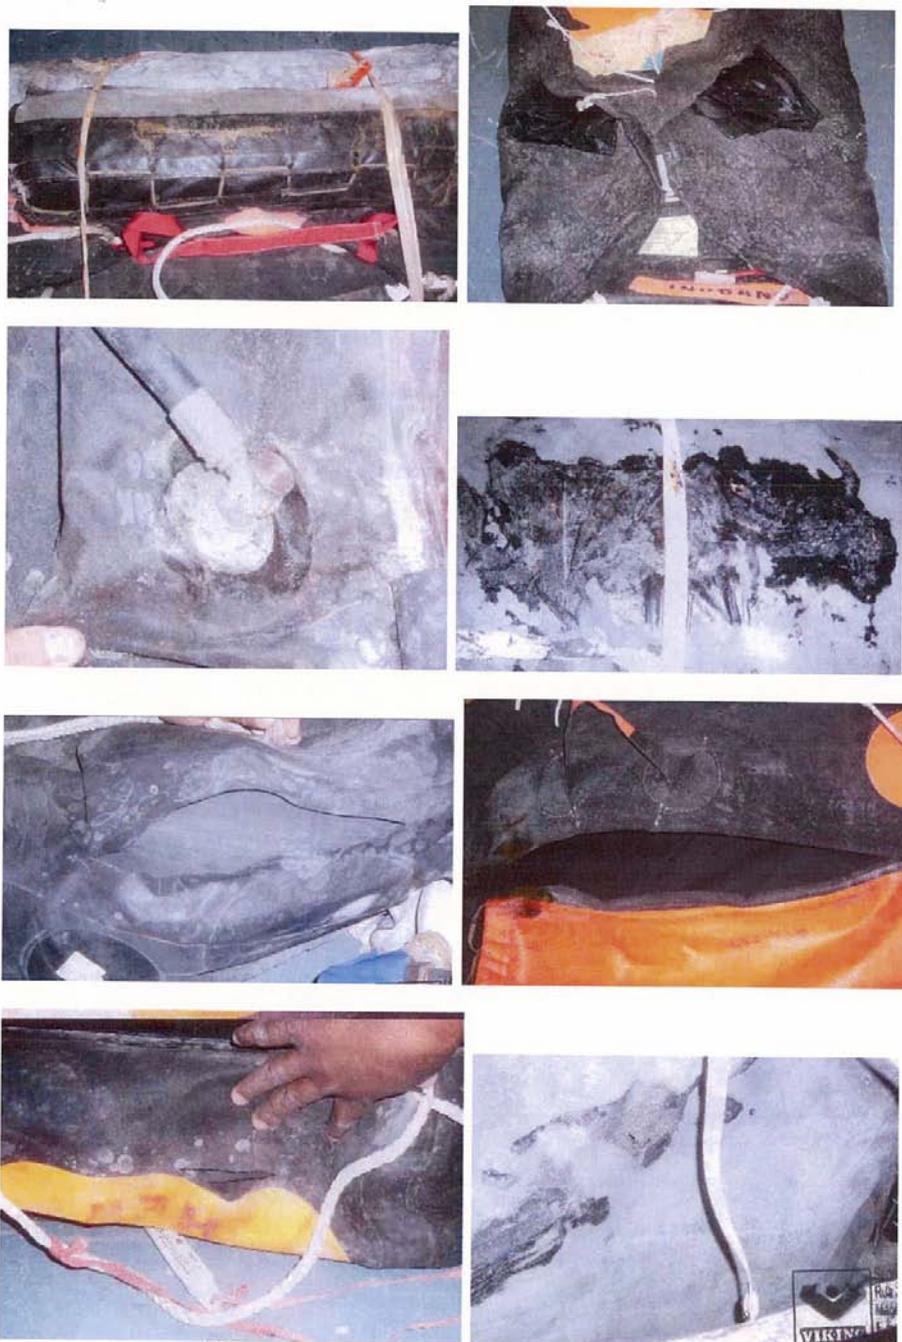
Figure 4 - Images of damaged life rafts

- ◆ The four rafts were found to be suffering from water ingress and corrosion;
- ◆ Severe oxidation was found on 20% of the buoyancy chambers, moderate oxidation on 10% of the total area and 35% of the canopy;
- ◆ On one raft the protective cover was missing from the inflation cylinder valve and the inflation tube was highly oxidised;
- ◆ When the International Maritime Organization (IMO) inflation test was carried out, leaks were observed and the buoyancy chambers burst near the connections of the survival pack and connections to the inflation cylinders;

The rafts would not have worked in the event of an emergency, potentially leaving the vessel crew with no means of escape.

- ◆ All life-saving equipment should be inspected closely following shore-side servicing to verify that the servicing indicated has been properly and thoroughly carried out. Some clear pointers to assist in this process could be:
 - Life raft sealing bands show signs of having been replaced
 - Evidence of talcum powder on exposed runner of life rafts indicates that the raft was opened and additional talcum powder was applied during repacking
 - Service labels updated on life raft wallet.

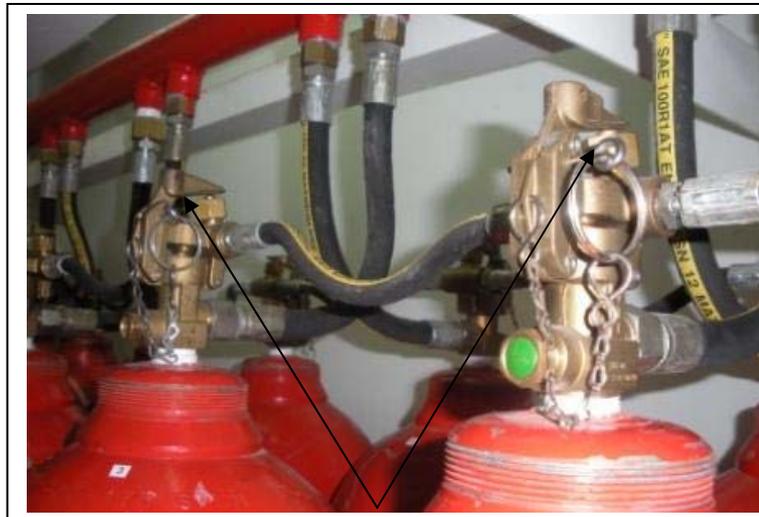
During an annual certification of critical equipment on a vessel, a contractor identified the safety pins used for transporting and disabling the system on the CO2 Cylinders had not been removed from the valves. This matter was brought to the attention of the Master on the bridge who subsequently removed the pins and informed the company via an incident report form for the identified near miss (see attached photo).

- The CO2 system is inoperable whilst the pins are in position.
- The pins are normally installed in the cylinder as a safety device during the transportation installation and testing phases. They must be removed to commission the system.
- The deficiency had not been identified in the vessel critical safety equipment inspections.
- This specific deficiency had not been identified in the audits carried out on board.

Safety pins in position. These MUST be removed for the system to function

- Every vessel master to immediately attend the CO2 room and personally ensure the vessel has a fully operational system and that no safety pins have been left in the valves. Verification of the check and location of the pins (in or out) when inspected to be forwarded to QHSE as soon as the inspection is completed.

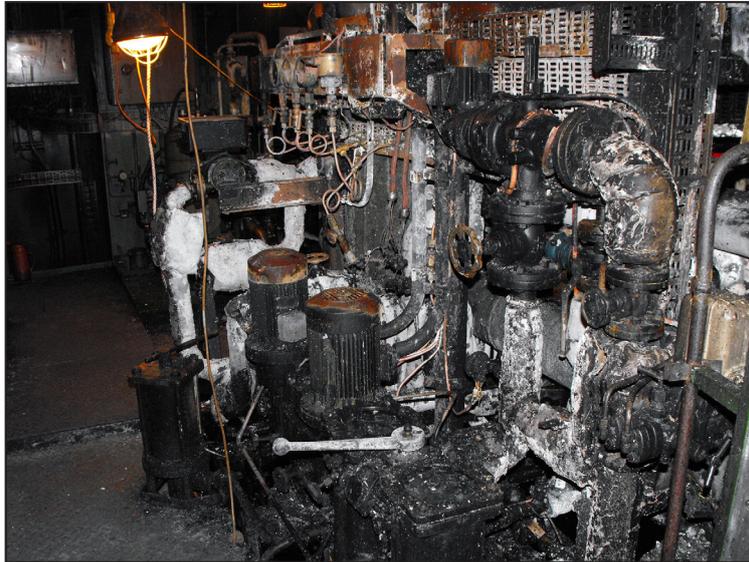
Figure 1

At approximately 1912 (UTC) on 2 February 2010, a fire broke out in the auxiliary machinery space on board the roll-on roll-off cruise ferry *Oscar Wilde*. The ferry had just sailed from Falmouth, UK after completing her annual docking. The seat of the fire was in way of a diesel alternator fuel supply module (**Figure 1**) and quickly spread across the compartment.

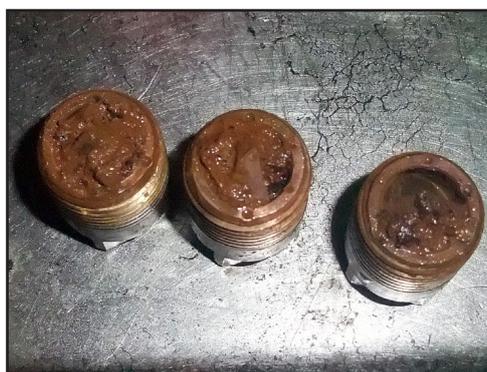
Figure 2

- 80% of the foam generator nozzles within the auxiliary engine room were blocked by debris (**Figure 2**) and about 50% of the nozzles in the other protected spaces on board were also clogged.

The debris found in the nozzles and piping is most likely to have been rust and scale that had built up in sections of pipe in which water and/or foam solution had previously been trapped. This debris would then have been distributed along the pipes and into the nozzles during the annual blow through tests and when the system was operated. The resulting blockages were sufficient to prevent the aspiration of the foam solution.

- Remove and inspect all foam generator nozzles to ensure they are free from debris.
- Inspect sections of distribution piping in which water or foam solution might collect and to fit drains where appropriate.

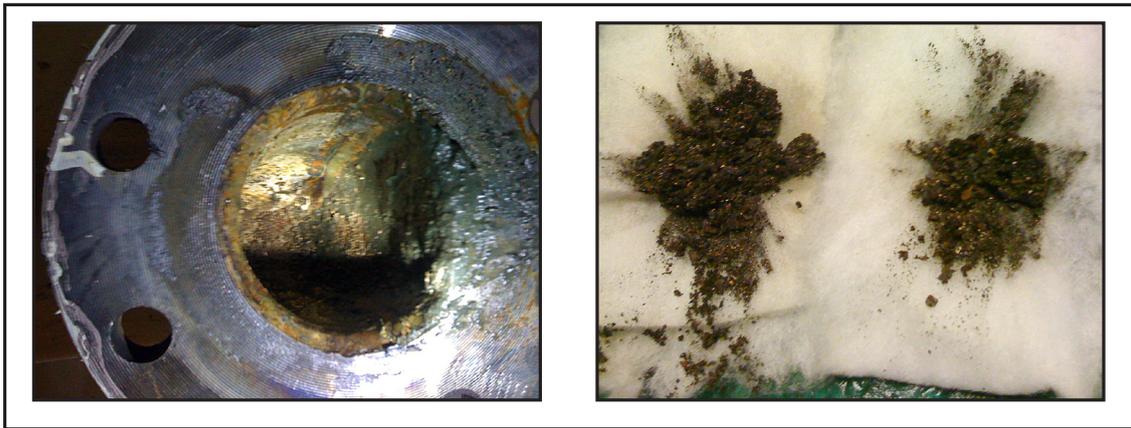
Figure 3

- The distribution pipework for the foam solution contained debris and was corroded (**Figure 3**).

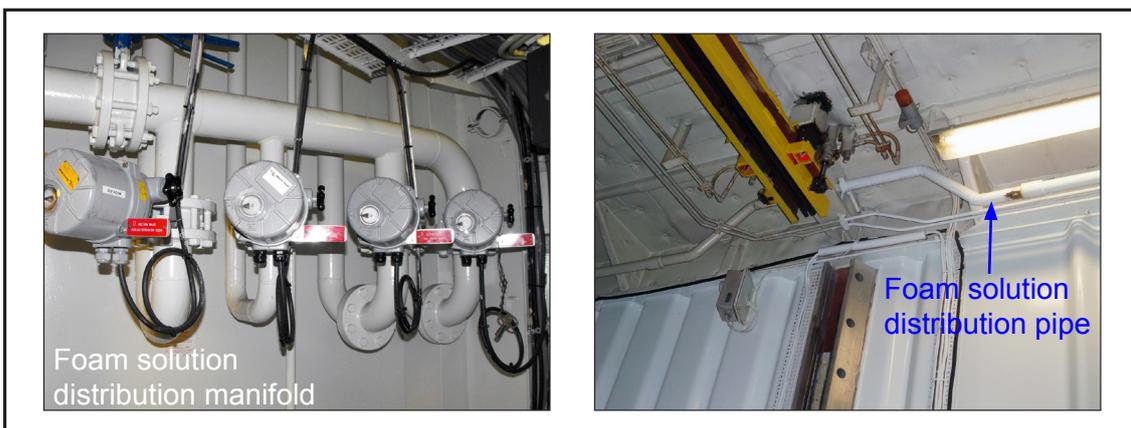
Figure 4

- There were several sections of the system's distribution pipes in which water and/or foam solution could have been trapped following the testing of the system (**Figure 4**).
