IMCA Safety Flash 04/13

February 2013

2 LTI: Fall from Height Leading to Multiple Fractures

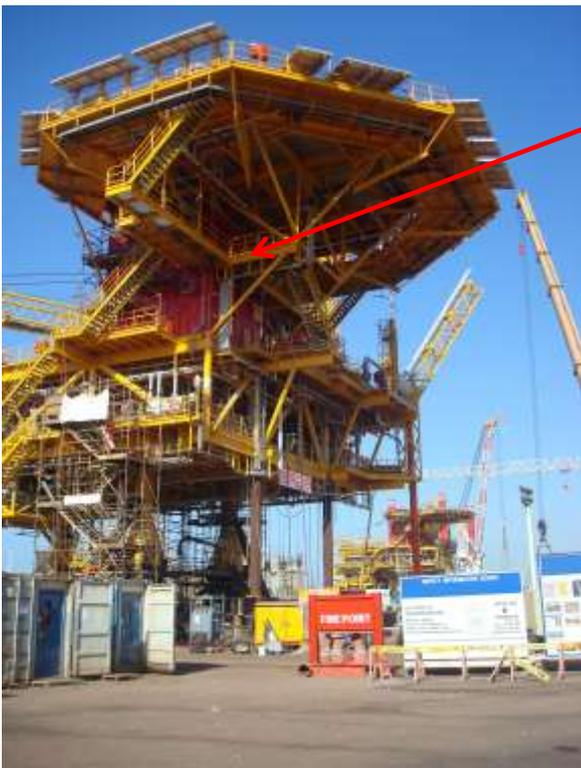
A member has reported an incident in which a worker fell 16m and sustained multiple fractures. The incident occurred when the worker was part of a team dismantling a hanging scaffold on part of a topsides under construction in the yard. The sequence of work meant that scaffolders dismantling the structure ended up supported on the bottom of the droppers (scaffold tubes attached to deck structure to support hanging scaffold). The worker was climbing the dropper to tie off his safety harness to the deck structure when the dropper slipped through the couplers and fell 16m with him attached. He sustained multiple fractures and was taken to hospital.

Showing site of incident

Dropper was attached here, 16m above ground

- ◆ When dismantling hanging scaffold always connect the fall arrest to a structure independent of the scaffold being dismantled;
- ◆ Where no independent structure is in reach of personal fall arrest lanyards, or a greater degree of movement is required, use an inertia reel;
- ◆ Always check tightness of dropper support and safety couplers:
 - after stacking or moving of decks and structures when scaffold is pre-installed
 - after any alterations are made
 - after high wind
 - after it has been erected more than 30 days
 - before dismantling of scaffold.

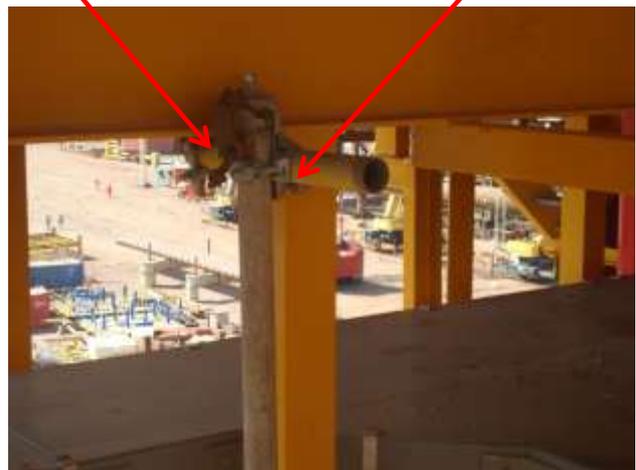
Safety or check coupler

Support coupler

Showing details of scaffolding

- ◆ The dropper support coupler is attached to a horizontal tube;
- ◆ A second coupler is attached above the support coupler to act as a safety or check coupler;
- ◆ The purpose of the safety coupler is to support the dropper should the support coupler become loose;
- ◆ In this incident both coupler connections on the dropper became loose allowing the dropper to slide through both couplers and fall.

- ◆ Primary support and safety couplers became loose and failed to support the dropper and the injured person;
- ◆ Fall arrest lanyard was connected to the dropper as no consideration had been given to fall arrest being independently tied off from the scaffold, e.g. inertia reel attached to the deck structure;
- ◆ No checks were made of the tightness of safety critical couplers after deck stacking and subsequently over a prolonged period (12-14 weeks);
- ◆ Partially dismantled scaffold indicated lax control of earlier activities;
- ◆ Supervisory personnel in attendance did not correct unsafe working at height practices and require an independent tie off;
- ◆ The task was not planned or risk assessed adequately.
