IMCA Safety Flash 04/16

February 2016

Summary

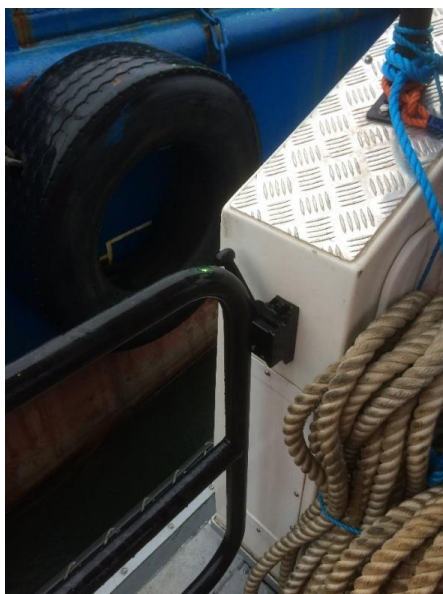
Starboard gate (closed) and latch.

- ◆ Underlying factors:
 - There was a mechanism failure in the latch of the boarding gate
 - There was no fail-safe or positive locking mechanism on the gate latches

- A missing washer reduced friction on the latching mechanism. This allowed vibrations during transit to and from berth to worksite to cause the latch to raise and the gate to open in an uncontrolled manner

- ◆ Inadequate latch design:
 - There was no secondary protection for the latch
 - Owing to a manufacturing fault, the latch very easily opened by vibration, snagging or lightly brushing against it

- The gate opened outwards
 - The washer mechanism in the latch on the starboard gate was damaged/loose making the latch handle move from side to side, increasing probability of vibration;

- ◆ A temporary secondary mechanism was fitted to both the port and starboard gates (the latches were tied shut during transit) – these were latched and tested for security, to allow vessel operations to restart. A more permanent method of fail-safe locking was engineered and installed;
- ◆ A defect report was submitted to the original equipment manufacturer and a safety bulletin was issued advising personnel of the situation, and corrective actions were taken to avoid future recurrence;

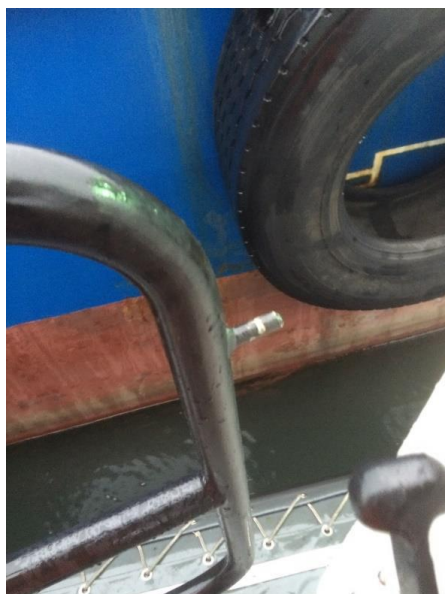
Starboard boarding gate open.

- ◆ Immediate cause:
 - The crew member leaned against an unsecured boarding gate which opened allowing said crew member to pass through and enter the water;

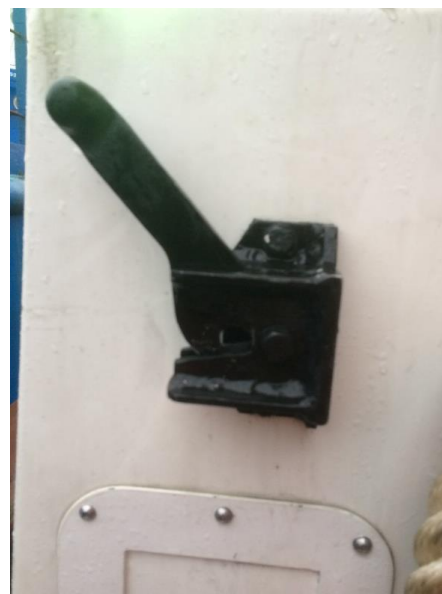
Close up of latch.

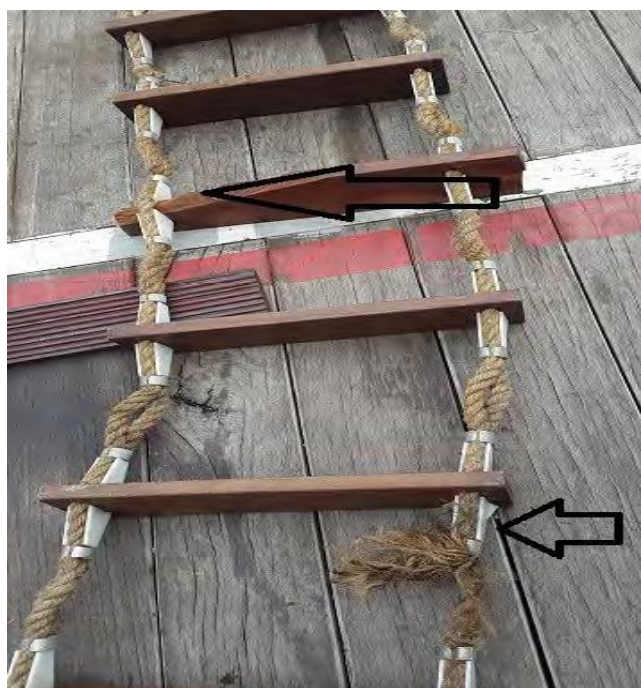
A member has reported an incident during an embarkation offshore, in which a rope on a pilot ladder snapped. The person boarding the vessel managed to hold onto the hand line which was rigged alongside the pilot ladder, thus preventing himself from falling overboard.

- ◆ The pilot ladder had been checked as part of the monthly safety checks and had been recorded as "Out of Order" – but had not been removed from use and quarantined;
- ◆ A requisition had been raised for a replacement pilot ladder, but the new ladder was still awaiting delivery;
- ◆ No crew member exercised the STOP WORK POLICY, despite being aware of the ladder being damaged;
- ◆ The following safety barriers were observed to have failed:
 - Operational procedures - existing guidance was not sufficient to deal with this case
 - Maintenance procedures;
- ◆ Our member took the following actions:
 - The pilot ladder was immediately quarantined
 - All other vessels were instructed to inspect their pilot ladders for serviceability
 - Changed company procedures on the quarantine of (faulty or damaged) tools and equipment.

Any tools or equipment found to be faulty, damaged or defective should be taken out of use and tagged/quarantined. This near miss incident need not have happened had someone on the crew taken the initiative to stop the job. Our members' STOP WORK POLICY should have been exercised, either during the monthly safety checks of the ladder or before the personnel transfer.

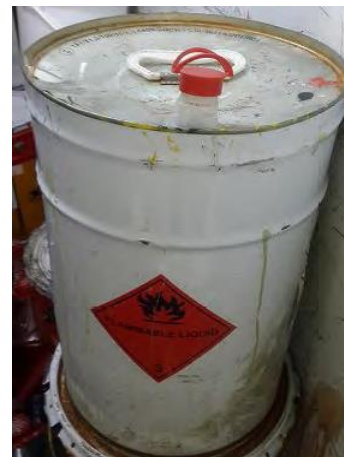
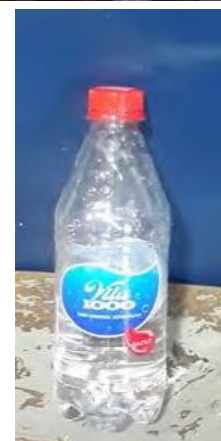
- ◆ There was a failure of control of substances hazardous to health:
 - “Thinners” had been decanted into incorrect storage, with insufficient warning labels

- Flammable materials were stored incorrectly near to or in accommodation
 - Incorrect Material Safety Data Sheets (MSDS) held on file, delaying immediate medical treatment;

- ◆ There was unsafe use of incorrect storage containers, leaving maintenance materials (thinners) incorrectly stored in the accommodation;
- ◆ No verification was done on board of the vessel to ensure there was proper and suitable equipment available for transferring small amounts of paint and thinners;

- ◆ The Bosun received first aid as per relevant MSDS requirements. He was transferred ashore by helicopter for further medical examination;
- ◆ A safety stand down was carried out with the vessel crew to further outline the hazards created by inadequate storage, segregation and labelling of hazardous substances;
- ◆ The vessel Master was instructed to have a check made throughout the vessel to see if there were any chemical agents stored in unlabelled bottles – in breach with the accepted norms and requirements.

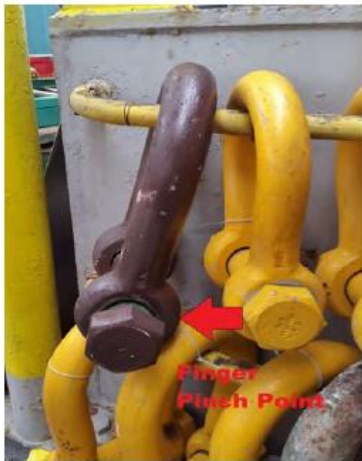
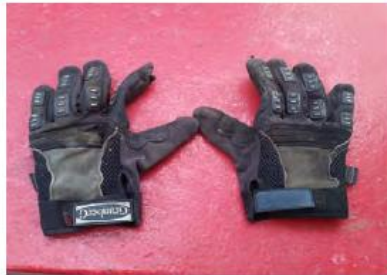
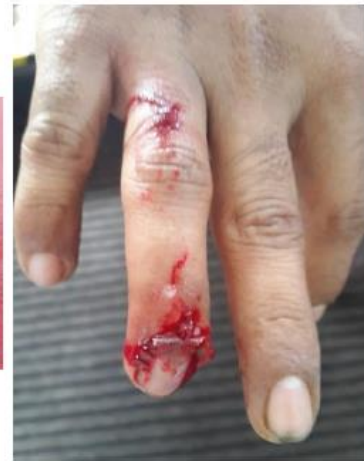
They lifted a large shackle, weighing 44kg, into position and the Bosun begun the count – on reaching 3, he let go but the injured person did not, causing his finger tip to become crushed between the dropped shackle and another shackle already on the rack below. He received first aid treatment on-board, but after examination by the platform medic, he was sent ashore

Showing shackles, gloves and injured finger.

- ◆ Despite a very detailed and discussed control of work process, some major items were missed:
 - The risk assessment was very detailed and included specific awareness on pinch points (following positive learning from a previous incident) and manual handling. However, no consideration was given to the use of additional, mechanical control measures – chain blocks, strops. – for handling heavier shackles

- Despite the difficulties experienced in lifting the heavier shackles, no-one exercised the STOP WORK POLICY. The Bosun and the injured person came up with an unplanned – and hazardous – solution, rather than stopping and re-assessing how the work could have been completed in a safer manner, using a dedicated safe lifting arrangement.

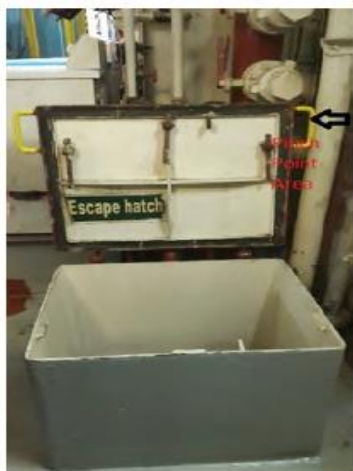
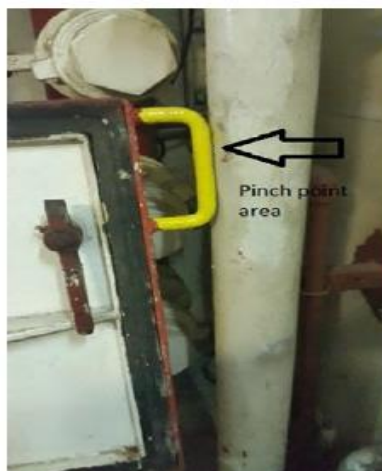
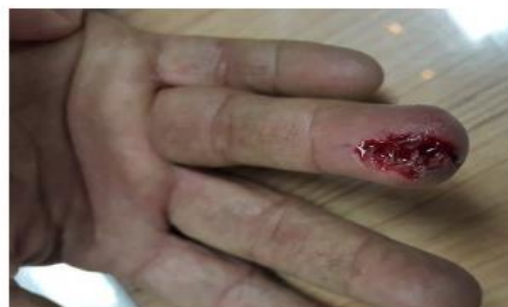
A member has reported an incident in which someone suffered a finger injury whilst working on a hatch. The incident occurred when a crewman was working on deck, and needed to lift an escape hatch cover to the machinery spaces. He raised the hatch cover using one of the fitted handles, but was unaware of a pinch point created between the handle and an upright pipe behind – his finger was caught in this pinch point, causing an injury to the fingertip.

- ◆ The handle was fitted in a manner that caused it to come into contact with the pipe when the hatch was opened;
- ◆ No-one had observed this pinch point, or highlighted potential injury risks presented;
- ◆ Because of a lack of observation or reporting of the pinch point, no warning signs had been placed.
