IMCA Safety Flash 04/18

February 2018

Dropped Objects

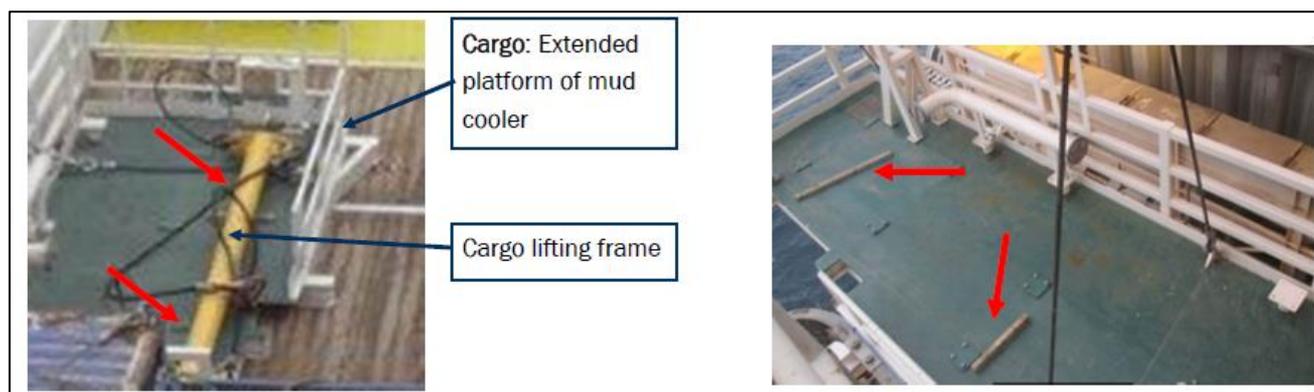
During deck cargo loading operations from a vessel to an offshore platform, two pieces of unsecured timber were inadvertently lifted from the vessel onto the platform, on top of the lifted cargo – a mud cooler module. This was discovered and reported by the deck foreman on the platform, who immediately informed all involved parties. There were no injuries or equipment damage.

Investigation revealed that the two timbers were initially placed as dunnage under the lifting frame (“spreader bar”) after loading onto the vessel at the quayside. Third party shore-side stevedores originally placed them to prevent damage to the lifting frame and its slings being caused by movement during the voyage.

When the platform hooked the frame, it was anticipated (by the third-party workers) that the crew would go under the suspended load to remove the dunnage. However, the vessel crew correctly declined to do so and left the timbers in situ. However, the vessel crew did not identify the further hazard left by leaving the timbers on the roof of the mud cooler module.

In this specific case, a possible solution could have been a pre-lift for repositioning the spreader bar, allowing removal of the timbers by using a hands-off approach, using push/pull poles.

- ◆ Task risk assessments for lifting operations were reviewed to include risk and controls related to potential dropped objects while handling bulky/heavy loads where cargo lifting frames are used;
- ◆ Permit to work checklist was reviewed to include a specific requirement to check for potential dropped object (PDO) associated risks;
- ◆ The incident, investigation and outcome to be shared with the quayside lifting authority, such that future lifting plans take into account the offshore environment.

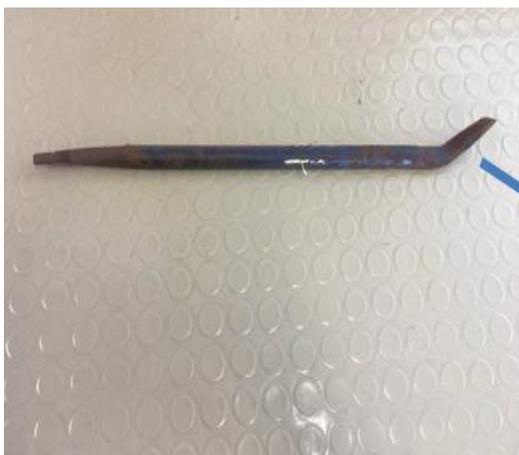
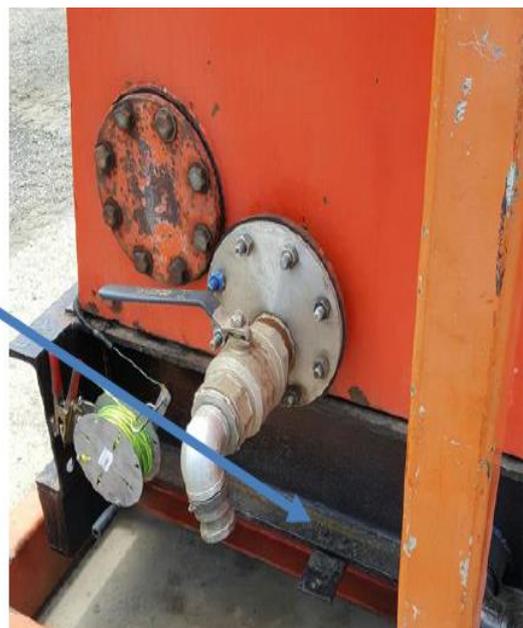
A member reports numerous instances of potential dropped objects being found on containers and equipment being loaded from port and offshore facilities.

Items of significant weight, such as a bag of fittings weighing 15kg, loose rocks, scissors, crow bars, large pieces of wood and loose lumps of steel affected by corrosion, have all been found when loading cargo.

The primary causes were poor housekeeping and failing to conduct inspections of loads before, during and after lifting operations.

- ◆ Containers and equipment being loaded and unloaded have been prepared by a third party. Great care and caution should be exercised when accepting these loads;
- ◆ ALL parties in the supply chain have a responsibility to inspect loads before first lift, during transit and when unloading;
- ◆ Ensure good housekeeping on and around all containers/equipment;
- ◆ Never stand under a load;
- ◆ Establish exclusion zones during lifts.

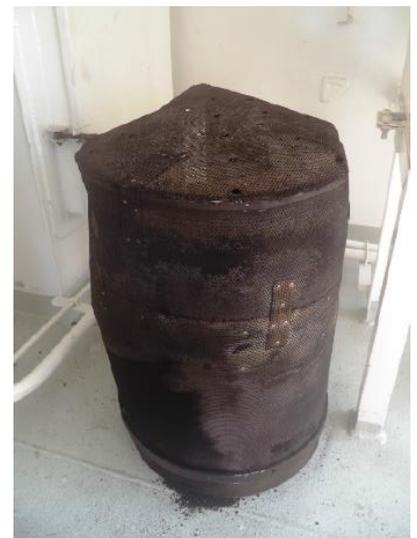
An 18kg spark arrestor fell 16 metres from the funnel stack and landed on the FRC deck. No-one was injured but this was considered a serious near miss. The spark arrestor was installed at the direction of the charterer only days before the incident. It was installed by a third-party sub-contractor; it was a requirement for working in the field and was new to the vessel.

- ◆ The spark arrestor became dislodged due to exhaust pressure and vibration;
- ◆ The clamp was not secured tightly enough;
- ◆ The mechanism of securing was pop rivets;
- ◆ Vessel management did not manage the quality control of the third-party work when the spark arrestor was installed.

- ◆ A causal factor was:
 - installation (fixing) of the spark arrestor was not adequate or to industry standards and not quality checked by the vessel crew or management;
- ◆ Root causes were:
 - failure of vessel operator to conduct a management of change (MoC) process for spark arrestor being installed
 - the vessel operator did not follow contractor management procedures as the third-party installer was not contracted by the vessel.

- ◆ There should be a management of change (MoC) process applied to all significant modifications or additions to vessel plant and equipment. This should include quality control to verify installation meets industry standards;

- ◆ Contractor management principles still apply even if there is no actual contractual relationship between the vessel operator and the third party doing the work.

- ◆ Review and update of safety management system (SMS) documentation (management of change (MoC) and Contractor Management processes) to ensure this scenario involving third parties is properly dealt with;
- ◆ Additional MoC training provided to vessel management teams.

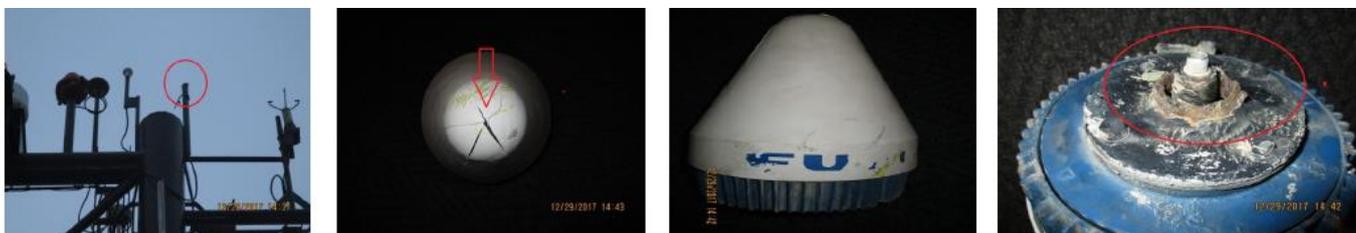
During a vessel transit in moderate seas, when the vessel was rolling and pitching, the Sat C dome fell from the main mast on the deck – a fall of approx. 17 meters. This incident could have been much more serious had crew been in the area when the dome fell. Understanding the reasons for, and following, a Clear Deck Policy, made a difference; reducing exposure of personnel on open deck areas during a sea passage in moderate weather conditions.

There was severe corrosion inside the Sat C dome, but this was hidden and *had not been spotted* in previous visual inspections carried out as part of the planned maintenance system (PMS).

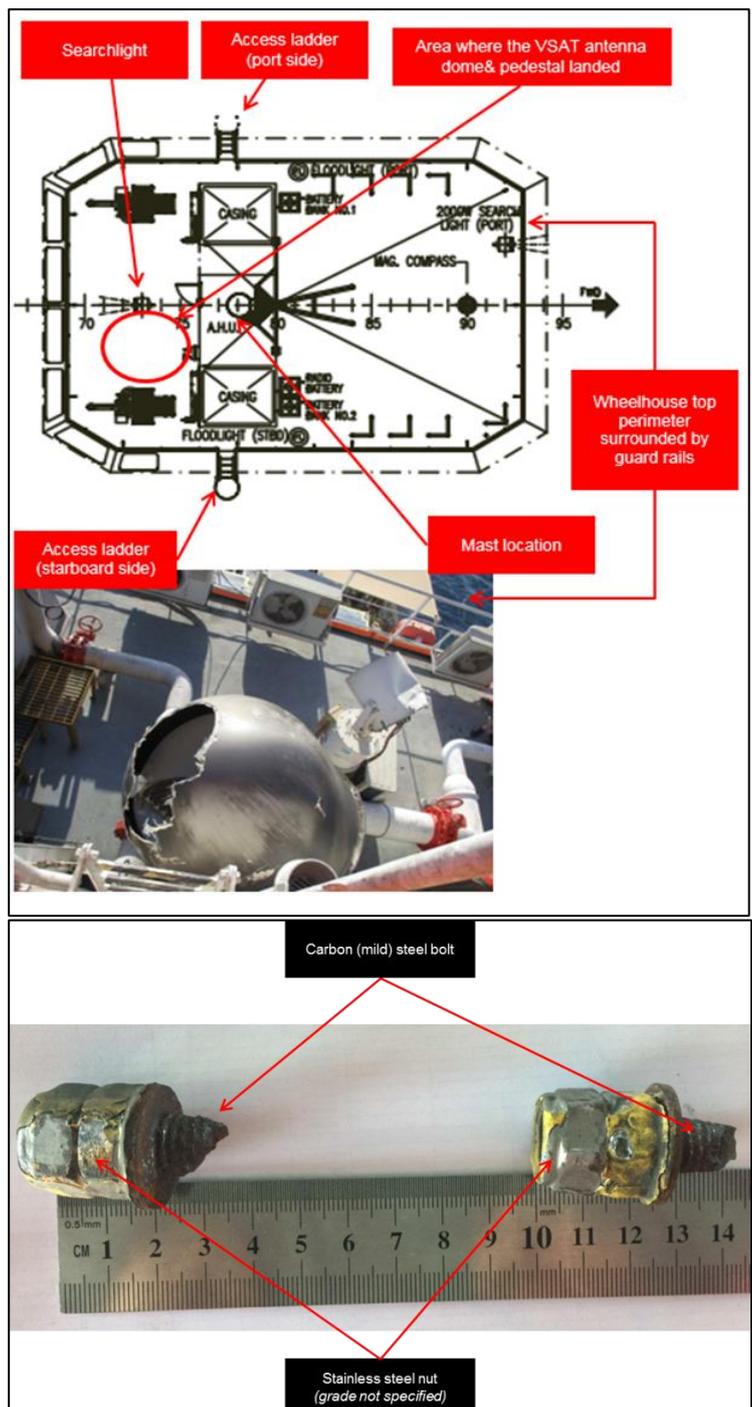
A vessel was sailing in its assigned standby location during heavy weather when the VSAT satellite antenna dome mounted on the vessel's mast fell off and landed in the monkey island above the wheelhouse. The fallen equipment was secured and the vessel master informed. The event was duly reported to shore side management. There were no injuries.

Preliminary investigation revealed corrosion as the cause of the failure. The corrosion was discovered in the bolts and the mounts and was due in part to the use of galvanically-incompatible materials.

- ♦ The bolt sizes were deemed insufficient for the static and dynamic loads that would be imposed on a VSAT antenna assembly while in service, particularly at the mast location, particularly given that corrosion is a long-term concern;
- ♦ The materials used for securing the pedestal to the mast were galvanically incompatible for the environment, i.e. mild carbon steel bolts used in combination with stainless steel nuts.

The use of dissimilar metals in the nuts and bolts anchoring the pedestal of the VSAT satellite antenna dome to the mast allowed gradual galvanic corrosion of the mild steel bolts and eventual failure. The location of the dome on the mast would have exacerbated the problem, as the dome would be exposed to both windage effects and tangential g-forces as the vessel responded to wave movement.

- ♦ The securing arrangement was very difficult to inspect properly, as the nuts and bolts were almost invisible;
- ♦ Welding the dome pedestal to the vessel structure should be of benefit;

- ◆ Where nuts and bolts are used, careful consideration should be given to ensuring the nuts and bolts are both the correct material for the environment in which they are used, and that they are the correct size.

- ◆ Inspections and maintenance – revise the vessel planned maintenance system to provide:
 - specific guidance as to what equipment to check when performing a visual inspection, and
 - clarity as to what common concern(s) to look out for;
- ◆ Improvements to the design process:
 - consider the use of a welded solution where practical
 - where a nut and bolt arrangement is practicable then the mounting material applied should be commonly used (and suitable for) in the marine environment, such as galvanized steel bolts and nuts. Mounting materials of different composition should be avoided to minimize corrosion in a marine environment.
