1 Confined Space Incident

2 Termination of Elastic Shock Cords

3 Near Miss with Cherry Picker Wire

4 Information on Material Change to SL-17 Yoke

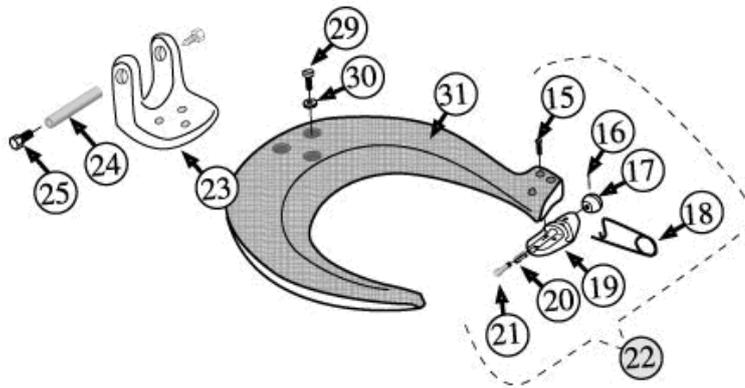
DSI is replacing the existing fiberglass yoke (31), DSI Part Number 520-060, with a new yoke, DSI Part Number 520-117 (no price change). The new yoke is made of a durable black polyurethane, molded around a stainless steel core, and is slightly heavier than the fiberglass. This yoke will become standard equipment on all SuperLite 17 A/B & MK 21 helmets produced as of June 15, 1999.

The new yoke is **fully retrofittable** with the fiberglass unit it replaces and is readily retrofittable to all SL-17 A/B helmets. The only difference is that the three stainless washers, (DSI Part Number 530-530 - location number 30 on the exploded view), used on the fiberglass yoke hinge installation are **not used** on the polyurethane yoke hinge installation.
