1 Failure of Lifeboat Lowering Mechanism

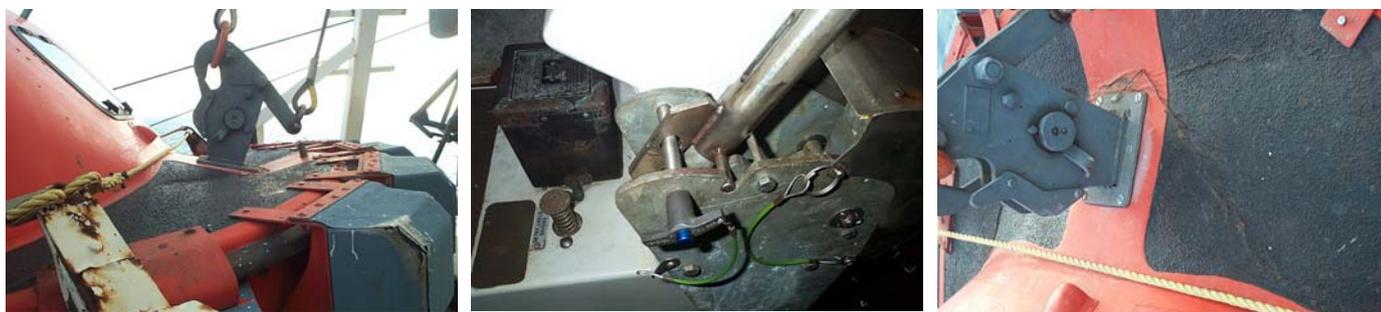
A member has reported that whilst lowering a lifeboat during coxswain training the bow release hook mechanism opened on contact with the water releasing the forward fall. The aft fall remained secured. Inspection found that the release was caused by a faulty cable mechanism. The forward operating cable end fittings had come loose and the cable was not holding the cam in place.

Pictures show mechanisms after modifications had been made.

- ◆ Lifeboat manufacturer or their designated agent to carry out full inspection of all mechanisms as soon as possible and replace where necessary (when locking pin is under handle as opposed to through handle).
- ◆ Regular inspection schedule to be established (part of weekly area inspections) and to be included as part of PMS.
- ◆ Manufacturer to carry out surveys at intervals recommended in SOLAS Regulations.
- ◆ Full visual inspection of all mechanisms to be carried out before any launching.
- ◆ All lifeboats to be test launched whenever the vessel is in port.
