## 1 Fall Hazards Associated with Temporary Deck Openings

## 2 Fatality During Cable-Pulling Operations

## 8 Incident during Winch-to-Winch Wire Transfer Operations

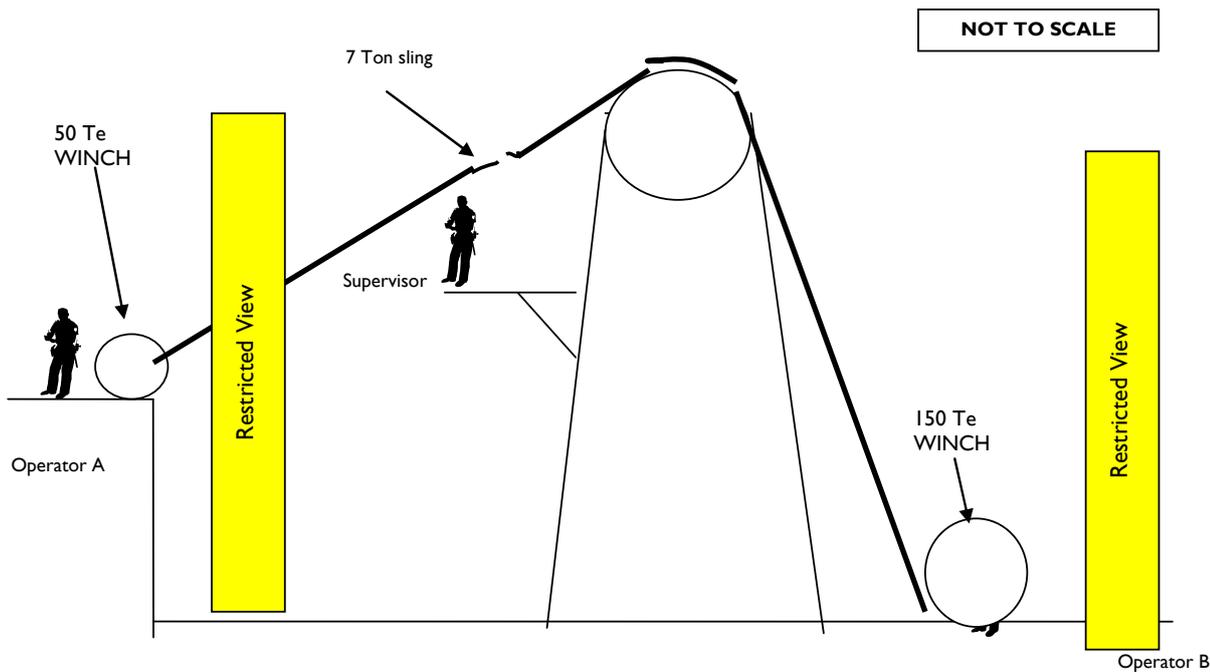
From the diagram below, it can be seen that the operation was totally reliant on the use of co-ordinated radio communications, as both winch operators were unable to maintain a line of sight with the operation.

As the wire connection arrived at the work platform, the supervisor called an 'all stop', which was not heard by 'Operator A'. The 50te winch continued to pull the 150te winch wire and the resulting tension caused the trip on the 150te winch to cut out. The 150te winch was fitted with a cut-out switch to prevent overloading, which had been previously set at 32te.

The supervisor called out two more 'all stop' commands, that were also not heard by Operator A. The tension in the rigging continued to rise as the 50te winch continued to pull. When the tension reached 42te, the 7-ton wire sling parted and the resulting whiplash destroyed the handrails on the work platform.

From the supervisor calling the initial 'all stop' command to the wire parting a total of six seconds had elapsed.

In any winch or crane operation where a line of sight cannot be maintained, it is fundamental to use correct radio procedure and protocol. All such operations are to be subject to a formal JHA and as a minimum a toolbox talk is to be held with all personnel involved in the operation.

- ◆ When carrying out lifts or winch operations that are out of the line of vision of the winch/crane operator (normally deemed 'blind lifts'), ensure that winch/crane operator receives a full briefing of the intended operation. Paint a verbal picture of the manoeuvres that are about to be carried out and do not proceed until he/she gives an acknowledgement of understanding.

- ◆ Full radio communication checks are to be made prior to the start of any winch or crane operation where line of sight between the operator and banksman cannot be maintained. If any doubt exists as to the efficiency of the radio communications, the operation must not proceed until full radio contact is established.

- ◆ During 'blind winch/crane operations' the criticality of the operation is such that the winch/crane operator must acknowledge and repeat all instructions he has received over the radio. The operation must not proceed unless a precise acknowledgement has been received from the winch/crane operator.

- ◆ During 'blind winch/crane operations' a hand signalling method and more than one banksman is to be used to relay instructions to the winch/crane operator. Each banksman should stand in a position where he/she can be clearly seen by the next person in the chain. All signals should be clear and precise. Wherever possible, the banksman at the load should have a complete overview of the activity.
