IMCA Safety Flash 05/04

June 2004

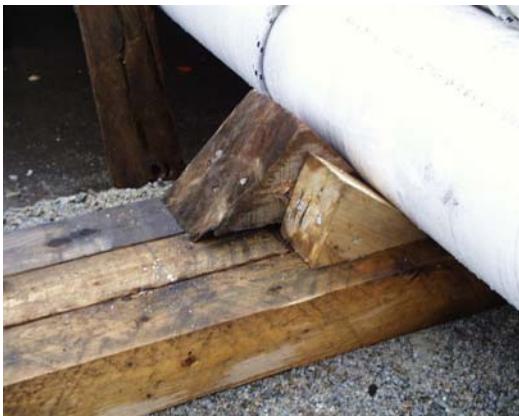
Original method

The procedure specified a stack with a maximum height of 8 layers of the 10" pipe joints. When placing the seventh layer on a stack, the front end pipe joint in the bottom layer slipped out of the restraining chock, pushing the other chocks ahead of it. This was followed by a slow slippage of the entire base layer, causing the rest of the pipe stack to slump. The slippage of pipes continued until it came to rest against a fork lift truck that was parked in front of the stack.

The investigation showed that the pipe coating was smooth, not sintered as expected, with little or no friction. This had been noted upon reception of the pipe joints, but not considered a problem. A subsequent sensitivity analysis, conducted as part of the investigation, revealed that the smooth surface more than doubled the forces that the wooden restraining chocks would have to withstand.
