I Flash Fire in Field Joint Coating Station

2 Burns Caused by Release of Steam and Boiling Water from Overheated Pump

3 Hand Injury Sustained by Diver

4 Isolation of Fuel Tanks

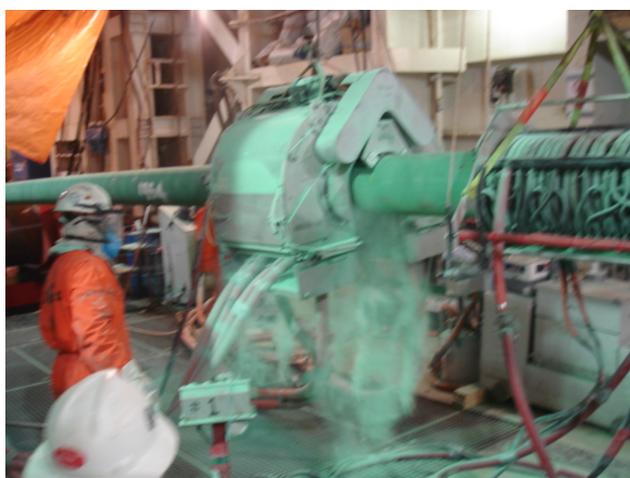
A member has reported the occurrence of a flash fire onboard a pipelay vessel. A fusion bonded epoxy (FBE) powder used in the pipeline coating process escaped from a coating machine and came into contact with a naked flame. The flame travelled in this cloud of powder towards the coating machine and set this machine on fire. One crew member was standing next to the machine and sustained small first and second degree burns to the left face, neck and forearm.

- ◆ insufficient extraction and sealing on the FBE machine used resulted in FBE dust releases upon each opening of the machine;
- ◆ coating repair in the vicinity of the machine required the use of a burning torch;
- ◆ the area was relatively open and the ignited dust "only" resulted in a flash fire. In a more congested area, it could have formed a dust explosion with associated damage from explosion overpressure;
- ◆ other types of dust (e.g. from grinding) could pose a similar hazard if brought in contact with a naked flame.

- ◆ Immediately report excessive FBE powder releases from coating machines and undertake any necessary repairs immediately;
- ◆ ensure there are no naked flames or smoking in the areas where flammable dust is gathered;
- ◆ never clean equipment containing flammable dust by means of air blower – use an explosion proof vacuum cleaner.
- ◆ never disconnect FBE hoses from the machine to use them for spraying FBE; use only approved equipment for spraying FBE;
- ◆ clean the area at the earliest possible opportunity.

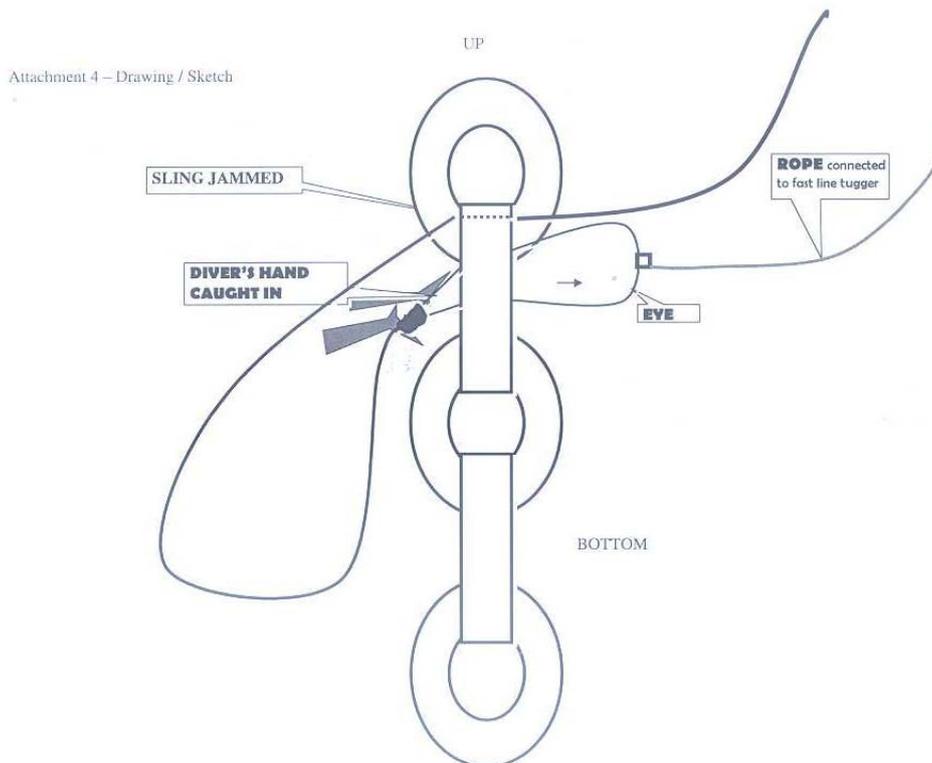
In an attempt to free a bight of a fouled transfer sling from its pinch point between two mooring chain links, the free hanging eye of the jammed wire rope was secured to a soft line for passing through the link and back to the surface crew on the buoy (see diagram). The intention was for the soft line to be hauled up, with the wire rope to follow. Once the eye had been pulled up to the chain it became necessary for the diver to reduce the diameter of the eye in order for it to pass through the link. Whilst the diver was working to accomplish this, the soft line which had previously been hauled by the riggers on the buoy was attached to a fast tugger winch on the vessel crane in preparation to assist in freeing the sling. The diver was not informed that this change had taken place.

After readying the eye for passage through the chain link, the diver gave the instruction to come up on the soft line. As he was in the process of manipulating the eye 90 degrees to ease its passage, it suddenly shot through and pinned his wrist against the chain. The diver immediately requested slack, but after a few seconds of increasing pressure on his wrist he opted to cut the soft line and free himself. After he returned to the surface, examination of his wrist on the vessel indicated no traumatic internal damage. The diver was sent ashore for x-rays to rule out fractures. He has since returned to work after a period of recuperation.

- ◆ Although the diver's hand was in 'the wrong place', it was noted that he had not been informed of the transfer of the soft line to the crane;
- ◆ An identical jamming of the transfer sling had occurred without incident on the previous dive. A suggestion had been made after the prior incident to use a shackle to mitigate the chances of a repetition of the incident, but this had not been seen as necessary at that time;
- ◆ The video footage of the incident was not removed as evidence and had been subsequently taped over;
- ◆ Though a task risk analysis (TRA) had been performed, which had addressed rigging hazards and the need for good communications, a number of people involved in a supervisory role in the operation had not taken part.

- ◆ An alternate method for rigging the transfer sling, using a shackle, is to be used for future tasks;
- ◆ A checklist is to be created for post-diving incident events to ensure that such items as the video recording and other evidence are gathered and secured properly. Ongoing upgrade to DVD and HDD recordings will help alleviate the shortcomings of the VCR method;
- ◆ There is to be a review of communications between vessel management and divers to ensure gaps and delays are reduced;
- ◆ Supervisory training in the management of change process is to be conducted to ensure the awareness, documentation and communication of task hazards to all involved with the job.
- ◆ The use of a shackle on the mooring chain when performing this task is to be appropriately documented as formal procedure.
