## I Near Miss: Burnt Out Electrical Socket

## 2 Water Ingress to Bow Thruster Space

### 3 Diver Injury During Air Cylinder Recharging

## 5 Oxy-Arc Umbilical Handling Winch – Fire on Deck

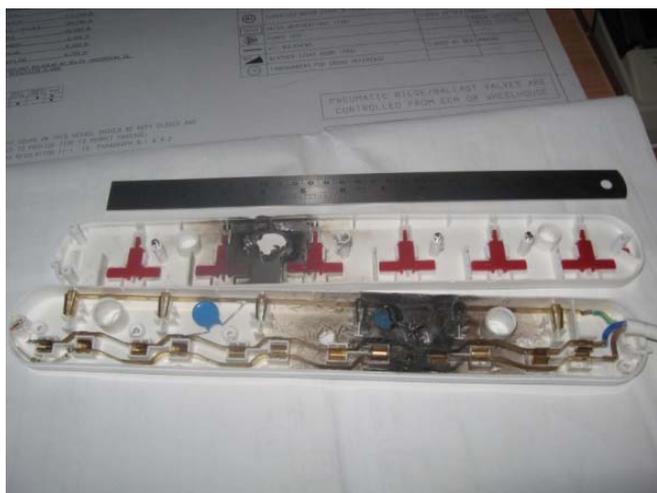
An examination of the socket showed that one of the surge capacitors had blown with enough heat to burn the socket. An identical socket, which had been purchased at the same time as the one involved in the incident, seemed to be working fine. However, it was taken out of service to assist in preventing any risk of possible recurrence. It was ascertained that the 6 way multi-socket had been purchased by a member of the vessel crew from a shop in the last port visited by the vessel.

*The inside of the 6 way socket extension, showing the damage caused inside the unit*

The direct cause of the incident was failed/defective portable electrical equipment – an oversurge of electrical current into the 6 way multi-socket caused the internal components, and external casing, to overheat and start smouldering.

The root cause was failure to follow procedures – specific procedures in place to control electrical equipment onboard the vessel were not complied with. The aim of this procedure was to ensure that all vessel electrical equipment, crew personal electrical equipment and third party project equipment is presented to the vessel electrician, prior to use on the vessel, to verify and test that it is safe and fit for purpose.

- ◆ A thorough electrical inspection of the cabin involved in the incident was carried out and it was found to be safe. The inspection showed that the cabin television had already been PAT tested, with testing label clearly visible and in date;
- ◆ A thorough sweep was undertaken onboard the vessel and all unsuitable multi-way sockets were removed.

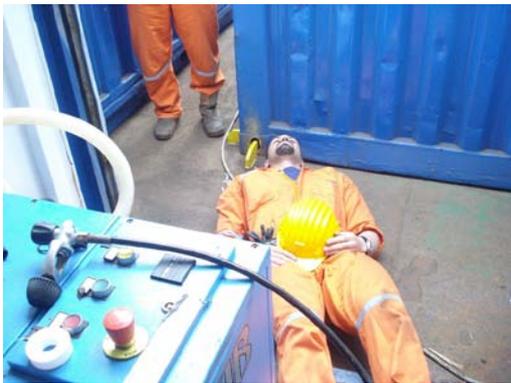
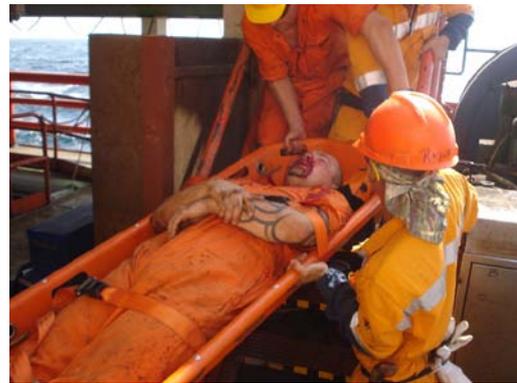
After hearing a loud noise, members of the dive team immediately proceeded to the recharging station where the injured diver, who had been working alone, was found laying down on the deck bleeding around his right eye. The cylinder pillar valve was found to be disconnected from the air cylinder.

The incident investigation carried out by the member company found that the diver had sustained a head injury due to the accidental disconnection of the air cylinder's pillar valve, coupled with the filling hose of the air compressor contacting the diver's head.

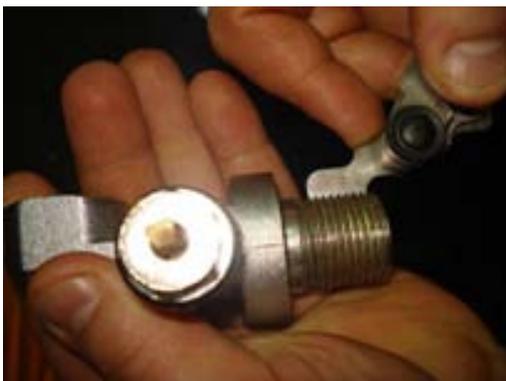
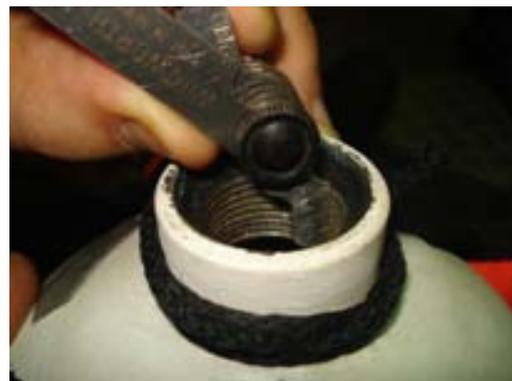
The investigation showed the root cause of the incident to be an incorrect coupling between the pillar valve and the air cylinder in that the pillar valve had an external metric thread of M25x2 whilst the cylinder had a Whitworth imperial thread of 1 inch (25.4 mm). The two threads are technically incompatible and did not provide a correct connection between the pillar valve and the air cylinder.

The investigation further found that the assembly procedure had not complied with EN 250-2000 and EN 144-1; a company requirement where only metric threads are to be used.

The member stopped all activities, checked all air cylinder threads and pillar valve threads for compatibility, ensured their appointed subcontractor had developed working procedures and instructions for marking and checking pillar valves and air cylinders, and ensured that a QHSE (quality, health, safety & environment) audit of the subcontractor had been performed onboard and at their premises onshore.

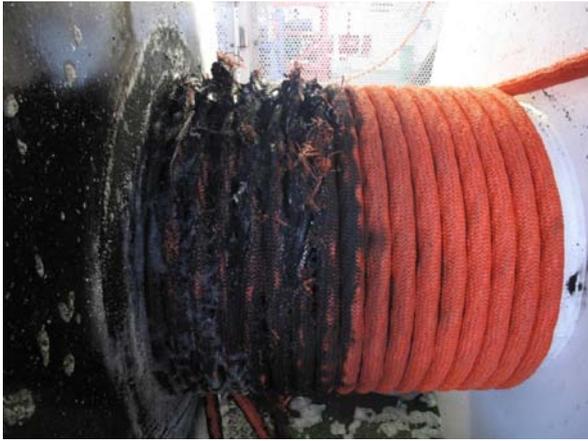
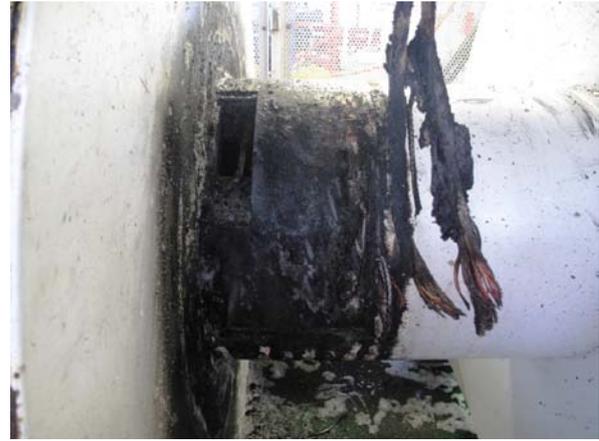
The preliminary investigation showed that the amperage on the welding machine was set at 803 amps. This was in excess of the normal value of 150-250 amps recommended for oxy- arc cutting.

This high amperage caused the insulation around the welding unit connection at the triple drum interior connection plate to breakdown/melt, causing a short and giving rise to an ignition source.

In order for the fire to have reached such intensity in the short time, the initial investigation found that the oxygen supply hose inside the drum had ruptured and fuelled the fire.

The welding unit was rated to 800 amps which is in excess of the requirement for oxy-arc burning and exceeding the 500 amps rating of the welding cable and connectors - information which onboard personnel were potentially unaware of.

The member raised a company safety alert highlighting the fact that the welding machines were capable of delivering up to 800 amps, and new signage was placed on the machines prohibiting use by non-authorized personnel. Lower current welding machines will be procured to replace the over specified units.
