## IMCA Safety Flash 05/12

June 2012

### I Uncontrolled Ascent of Lift Bag

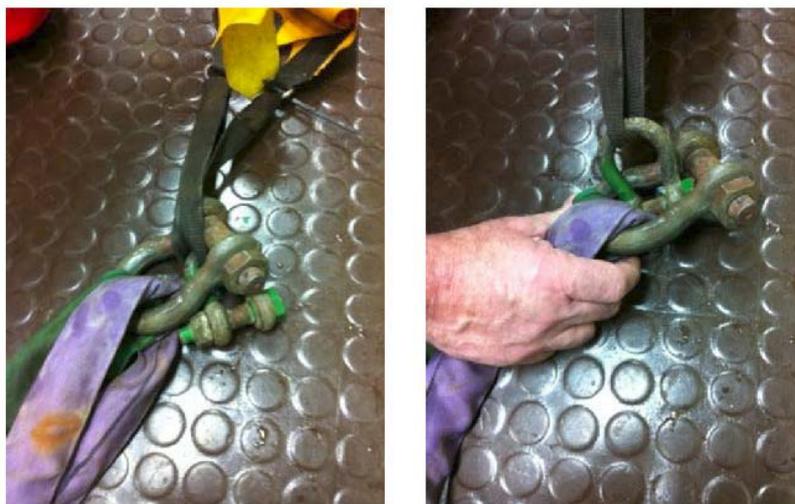
When connecting the two however the diver, instead of joining the two shackles together, simply passed the lift bag strops through the larger shackle (see illustration below). When the rigging was complete, the diver untied the inverter line and asked the dive supervisor for pneumo gas to be supplied, so he could put a small amount of gas into the lift bag, to cause it to stand up, and check the overall arrangement.

*Showing arrangement of shackles that allowed lift bag to come free and ascend to surface*

As the diver proceeded to tie the inverter line to a standoff, the gas in the lift bag caused it to ascend with just enough buoyancy to lift the lift bag rigging and small shackle through the larger shackle. Although by no means fully inflated the lift bag then ascended to surface.

- ◆ The immediate cause was that the diver, though competent for the task in hand, made a mistake during the rigging up of the lift bag;
- ◆ Underlying causes associated with the incident were considered to be:
  - risk assessment for the various parts of this task was not adequate nor fully applied
  - written instructions for internal use were not entirely clear or in sufficient detail (although an admittedly obvious precaution, neither [IMCA D 016 – Underwater air lift bags](#), nor the company procedure for the use of lift bags based

on this guidance, included a step specifically stating that holdback and inverter lines should be attached BEFORE any gas is introduced)

- monitoring – checks and inspections of workplace precautions and risk control methods were not adequate.

- ◆ Vessel 'safety focus' on checking/rechecking progress with activities/tasks;
- ◆ Revision of in-house procedures for use of lift bags, to include specifics on checking lines/rigging before inflation;

- ◆ IMCA was advised of the incident and a proposal was put forward for revision of IMCA D 016;
- ◆ Appropriate pre-job briefings were enhanced (where there is a use of lift bags) to ensure safety requirements and lessons learnt from the incident are communicated and applied as part of ongoing raising of awareness;

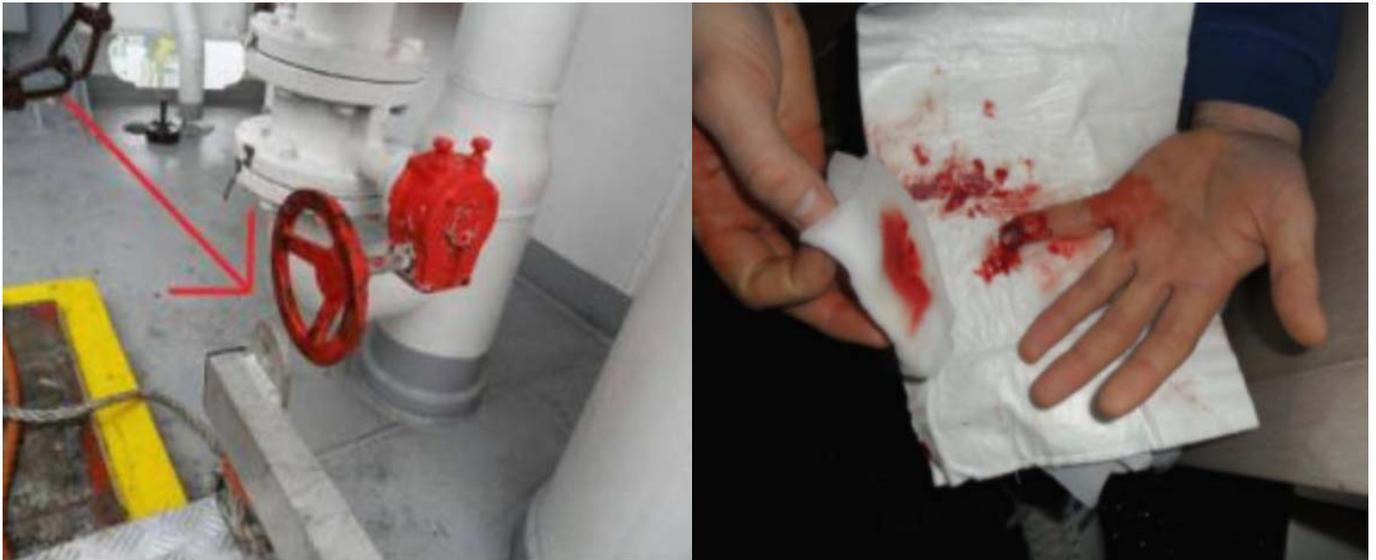
A member has reported an incident in which a crewman suffered a serious pinch injury to his finger whilst moving a gangway. The incident occurred during preparation for departure from port when two crewmen and the second officer were removing and stowing the ship's gangway. The gangway was lifted onboard and whilst it was being slid along the deck for stowage, one crewman had his finger pinched between the gangway frame and an isolation valve on deck resulting in a deep cut to his finger.

*Showing pinch-point between gangway frame and valve, and injured finger*

- ◆ The crane normally used for moving the gangway was out of order and awaiting repairs. Therefore a smaller gangway was used that allowed for crew members to manually handle it into position;
- ◆ This smaller gangway was normally stored on the cargo deck but was in the way during cargo operations and had been removed;
- ◆ The risk assessment was not adequate:
  - it did not adequately cover the gangway being manually handled
  - it did not identify the possibility of pinch points
  - other structures such as the isolation valve had not been highlighted as a potential danger;
- ◆ A toolbox meeting was held, but did not identify the additional risks involved with the manual handling of the gangway;
- ◆ No management of change was carried out for the change of gangway.

- ◆ Reviewed the risk assessment for this operation;
- ◆ Made engineering changes to the isolation valve so that it cannot become a pinch point;
- ◆ Investigated alternative gangway storage facility;
- ◆ Alter positioning of gangway to establish easy handling and positioning of the gangway by the crane;
- ◆ Introduce and require use of a management of change procedure.
