IMCA Safety Flash 05/13

April 2013

I Explosion Causing Fatal Injury During Maintenance of Metocean Buoy

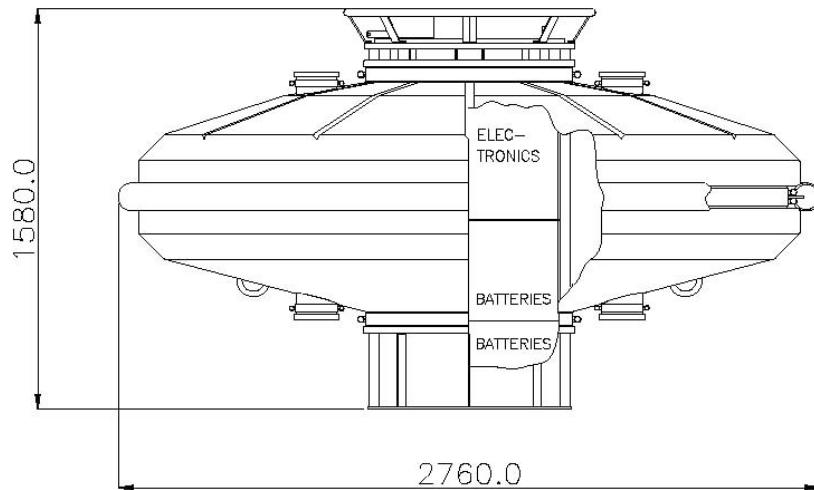
Line drawing of metocean buoy

The **immediate cause** of the explosion was found, on investigation, to be sparks from the grinder igniting an explosive mixture of hydrogen and oxygen which had built up inside the compartment. The hydrogen build-up was assumed to stem from the lead-acid batteries. The lead-acid batteries contained in all metocean buoys of this sort are of the so called valve regulated type, meaning that they are sealed, except for a pressure relief valve. These batteries feature a built-in gas recombination system, and the small amounts of gas released through the valve pass through an additional catalyst before being conveyed to the outside of the buoy. This system is intended to prevent any build-up of hydrogen. The final technical investigation showed no sign of malfunction of the battery venting system.

The **root cause** of the incident was determined to be to a combination of lack of maintenance and a failure to follow existing procedures. The investigation concluded that the following chain of events led to the hydrogen build-up, and eventually the accident.

1. Corrosion around lid sealing due to bird droppings and rain or sea spray caused the sealing to fail;
2. Water, sea salt and bird dropping (guano) ingress into the instrument compartment past the leaking lid sealing;
3. Corrosion and subsequent volume increase on details of battery rack due to ingress;
4. Increased pressure on batteries from rack, resulting in cracked battery cases;
5. Hydrogen build up due to one or more of these effects;
6. Corrosion of aluminium, accelerated by guano and sea salts dissolved in water;
7. Corrosion due to spilled battery acid from cracked batteries;
8. Gas leakage from cracked battery cases;
9. Hydrogen escapes due to leaking lid sealing and increasing temperature;
10. Grinder ignites hydrogen.

- ◆ Improvements to warning signs and clearer instructions were developed, and also improved designs for the instrument compartment and battery rack;
- ◆ Development of clearer instructions, which emphasize that at all times the buoys should be treated with the assumption that they could contain an explosive gas mixture.

- ◆ Exercise particular care with buoys that have not operated normally in the period prior to retrieval;
- ◆ Equalise the pressure inside the buoy to the ambient air pressure by opening the gas filling valves;
- ◆ Purge the interior of the buoy with air or nitrogen in order to remove any possibility of hydrogen gas, using the procedure described in the user manual;
- ◆ Do not allow any ignition source - including power tools - near the buoy until it is fully opened;
- ◆ Maintain a safe distance. Only the minimum required number of persons should be in the vicinity of the buoy until it is fully opened. Never stand in direct line of the instrument compartment lid;
- ◆ When flushing has been completed, proceed immediately with the opening of the lid;
- ◆ Leave the lid fully open for a further 10 minutes.

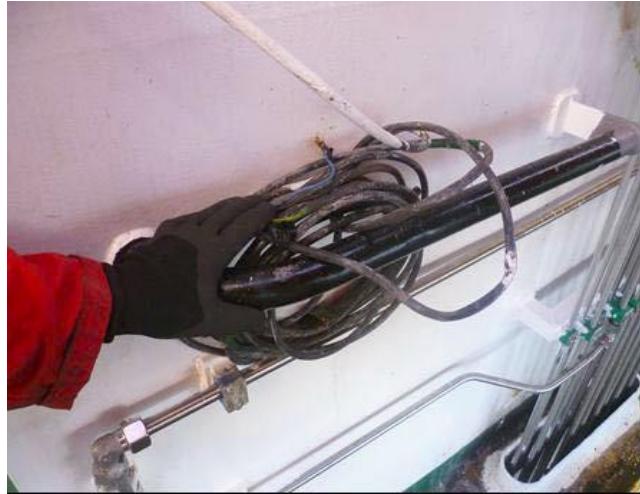
A member of the crew working near the new hyperbaric lifeboat noticed an electrical cable which was coiled up and stowed between a handrail and an adjacent bulkhead. The ends of the cable were not terminated but had been separated and wrapped up in electrical insulating tape. It was noted that a small amount of smoke was coming from the end of the cable and some sparking (the cable was in contact with the bulkhead). Realising that the cable was live the crewman immediately contacted the deck electrician and asked him to come and investigate. The electrician subsequently traced the cable and made it safe. The cable was identified as the supply to a halogen flood light originally intended as overboard illumination for the launch station of the vessel's FRC.

Figure: showing electrical cable and bare live wires

- ◆ There had been inadequate planning and inadequate supervision of the work;
- ◆ The old flood lamp had been removed with no Permit To Work (PTW) or Electrical Isolation (EI) certificates in place.

- ◆ The induction to the vessel during dry dock is to be reviewed and will include additional information regarding the Management of Change procedures;
- ◆ The use of a single point of contact for each work area was not in place while the vessel was in dry dock. This would have allowed the third-party contractor to approach their contact and arrange the necessary PTW and EI for the additional works they required;
- ◆ Although this work area still had additional works to be carried out, the area was not fully surveyed once the initial works had been completed prior to handover.

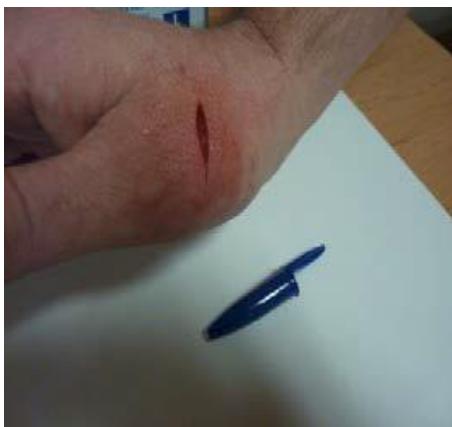
Figure: 2 cm laceration caused by knife blade

- ◆ The cook was attempting to undertake too many tasks at the same time whilst working alone at a busy time;
- ◆ Assistance from other team members was not sought during a busy period in the galley;
- ◆ Existing safety systems were not followed, i.e. knife handling policy and Task Based Risk Assessment (TBRA).

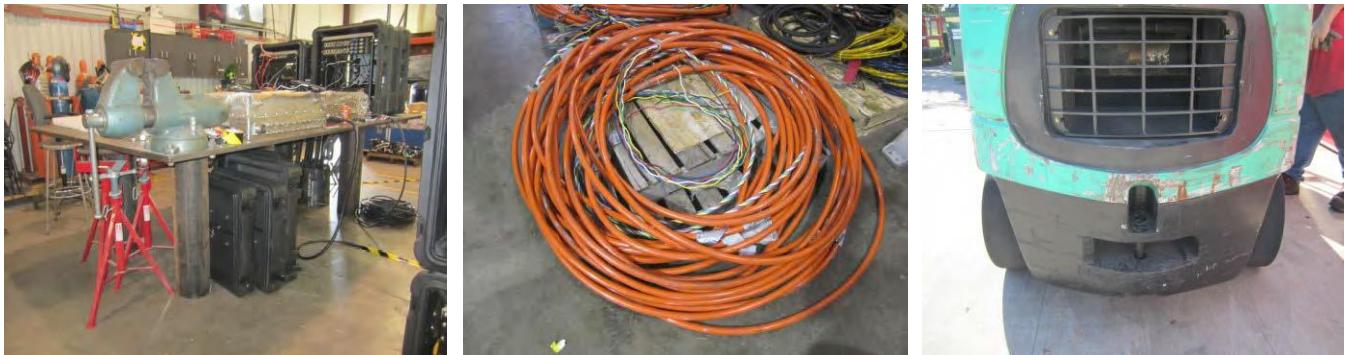
No personnel were injured and no equipment was damaged. However, the potential for personnel to have been injured and equipment to have been damaged was very high had personnel been at the work table or had the work table been pulled over. At the time of the incident there were a number of costly pieces of electronic equipment on the work bench.

Figures: (Left) Work bench (Middle) electrical cable being tested (Right) Fork lift truck

- ◆ There were no test procedures for the set-up and use of the forklift for stretching and tensioning the cable;
- ◆ There was no job safety analysis (JSA) addressing actual or potential hazards of stretching and tensioning the cable with the forklift in order to support troubleshooting of the electrical cable;

- ◆ Testing methods, especially when unique or uncommon, should be documented and a Job Safety Analysis performed to ensure all hazards and risks are identified, understood and mitigated against;
- ◆ Controls for equipment, personnel and process should be planned, defined and monitored for compliance by assigned, responsible personnel;

- ◆ Ensured that improved communication processes were established and maintained to prevent recurrence of same or similar incidents;
- ◆ Continued to reinforce safety protocols, practices and behaviours with all personnel to overcome complacency to work place hazards.
