1 Transponder/Beacon Explosion

2 Personnel Lifting System Fatality

3 Serious Fire Extinguisher Alert

4 Hydraulic Injury to Hand

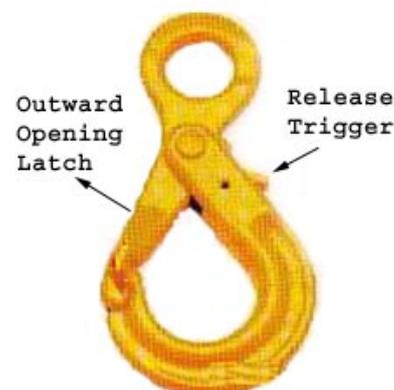
We have learned of a fatality when a worker fell from a full body harness boatswain's chair when ascending on a hoisting system. The initial information from the investigation team indicates that the individual fell when he became detached from the self-locked grip latch hook, similar to that depicted below. The latch on the hook depicted on the right opens outward.

The company involved has implemented a survey of all personnel hoisting and fall arrest systems seeking:

- ◆ verification that all hook components are designed and manufactured and certified for lifting personnel;
- ◆ where such hooks are used, these should be self-locking and self-closing with an inward moving latch.

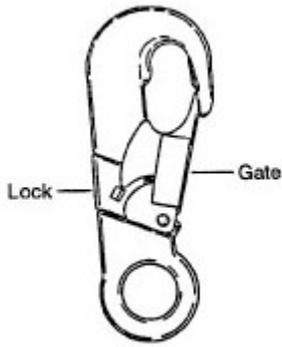
Snaphook, Self-locking

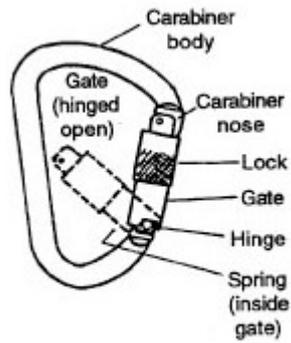
Carabiner, Self-locking

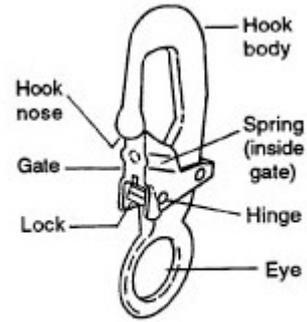
Snaphook, Self-locking

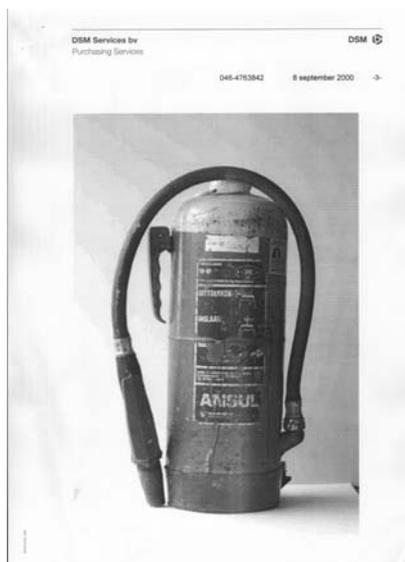
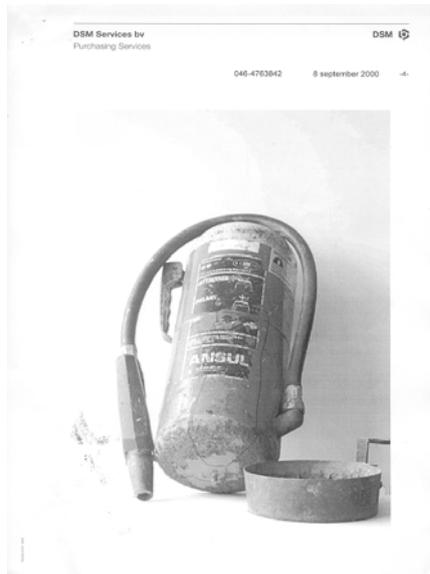
We have received a report of a fatality whilst using a fire extinguisher. A worker was using a fire extinguisher to put out a small fire when the extinguisher suddenly exploded, resulting in the person's death from the flying debris. Part of the extinguisher cracked open when the internal CO2 cylinder opened (225 psi/17 bar), hitting the user in the chest.

The cause of the incident was corrosion of the cylinder under the rubber protective foot. Water had entered the rubber lining, causing serious corrosion.

We understand that the vendor has distributed a warning to all owners of this type of fire extinguisher stating that the annual inspection should include visual inspection of the bottom of the cylinder after the rubber foot has been removed. Please see the photographs below:
