IMCA Safety Flash 06/07

July 2007

1 Diver Injury Using Cavitation Blaster

2 Weld Failure on Kirby Morgan KMI7B 505-055 Neck Clamp

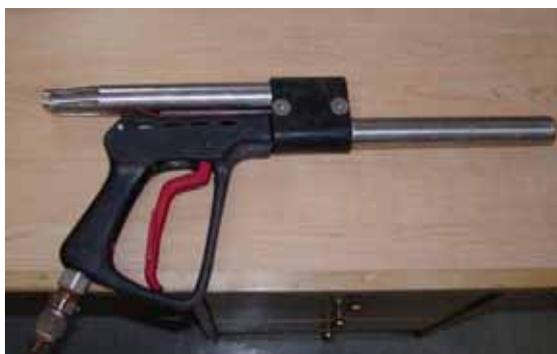
Cavitation gun

During marine growth removal operations the diver released the trigger on the cavitation gun to reposition his body. When the diver reapplied pressure to the trigger, the cavitation gun kicked back towards the diver, causing the retro end of the gun to come into close proximity of his wrist and forearm. The retro jet subsequently caused a high pressure (approximately 1000 psi) seawater injection injury to the diver's forearm.

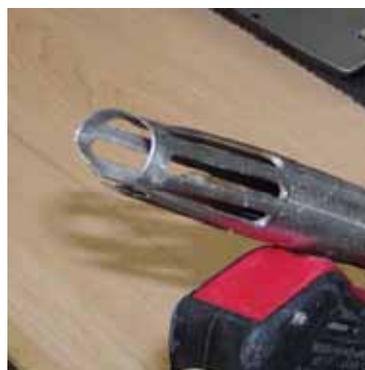
Retro jet showing proximity of nozzle to end of baffle (approx 3 cm)

The risk assessment had not highlighted the fact that the retro jet posed a high pressure injection risk to the diver.

The manufacturer has now modified the retro jet by moving the nozzle further back inside the rear baffle. The company involved will be carrying out a full examination of the modification before allowing the cavitation blaster back into use.

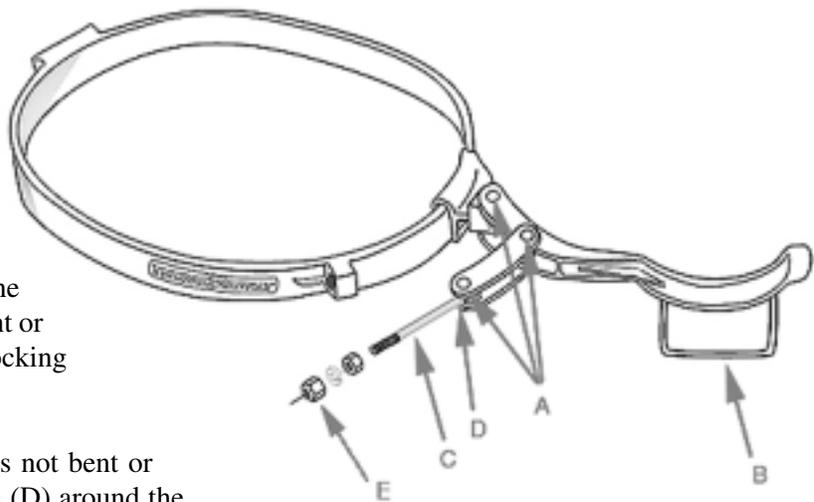
Visually inspect the moving parts of the clamp assembly including the three pins (A) in the over-center lever assembly, and the three clevis blocks. Visually inspect for bent or broken pins or a bent or broken handle and locking bail (B).

Check to ensure the adjustment stud (C) is not bent or damaged. Visually inspect the welded area (D) around the base of the stud for signs of stress or weld cracking.

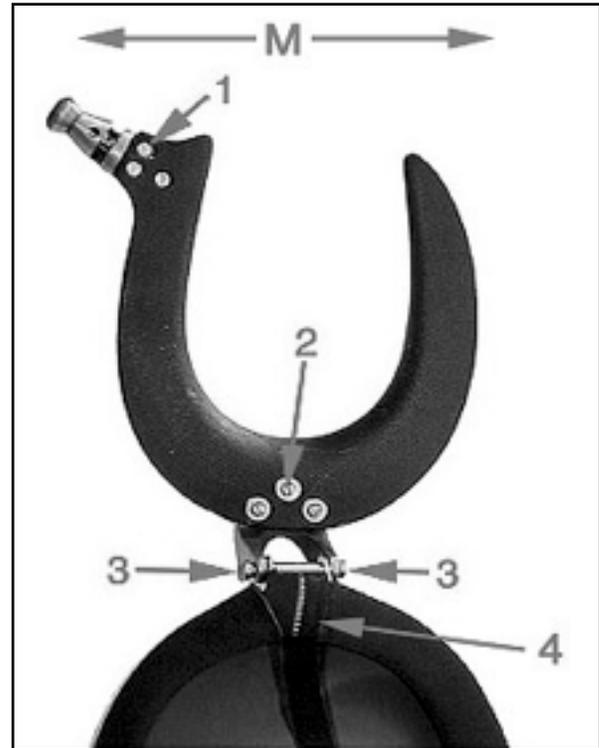
As the neck dam ages it compresses and the clamp must be adjusted by tightening the adjustment locking nut (E) so that the clamp operates as described above.

The stainless steel nylon lock nut (E) will require periodic replacement as the nylon insert wears out due to the periodic adjustments to the clamp that **MUST** be made as the neck dam ages or you change to a dry suit mount. **YOU SHOULD NEVER HAVE TO FORCE THE CLAMP SHUT!**

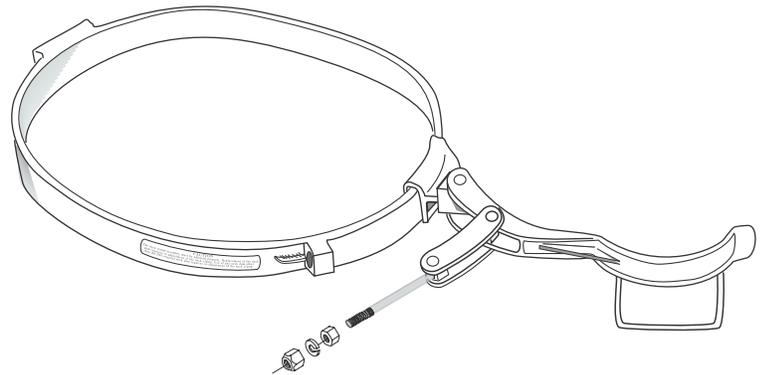
Kirby Morgan Dive Systems, Inc. (KMDSI) was alerted by its Authorized Dealer in Southern Africa about the following incident: A Kirby Morgan SuperLite 17A/B (Serial #82929, purchased in April 1997) neck clamp assembly was found jammed in a container door. The neck clamp was hanging on the umbilical rack on the door and the person closing the container door did not notice that it was jammed. When the jammed neck clamp was discovered, it was removed and closely inspected.

During the clamping process (onto the helmet) one of the welded pins on the neck clamp assembly broke off. On closer inspection it was noted that there was no way of identifying this potential break as both sides of the pin are welded.

It is important that a visual inspection of the neck clamp assembly be done before every dive. Normal inspection of the neck clamp assembly is covered in the Kirby Morgan Daily Pre-Dive inspection Appendixes A2.3, Monthly Inspection A2.2 and the Annual / 400 Hour Overhaul A2.1. These Appendixes can be found at <<http://www.kirbymorgan.com/>>www.kirbymorgan.com under notices/maintenance checklists.
