IMCA Safety Flash 06/08

I Sikorsky S76A+ and S76A++ Helicopters

SERVICE BULLETIN

Subject: Installation of a sealed Power Turbine (PT) overspeed tachometer box.
Incorporation of modification TU 330.

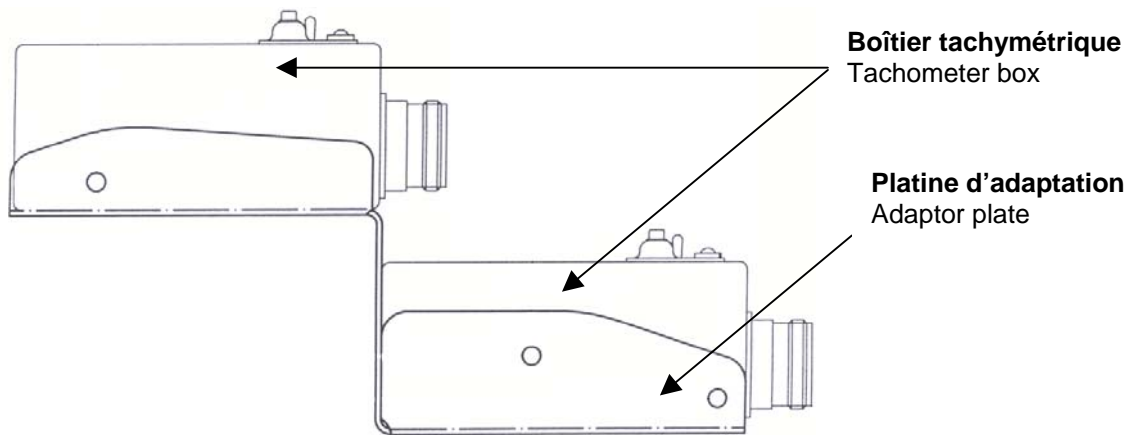
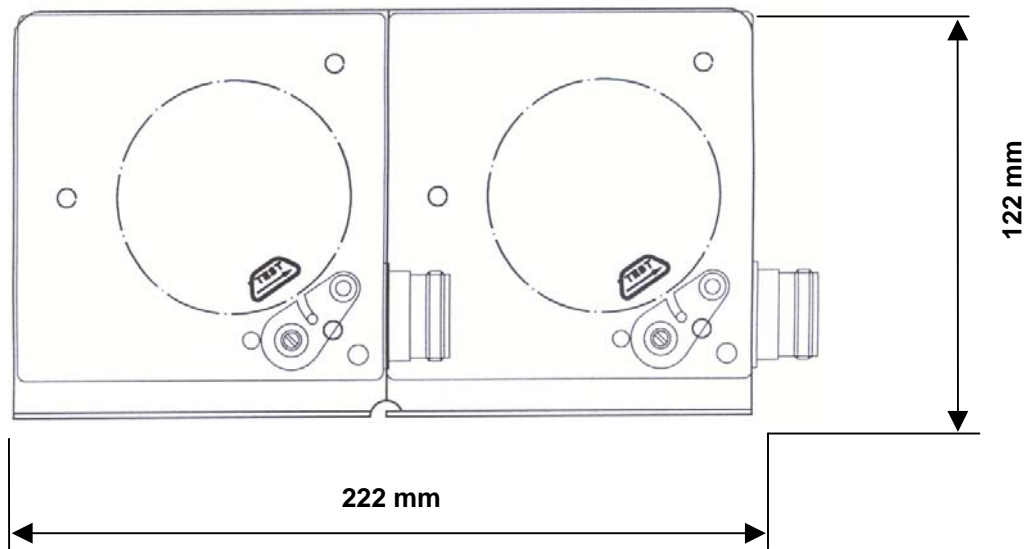
ANNEXE 1 / APPENDIX 1

This modification consists of introducing the post TU 330 tachometer box as an option in order to allow the replacement of pre TU 330 boxes that show traces of corrosion or that are used in humidity-saturated atmospheres.

Boîtiers tachymétriques pre TU 330
Pre TU 330 tachometer boxes

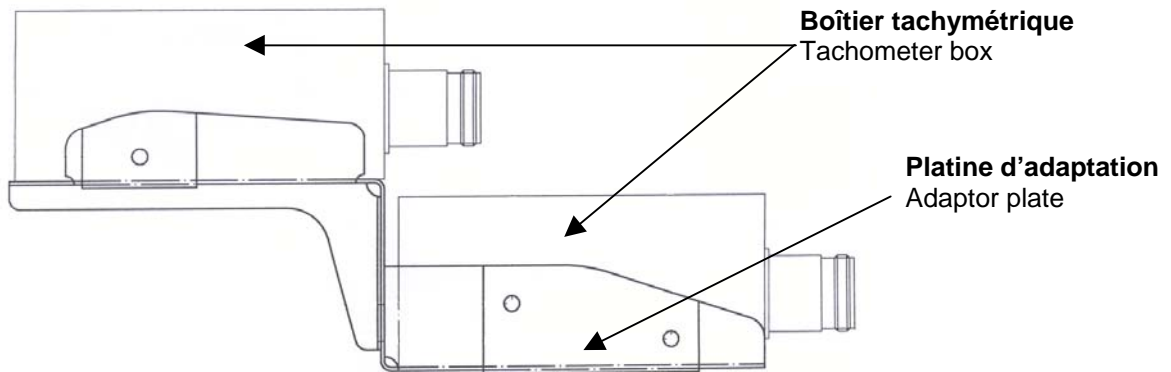
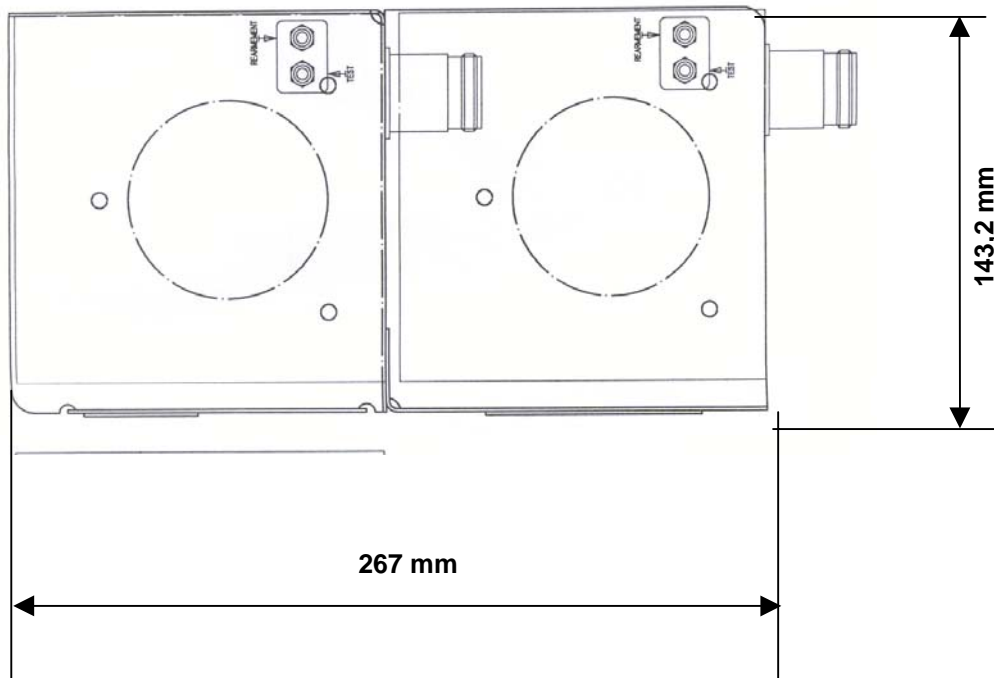
ANNEXE 2 / APPENDIX 2

Boîtiers tachymétriques post TU 330
Post TU 330 tachometer boxes

This replacement requires a new adaptor plate that is compatible with all boxes manufactured by TURBOMECA.
