IMCA Safety Flash 06/09

May 2009

2 Fatality During Lifting Operations

3 Failed Nipple on Bolt Tensioning Jack

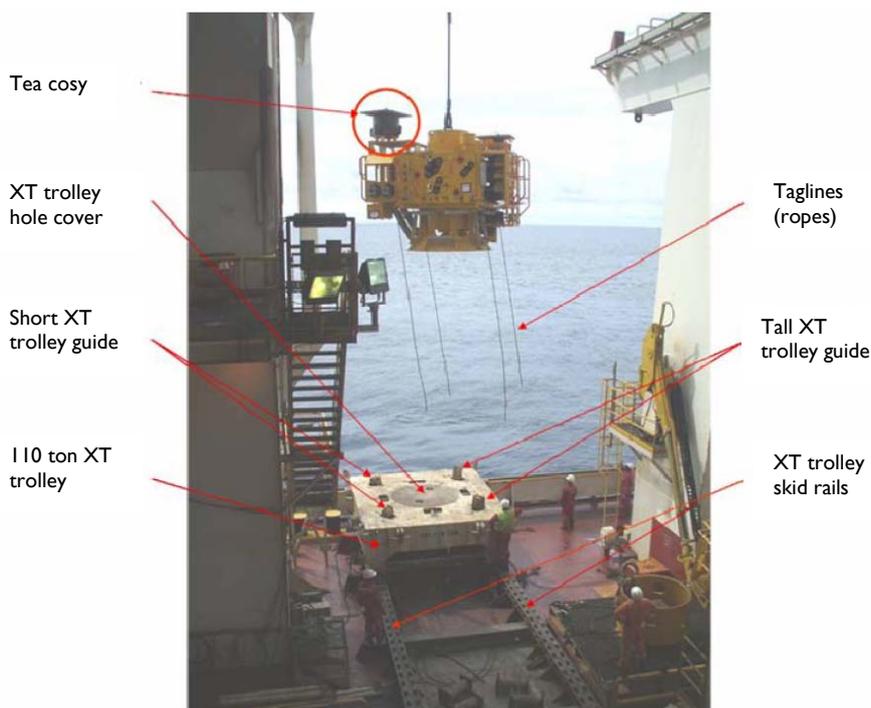
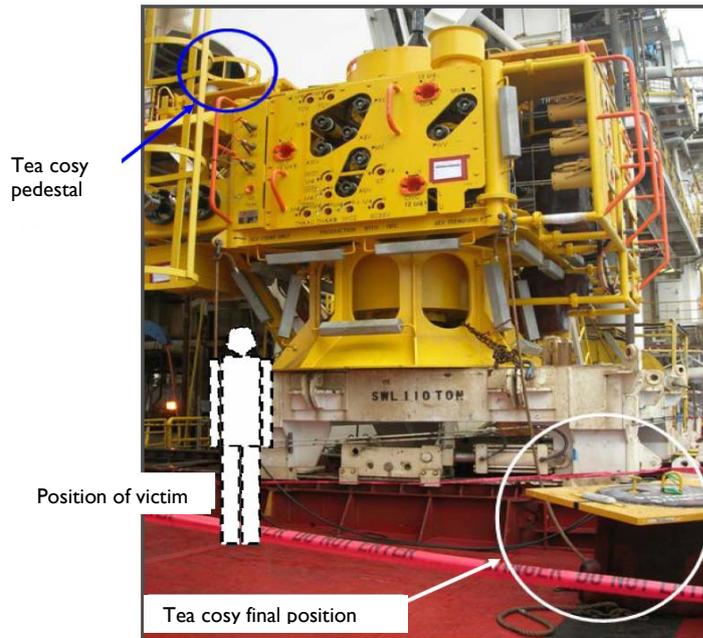
A member has reported an incident in which a fatality occurred during lifting operations. The incident occurred on a drillship while attempting to land a christmas tree (XT), using one of the vessel cranes, on to the XT trolley (see general view below). It was important to centralise the XT, which weighed 50 tons in air, on to the trolley.

The tree was approximately 0.6m above the trolley for final positioning when the main hoist hydraulic motor of the crane failed catastrophically. The 50 ton XT fell on to the trolley and as a result a further item known as the ‘tea cosy’, weighing 335 kg, came loose from its pedestal on top of the XT and bounced off the XT on its way down to the deck. A member of the crew supervising the operation was struck by the tea cosy and died instantly.

- ◆ Failure in crane control:
 - A week before the accident the main hoist hydraulic motor was replaced by an incorrectly sized motor available onboard the vessel. Though both motors look very similar and can be installed in the same position they have very different torque characteristics and are designed for different purposes

- There was no in-depth investigation performed following the first hydraulic motor failure a week before
 - The hydraulic motor was changed without reference to the crane manufacturer’s manuals (which were available onboard)

- ◆ Failures in operational control:
 - The tea cosy was not fully secured on its pedestal. Under ‘normal’ lifting conditions, full securing of the tea cosy was not considered necessary; the sudden shock due to the free fall of the entire XT had not been identified as a hazard

- ◆ Ensure all are aware of the possibility of inappropriate hydraulic motors interchange on crane SEATRAK Model 7228;
- ◆ Ensure full assessment during lifting/crane audits of onboard preventive maintenance system;

- ◆ Improve thoroughness of risk assessments in order to correctly identify all hazards. Results and findings must be communicated during pre-job meetings to all persons involved in operation;

- ◆ The design process and hazard identification study (HAZID) review of the XT should not only focus on final use of the product but also upon packaging, fastening, lifting, transportation and installation conditions and hazards. This should include design of the tea cosy pedestal and fastening method of all non permanently attached items;

- ◆ Redesign and re-engineering of the centralising guides on the XT trolley;
- ◆ More careful attention to the handling of heavy lifts on a drillship with a near vertical crane boom.

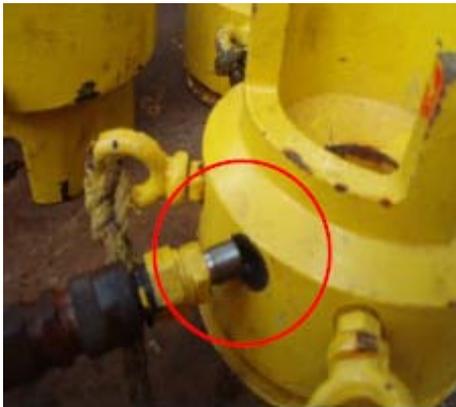
On investigation it was noted that an incorrect bolt tensioning jack assembly had taken place when a nipple intended for the interconnecting whips had been installed instead of the recommended correct one. The difference in thread size is quite minimal but can be easily identified visually by the different size orifice. Whenever the incorrect nipple comes loose through constant utilisation, this difference is sufficient for it to be forced out when hydraulic pressure is applied to the system.

Nipple shown loose

It is recommended that all nipples on used bolt tensioning jacks/interconnecting whips should be removed and visually checked to ensure that the correct fitting is in place, and replaced as necessary, followed by a maximum system pressure test.

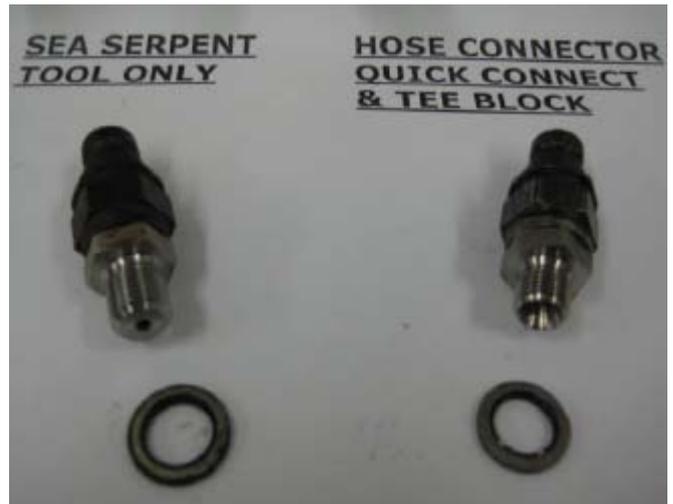
Correct adapter
