IMCA Safety Flash 06/10

September 2010

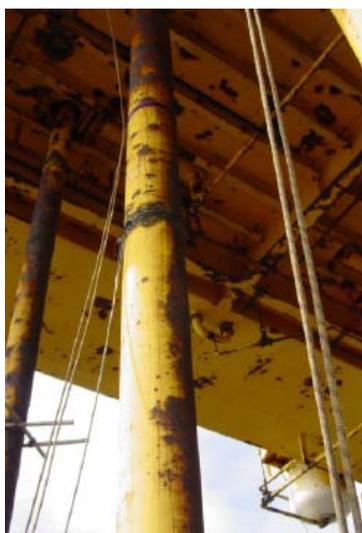
A member has reported an incident in which a rope access technician (RAT) suffered third-degree burns whilst engaged in hot work. The injured person was engaged in rope accessed structural cutting activity using an oxy-acetylene torch on a 20 inch pump caisson. During the operation sparks and molten material were blown in the direction of the injured party, and a small piece of molten material was caught in the tongue and ankle protector of his left safety shoe, causing serious burns to the left foot. The injured person was able to stop work, swiftly remove his safety shoe and safely descend to deck level using the rope access gear. Following initial first aid, it was noted that the burn was more serious than could be treated onboard and arrangements were made for the injured person to receive further treatment in hospital ashore.

Figure 1 - Area in which rope access hot work was taking place

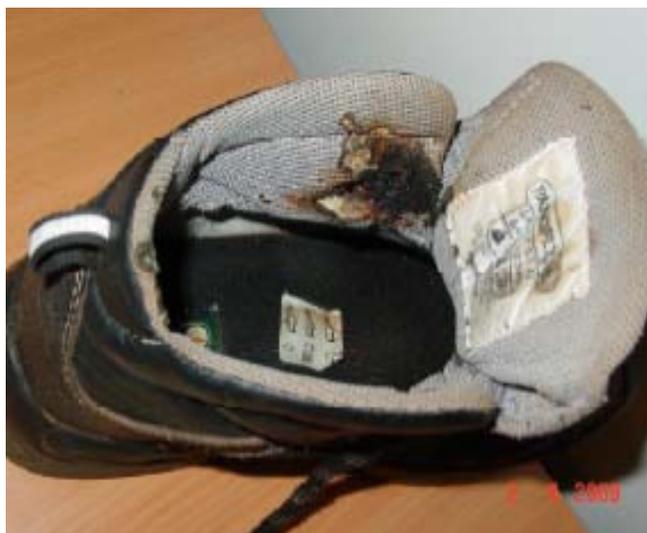
Figure 2 – Injured person's safety shoe showing burn damage

The direct cause of the incident was failure to use the correct personal protective equipment (PPE). Spat protectors were not readily available, partly due to inadequate organisation. These offer flame retardant protection to part of the under leg, ankle and shoe.

The root cause of the incident was inadequate procedures and standards of work.

- ◆ Arrangements were made to make spat protectors available as soon as possible;
- ◆ Investigated the use of more substantial protective equipment for persons doing hot work;
- ◆ Arranged for all appropriate worksite safety documentation (e.g. PTW, JSA and TBT records) to be available with specific detailed job-related entries;
- ◆ Investigated further training for personnel engaged in hot work, particularly flame-cutting.

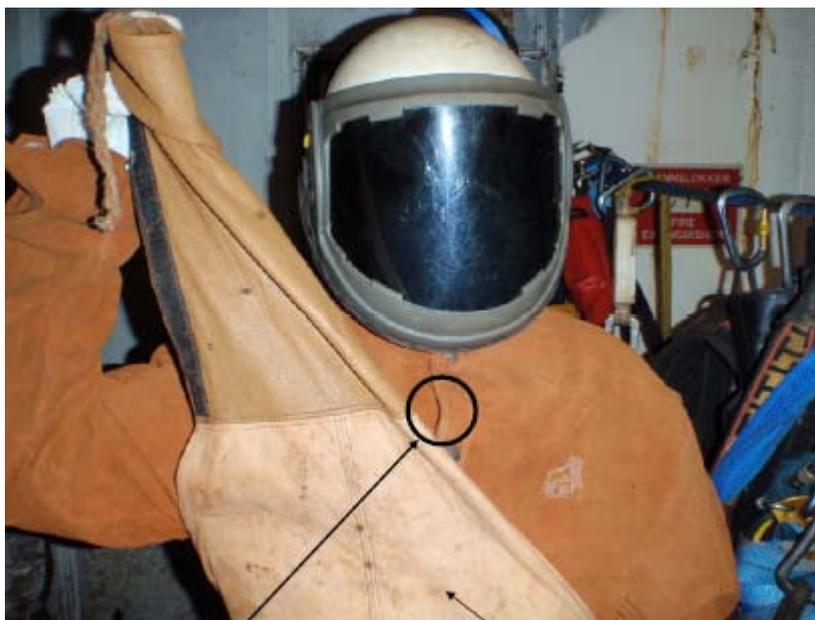
- ◆ The direct cause of the incident was molten particles entering through an opening between the buttons of a fully closed leather protective jacket. This personal protective equipment (PPE) was not giving full body protection.

Figure 1 - Protective clothing for rope access technicians showing small opening through which hot particle passed

- ◆ Protective jackets used for hot work should close using "velcro" closing straps rather than buttons;
- ◆ Consideration should be given to different kinds of protective clothing, including flexible fireproof hoods designed to cover shoulder, chest and neck area;
- ◆ It should be emphasised at toolbox talks and in preparation for hot work that molten particles can enter PPE through the smallest openings.

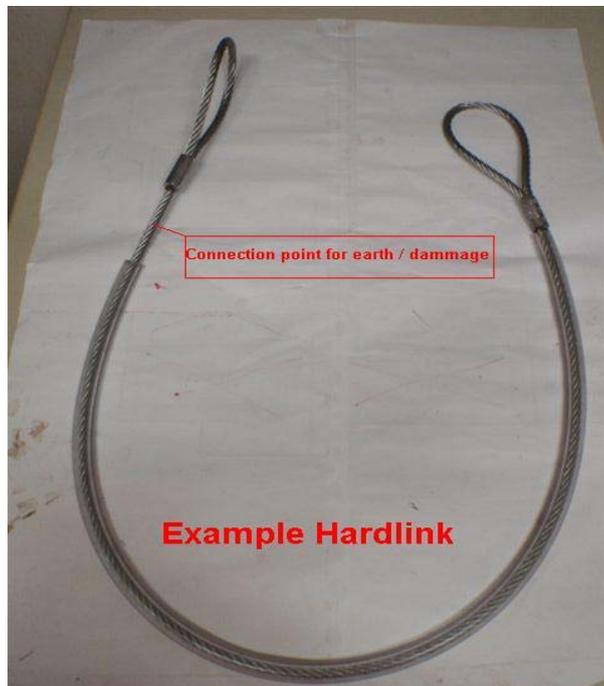
At the moment the RAT opened the air flow to start gouging, water streamed out of the nozzle instead of air. This resulted in the technician instinctively pulling back the gouging torch. During this uncontrolled movement, the gouging torch connected with the stop descender - a steel part of the technician's climbing gear. Since the technician was connected using a hard metal link to a beam on the platform, the technician's metal climbing equipment made an electrical circuit to earth and current flowed from the gouging torch. As a result, three of the six strands of the hard link were burnt through.

Figure 1 - Typical metal 'hard-link' for rope access technicians

- ◆ Replace metal hard-link with a non-conductive nylon climber's sling;
- ◆ Ensure water is drained out of air supply before use with gouging torch.

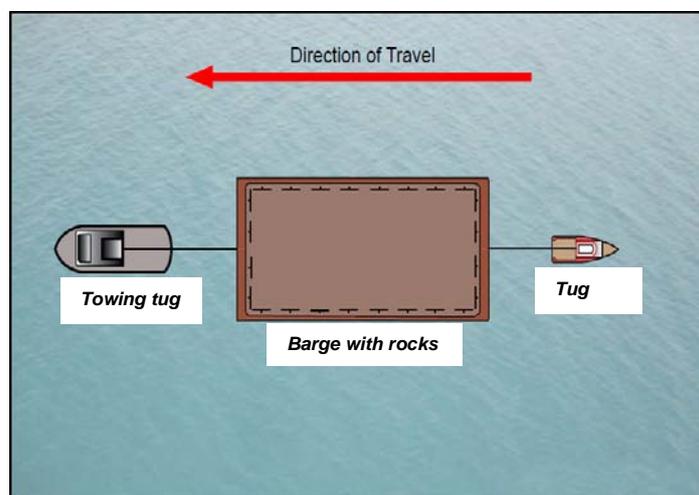
A member reports an incident in which a tug girted and capsized during towing operations. A third-party contractor's tug was acting as a stern tug for a heavily laden barge arriving in port. The master of the stern tug chose to deploy the towline over the stern of his vessel, and intended to maintain position and heading relative to the barge by using the tug's engines. A bridle (Gob) wire was not rigged. As the lead tug increased speed, the master of the stern tug found that he was unable to effectively control the yawing of his tug, and five minutes after connecting to the barge, the vessel took a large sheer to starboard, girted and capsized. The crew escaped without injury.

Figure 1- Diagram of the Towing arrangement

- ◆ For a conventional tug, towing over the stern, particularly while running astern, is an inherently unstable mode of operation;
- ◆ The towing speed was too high in this instance;

- ◆ The lack of a bridle wire or “gob rope” meant there was no physical safety device to prevent the tug from girting when directional control was lost;

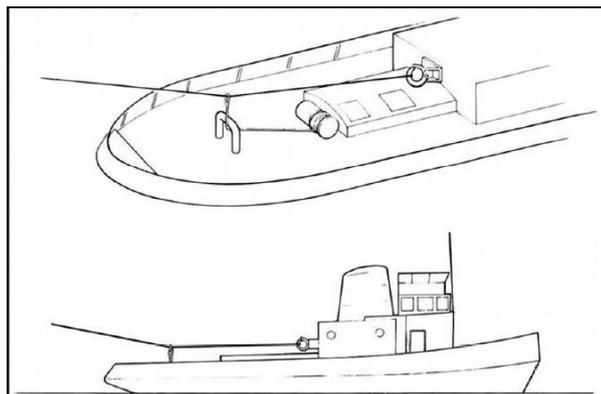
Figure 2 - illustration of ideal towing arrangement

- Captains of towed vessels should remain aware of using the propulsion, and the combination of forces acting on the hull;
 - The use of a shot string (standard on single propulsion, advisable on double propulsion vessels) helps to keep the towing wire on the aft ship centrally positioned and avoids girting, the towing point being brought to the aft of the ship instead of on the pivot point of the tug. See example in Fig. 2.

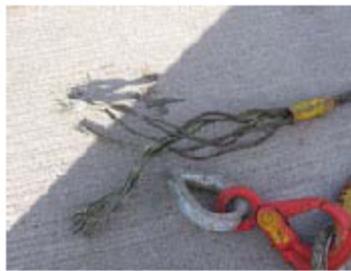
This incident occurred on an offshore installation during the lifting of a container weighing 9.5 tonnes. A 5m long 15 tonne working load limit crane pennant was connected between the crane hook and the master link on the container sling set. The crane pennant had been manufactured from 36mm diameter wire rope and the eyes on each end had been formed by using the Flemish eye technique. Steel ferrules had been used as the termination and these had been pressed over the Flemish eye rope strand tails. During the lifting of the load the wire rope strands in the tails of the Flemish eye connected to the pennant hook became free inside the ferrule allowing the Flemish eye to unravel and the load to fall. The photograph shows the crane pennant and the Flemish eye tails which have unravelled and pulled out of the ferrule.

The crane pennant and the Flemish eye tails which have unravelled and pulled out of the ferrule

The ferrule-secured system designers¹ published instructions detailed the ferrules that should be used for particular rope diameters. However, 36mm diameter rope was not listed. The crane pennant manufacturer had selected a ferrule (1.5") and considered sufficient tests had been undertaken to verify this selection. This incident has highlighted that these tests did not fully replicate the dynamic (tensile and torsional) loading experienced by an offshore crane pennant.

1. Check whether wire rope slings and crane pennants with Flemish eye terminations are in use.
2. Verify with the supplier or manufacturer that the rope diameter to ferrule combinations used in the construction are in agreement with those published by the ferrule-secured system designer.
3. In the case of combinations, which are not in agreement, obtain verification from the supplier or manufacturer they can satisfy point 2 below.
4. Where such verification cannot be obtained, remove these slings from service.

1. Only supply wire rope slings and crane pennants that adhere to the ferrule-secured system designers published combination of rope diameters to ferrule sizes.
2. Any additions to these published combinations should only be undertaken with the agreement of the ferrule-secured system designer and verified by a range of type tests representative of the dynamic loadings that will be experienced in service. The results of these type tests should be made available to users if requested.
3. Where slings and crane pennants have been supplied which do not meet the above criteria contact their customers and advise them to remove such items from service.
