IMCA Safety Flash 06/11

July 2011

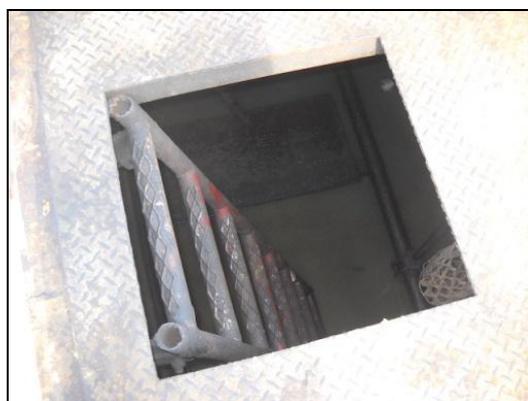
IMCA has received information about a confined space incident in there were multiple fatalities. The incident occurred at an oil well on land. A workman entered a water tank that contained water mixed with nitrogen, and collapsed. A co-worker entered after him in an attempt to rescue him, and likewise collapsed. He was followed by two further workers who also collapsed.

Water tank where incident occurred

- ◆ Procedures were not followed
 - There was no permit to work for confined space entry arranged in this case;
 - There were no multi-gas tests conducted (LEL, O₂, CO₂ and H₂S) before confined space entry.
 - Personnel did not wear appropriate personal protective equipment (PPE) for task;
 - The rescue attempt was not properly planned or thought through.

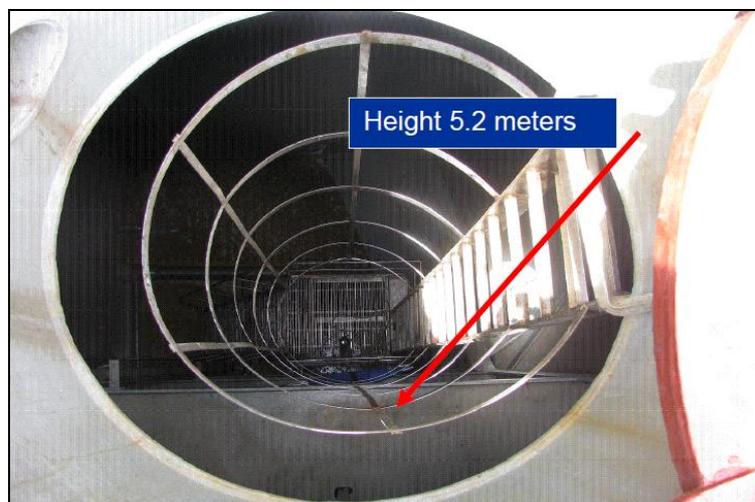
All three persons became unconscious in the tank. Shortly thereafter the second officer started preparations for entering safely into the starboard slop tank. A portable fan was fitted to the slop tank in order to accelerate the ventilation. In the meantime the atmosphere inside the tank was measured by a portable gas analyser. The device went off to indicate the existence of the H₂S in the tank. The read values were O₂: 20, CO: 0, H₂S: 60 and LEL: 0. Then the second officer put on a BA set and entered the slop tank. Afterwards the crewman, the chief officer and the bosun were all lifted out of the tank. The crewman and the chief officer were hospitalised and made a full recovery. Unfortunately the bosun could not be resuscitated and died.

Entrance to slop tank in which incident occurred

- ◆ The bosun had fallen into the slop tank for unknown reasons;
- ◆ The chief officer entered into the tank impulsively ignoring the safety rules completely and acting emotionally to help his colleague;
- ◆ The crewman also reacted emotionally rather than logically and entered the tank to assist the chief officer to rescue the bosun;
- ◆ The recovery operation, including identified the danger caused by the accumulated gas in the tank, the rescue of the victims from the tank, the application of the first aid treatment and the helicopter medevac was carried out successfully and professionally in accordance with company procedures;
- ◆ There was inadequate understanding of how this lethal concentration of H₂S had been produced in the slop tanks.

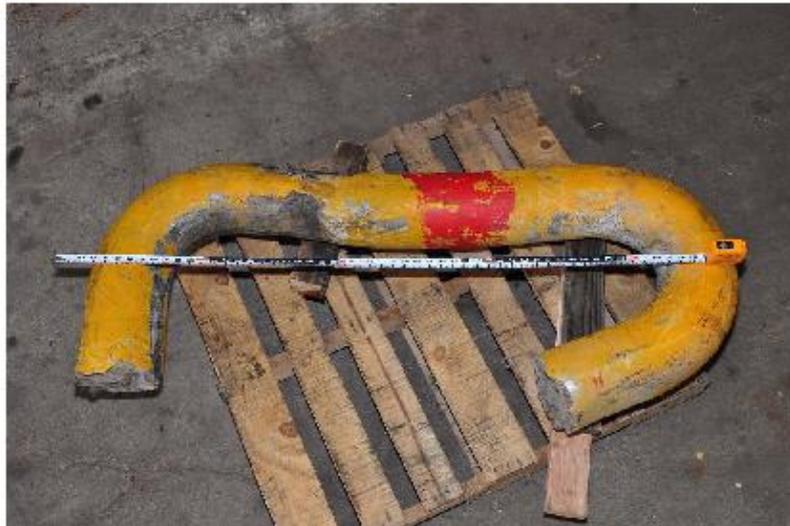
Failed Chain Link

The investigation determined that a 6 3/4-inch diameter, 862-pound chain link in the tether chain had fractured and separated near its butt weld. Analysis of the fracture indicated that the chain link had a weld repair and the fracture initiated in the middle of the weld. Three links of the 24-link tether chain were found to have weld repairs. After the chain had been heat treated, the non-US based manufacturer had made weld repairs to the chain by grinding defects and filling the void with weld material. The chain was being built in accordance with Det Norske Veritas (DNV) Offshore Mooring Chain standard. Post heat treat weld repairs are disallowed per DNV's Offshore Mooring Chain standard. The post heat treat weld repairs made the chain susceptible to hydrogen induced stress cracking due to the extreme hardness

of the weld material and the residual stress within the weld.

- Operators should monitor and inspect critical mooring components 100% of the time during the manufacturing process.
- Operators should ensure that the personnel and companies contracted to perform inspections and quality assurance of critical mooring components are qualified to do so.
- Operators should treat the area above a buoyancy air can for a free-standing hybrid riser as potentially hazardous. No floating production facility or support vessel should be allowed to pass over a free-standing hybrid riser.

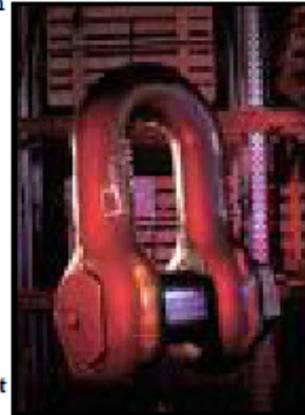
Incident No. 1: A one-ton, 8+ inch-diameter shackle connecting a mooring system to anchoring pilings failed on an overseas floating production facility. Subsequently, an identical shackle scheduled to be used in a deepwater GOM production facility also failed catastrophically under test loads below specifications. Operator reviews of the manufacturing and testing procedure and additional material testing indicated that all of the shackles were possibly defective.

- In both cases the manufacturing procedures are thought to have been defective. Heat treating after casting apparently resulted in a metal unable to meet "Charpy" standards for material "toughness."
- In both cases, the Operator's and/or manufacturer's specifications for the items were either out of date or inadequate.
- In both cases the Operator's material testing requirements were either not followed, or were not adequate to insure specifications were met.
- Material handling during installation may have exposed the equipment to potential critical damage.

Example: Mooring Shackle

- Operators should review their specifications requirements to insure testing and manufacturing produces a product that will meet the usage demands.
- Operators should include sufficient *Charpy testing requirements* in the specifications to insure the materials and manufacturing process will produce a product of sufficient toughness.
- Operators should review their requirements for both destructive and non-destructive testing of critical elements. Operators should insure their test coupons are properly representative.
- Operators should review their requirements for equipment inspection and handling to insure no damaging techniques are employed in transportation or installation.

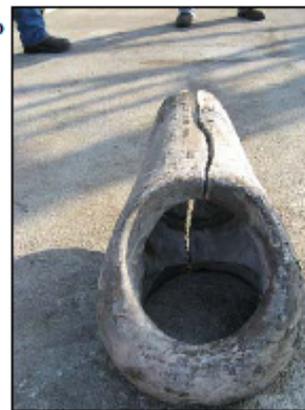
Incident No. 2: Two sockets in a mooring system for a MODU failed under moderate loading. Testing of the remaining sockets found that others were also defective and a number of them failed catastrophically at less than specification loading.

Failed Mooring Socket
