IMCA Safety Flash 06/12

June 2012

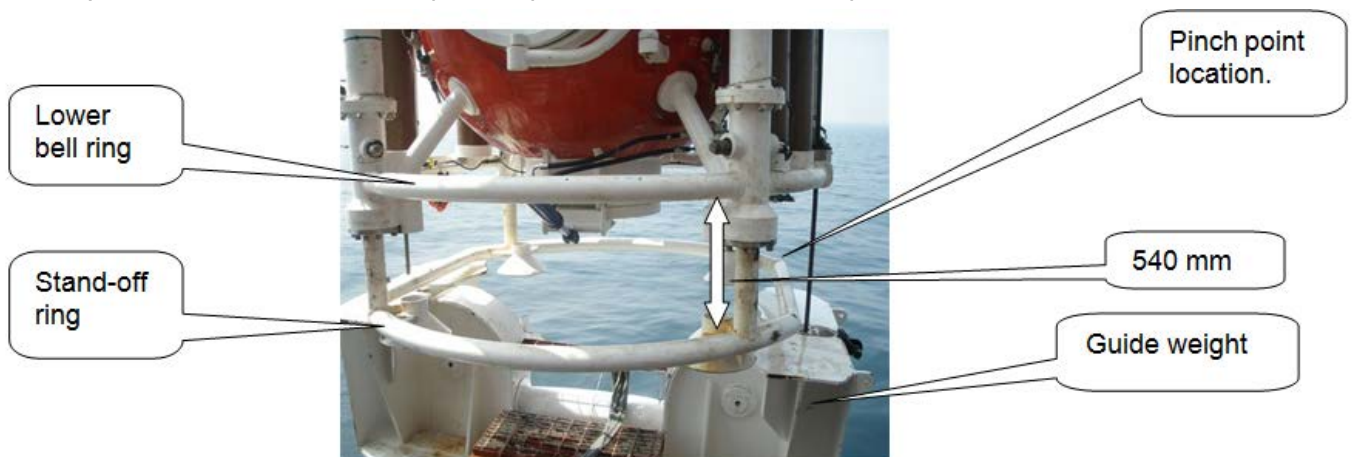
A member has reported a near-miss incident in which a saturation diver on the seabed lost reclaim and immediately thereafter, lost his main gas supply. The incident occurred during pipeline free span correction measurements at a depth of 100m. The diver made his way back to the bell on emergency gas, and while doing so, requested 'up on my hose'. However no such action followed. Slightly over a minute and a half later the diver had made his way unassisted back to the bell on emergency gas. As he passed by the bell stand-off ring he became aware that his hose was trapped between the stand-off ring and the guide weight. Once the diver was inside, the bell was raised and the umbilical retrieved and inspected for damage. The diver was unharmed.

- ◆ There was no written procedure for setting the bell directly on the guide weight during dives;
- ◆ Egress from the bell was between the guide weight and the stand-off ring rather than between the stand-off ring and the lower bell ring;
- ◆ In-boarding of the bell launch and recovery system (LARS) resulted in a decrease in the gap between the guide weight and the stand-off ring which subsequently trapped the excursion umbilical to the extent that gas flow through all lines was interrupted. A video image of the gap area was available at the control panel of the LARS but not in dive control.

A view of dive bell showing pinch point location

- ◆ A stand down and investigation was initiated prior to continuing diving operations;
- ◆ An enquiry was made to the system manufacturer as to the intended method of entry and exit from the bell.¹ It was confirmed that the normal route was between the stand-off ring and the lower bell ring. The use of twin 12 litre cylinders with flotation attached impeded access through the designed route (540 mm). The bottom hatch opening is itself 700 mm. It was further agreed that the space limitation would compound matters in the performance of a rescue dive. For this reason the route chosen was not altered for the remainder of the project;

- ◆ Investigation as to the feasibility of modifications to increase the gap to 800 mm are on-going with the manufacturer and the owner;
- ◆ For subsequent dives a sign was posted at the LARS control console advising landing of the bell upon the guide weight while divers are locked out, with reminder to confirm with the Supervisor prior to any movement of the launch equipment while diving. A statement to this effect was included in written procedures and communicated throughout the company;
